# Erosion

## Introduction

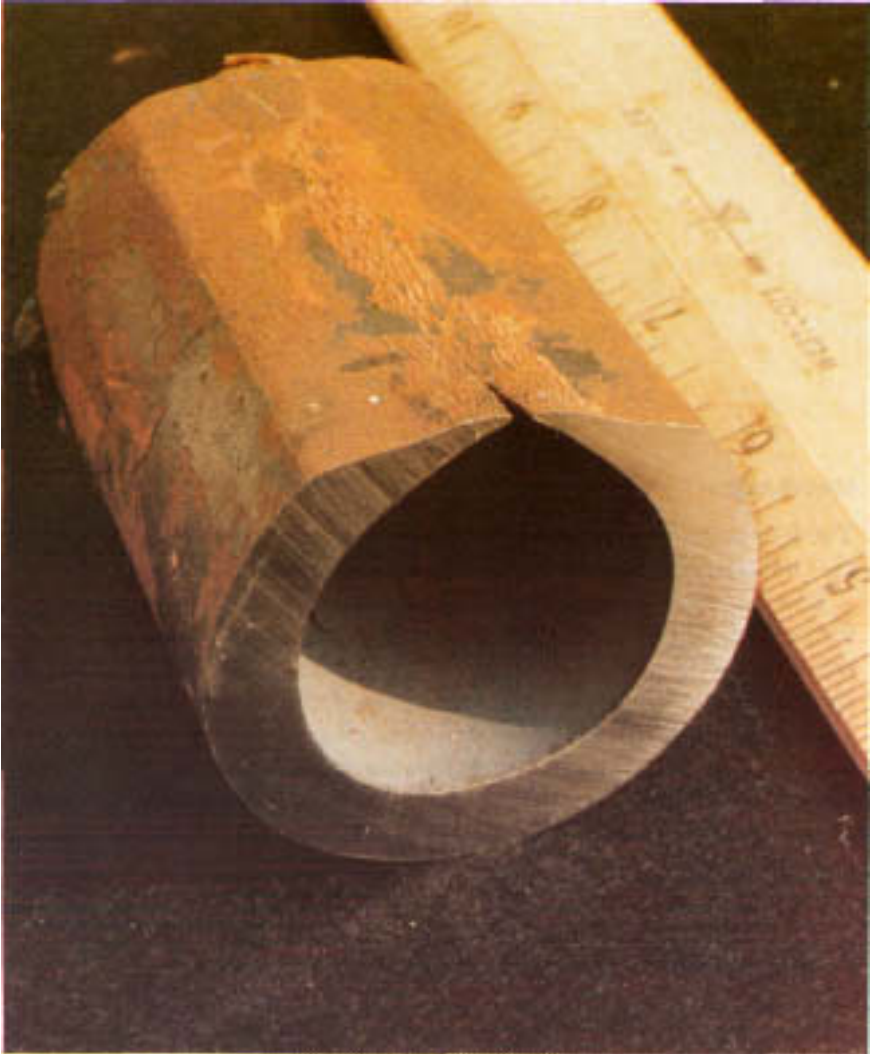
**Figure 17.1** Superheater section thinned by soot-blower erosion. Note the flattened surface. The tube bulged and ruptured on the thinned side. Also, note how the eroded surface color is not dissimilar to unattacked regions, indicating intermittent attack.

Perhaps the most common cause of erosion in boilers is soot-blower attack. Usually a misdirected blower allows a high-velocity jet of steam or air carrying condensed water droplets to impinge directly upon tube surfaces, rather than to be directed between tubes. Physical abrasion and accelerated oxidation cause metal loss. Damage can be accelerated by fly ash entrained in the high-velocity jet stream directed against the tube surface. Erosive thinning often leads to tube rupture (Figs. 17.1 and 17.2).

Proper soot-blower operation, alignment, and function are required to reduce attack. Periodic inspection of nozzle position and alignment is recommended. Elimination of moisture in blowing steam can be accomplished by allowing adequate steam warm-up and providing for adequate drainage of steam supply lines. Metallizing, welding, and plasma spray techniques can increase wall thickness in affected areas and thereby prolong tube life. Coating processes, however, can slightly reduce heat transfer locally and do not remove the root problem.

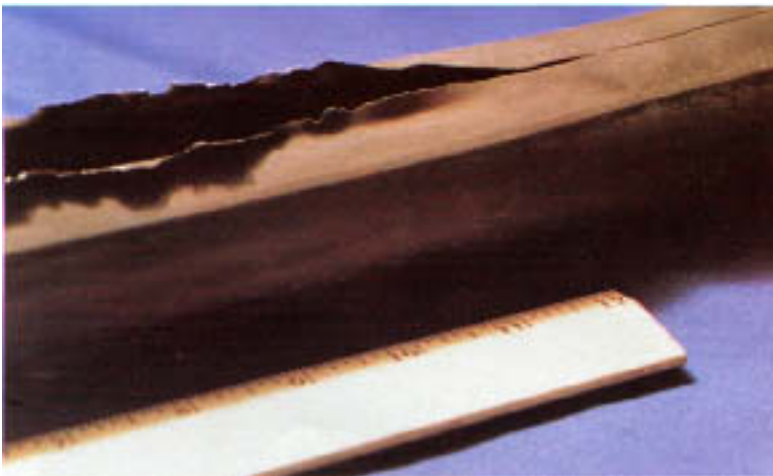
Soot-blower erosion is caused by improper blower alignment. Entrainment of either condensed water or fly ash in the blower gas also accelerates attack. Raising blowing pressure increases gas velocity and thus promotes damage by entrained fly ash. Improper alignment and operation are the most common sources of damage.

**Figure 17.2** Tube rupture caused by a misdirected soot blower. Rupture edges are thin and ragged because of tearing of the wasted steel in the eroded zone. The tube surface is light gray and shiny as a result of erosion of the normally present fire-side oxides and deposits.

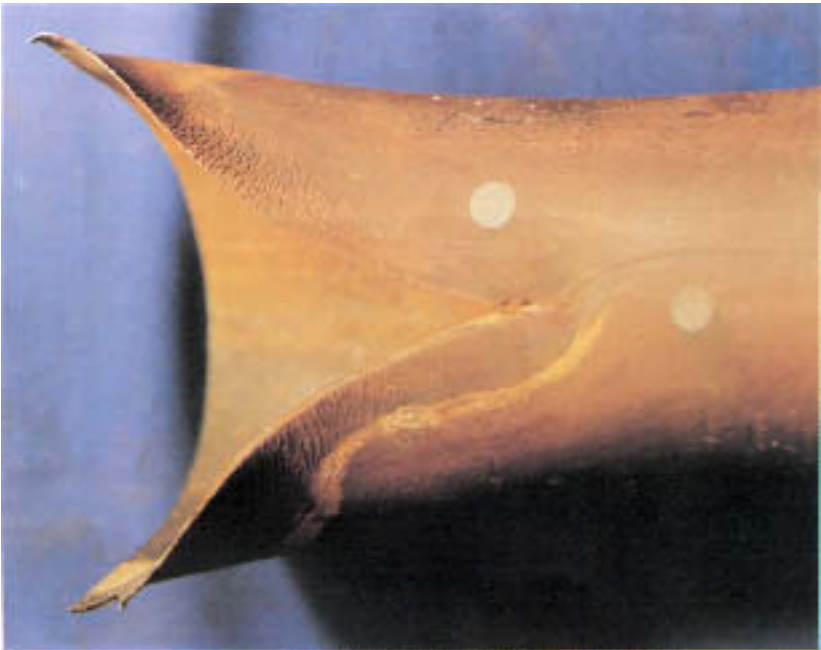
**Figure 17.3** Numerous parallel surface ripples at the edges of an external-surface rupture in a superheater tube. The light circles are regions where acid drops removed the thin oxide layer during laboratory testing.

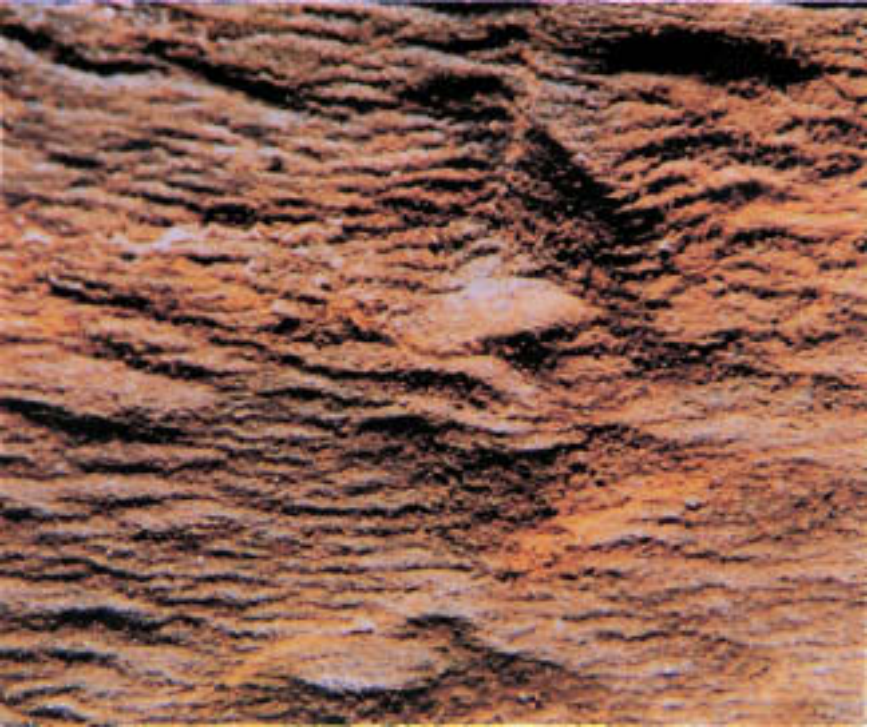
**Figure 17.4** Finely spaced, wavelike, parallel undulations on eroded fire-side external surface of superheater tube. The striations resemble waves viewed from the air and are aligned perpendicularly to the direction of steam impingement. (Compare with Fig. 17.3.)

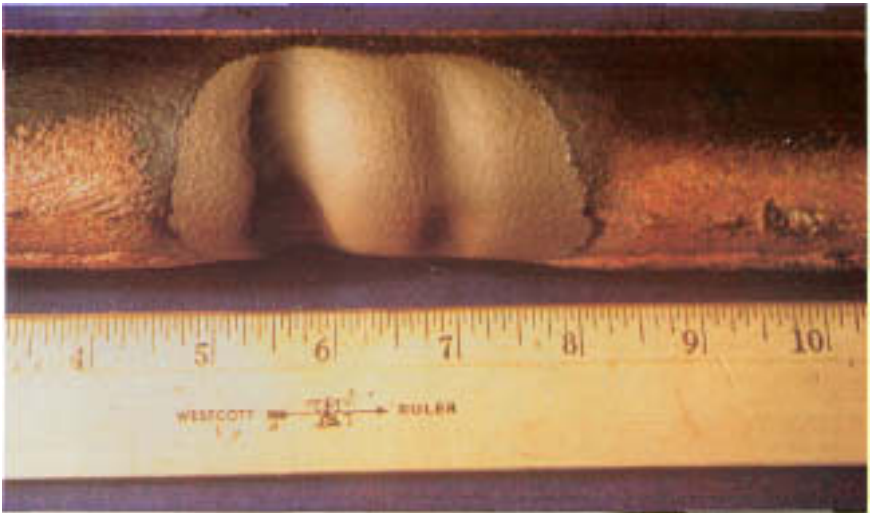
**Figure 17.5** Utility superheater tube cut by steam leaking from an adjacent tube that failed at a manufacturing defect. Note the smoothly undulating surface and removal of red and black oxides and deposits in the wasted area.

A series of failures of superheater tubes occurred almost 2 years after extensive retubing. Nearby tubes contained forming defects present as deep fissures. These fissures opened in service, causing steam cutting of adjacent tubes (Fig. 17.5).

It is remarkable that failures similar to this one occurred almost 2 years earlier, and for essentially the same reason. In spite of the extensive retubing, some defective tubes were missed. Tubes containing deep fissures remained in service for at least 2 years before failure occurred. When these defective tubes finally failed, extensive steam cutting of nearby tubes resulted.

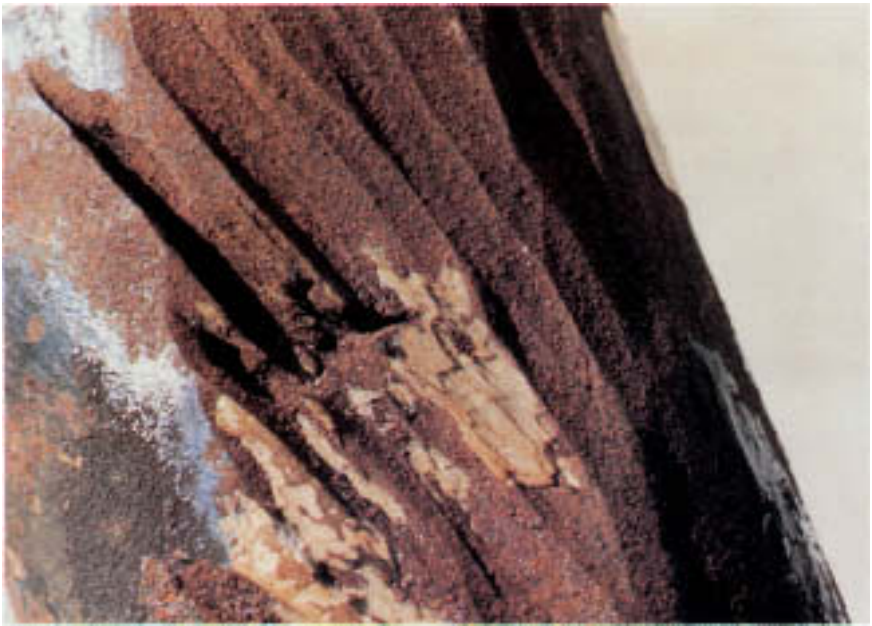
**Figure 17.6** Grooving on pendant U-bend superheater leg caused by steam leaking through a corrosion-fatigue crack at the U-bend. Grooves were rusted after removal from boiler.

A superheater tube failed at a pendant U-bend. Failure was caused by corrosion-fatigue cracking. Leakage was relatively slight before opposite legs were steam-cut (Fig. 17.6). More tubes had to be replaced because of chain-reaction failures associated with steam cutting than because of the precipitating corrosion fatigue.

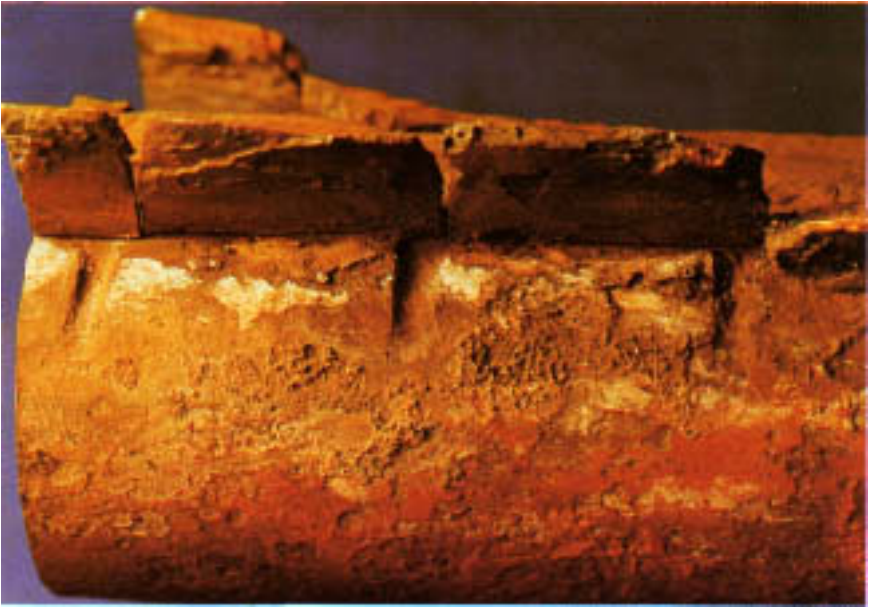
**Figure 17.8** Deep grooves cut into the hot side of a waterwall tube. Grooving was caused by channeling of furnace gases containing entrained fly ash.

A rupture occurred at a repair weld. Welding was used to increase lost wall thickness to about 50% of the specified wall thickness. These welds built up metal loss from fire-side surfaces.

External-surface metal loss was caused by erosion due to the impingement of fly ash entrained in flue gas. Deep grooves were cut in the tube wall at membrane gaps (Fig. 17.8).

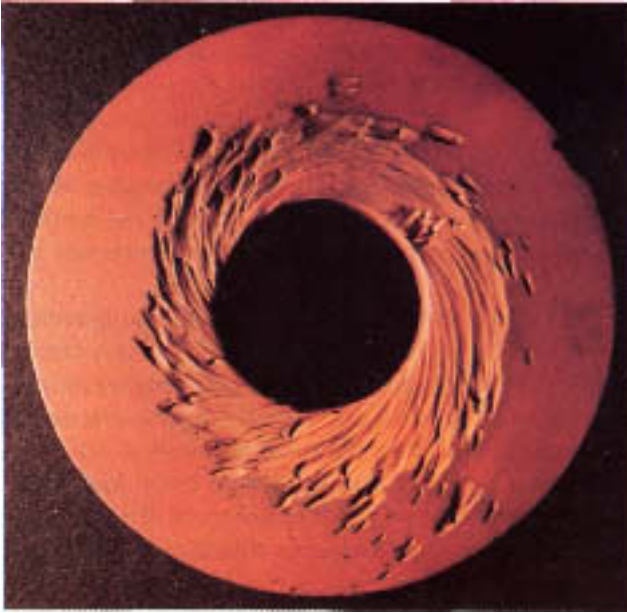
*Preboiler.* Erosion caused by turbulent water flow in pumps usually produces smooth grooves, craters, and general thinning (Fig. 17.9). The oxide layer in eroded regions is thinner or absent, usually is a different color, and has a smoother surface texture than in unattacked adjacent regions. A drop of acid placed on freshly eroded carbon steel will reveal

**Figure 17.9** Feedwater-pump spacer eroded by turbulent high-speed water. Flow patterns are obvious.

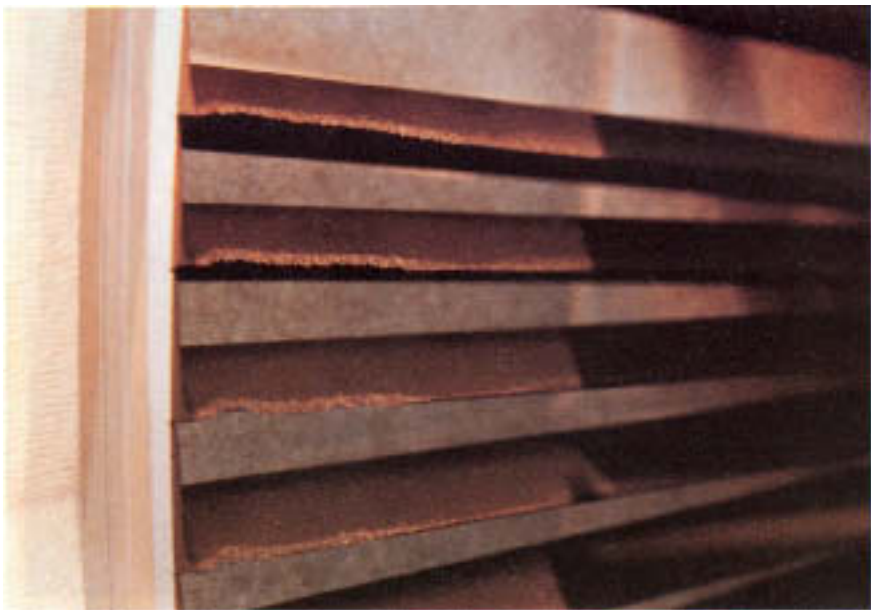
**Figure 17.10** Ragged leading edges of final-stage turbine blades. Damage was caused by water-droplet impingement.

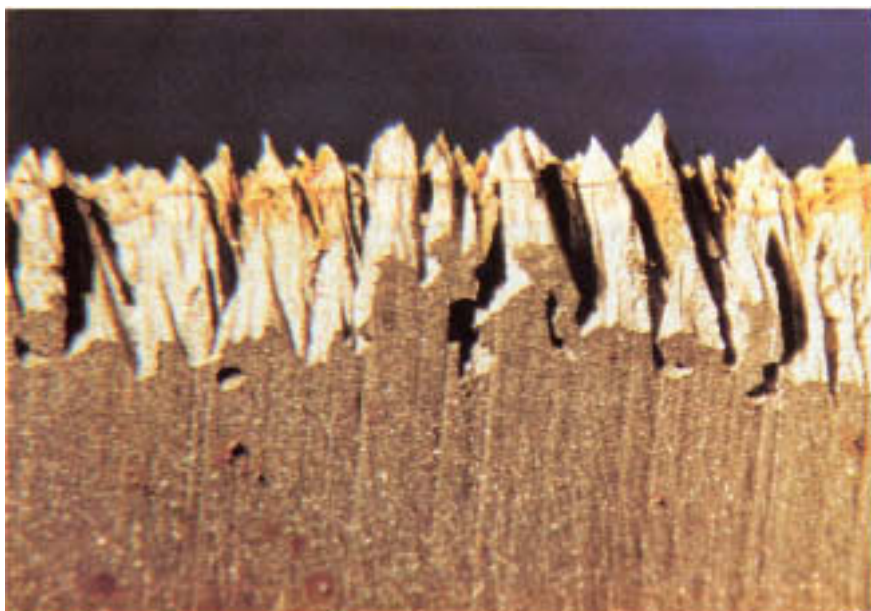
**Figure 17.11** Fine, striated grooves on front face of final-stage turbine blade caused by water-droplet impingement. (Magnification: 7.5X.)

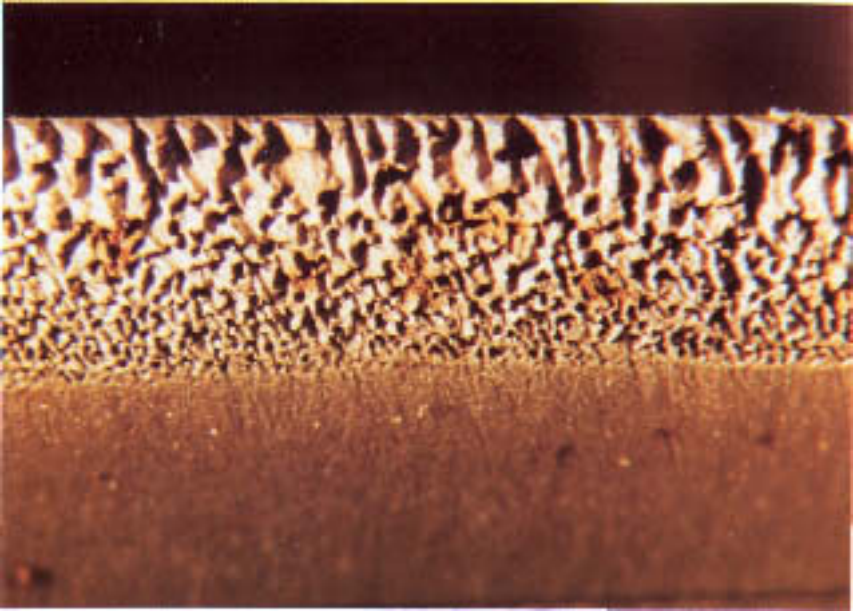
**Figure 17.12** Dimpling of back edge of bucket surface shown in Fig. 17.11.

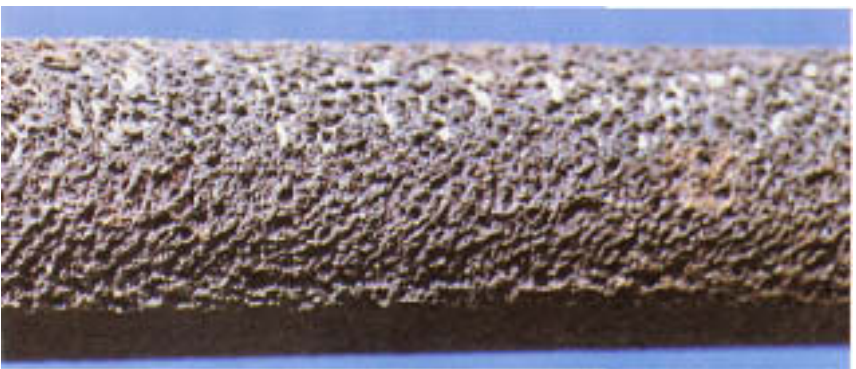
**Figure 17.13** Erosion on mild steel turbine drain line. Surface is festooned with small, conical projections pointing toward the direction of impingement.

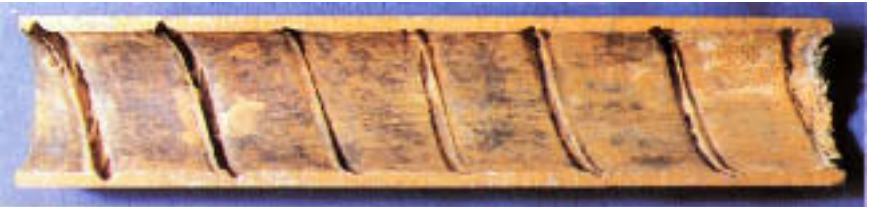
A longitudinally split section of flue-gas cooler used to preheat boiler feedwater contained helical grooves on internal surfaces (Fig. 17.14). Some grooves penetrated the tube wall, producing helical cracks, while other grooves went only one-third of the way through the wall. Grooves were undercut in the direction of gas flow.

Erosion occurred along a helical coil inside the tube. The helix was used to increase turbulence and eliminate deposits. High-velocity flue-gas flow became sufficiently turbulent at the helix to cause erosion failures.

**Figure 17.14** Spiral grooves cut into internal surface of flue-gas cooler by erosive gas flow. A spiral, stainless coil present inside the tube caused increased localized turbulence.

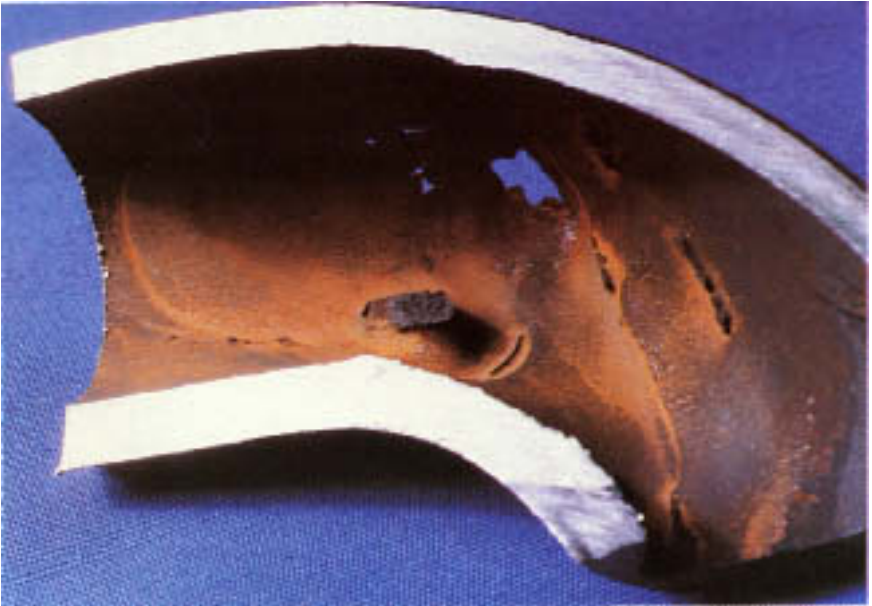
Severe localized metal loss from internal surfaces caused a perforation in a U-bend 10 months after tube installation. This was the only tube that was affected in this manner. An elliptical pattern of metal loss was present in the immediate vicinity of the perforation (Fig. 17.15). Islands of intact tube wall were present in the wasted region.

Failure was caused by impingement of high-velocity fluid on tube surfaces. It is likely that an object lodged in the tube on the upstream side of the bend constrained the water flow into a narrow channel. Erosion was induced locally by increased water speed and greater turbulence near the foreign object.

**Figure 17.15** Elliptical metal-loss pattern and intact island of tube metal at perforated superheater U-bend. Erosion was caused by an object left in the tube 10 months earlier.

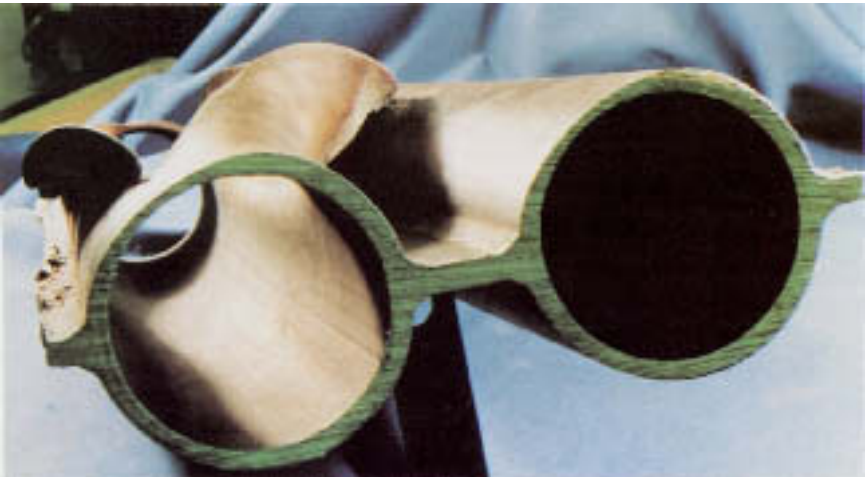
The section has a massive longitudinal rupture in a zone of severe metal loss from external surfaces (Fig. 17.16). Failure was caused by external-surface erosion. Microstructural examination revealed that hard particulate matter (sand) was entrained in bed gases. Impingement of sand against the tube reduced wall thickness, resulting in severe thinning. Rupture occurred when internal pressure exceeded the yield strength of the thinned tube.

The forced-draft fan maintained a 60- to 70-in. (15- to 17.5-cm) pressure head of water to fluidize the bed. No refractory or other surface protective devices such as studs or wear bars were present at the failure site.

**Figure 17.16** Ruptured division-wall tube from fluidized-bed boiler. Attack was caused by sand abrasion in the bed.

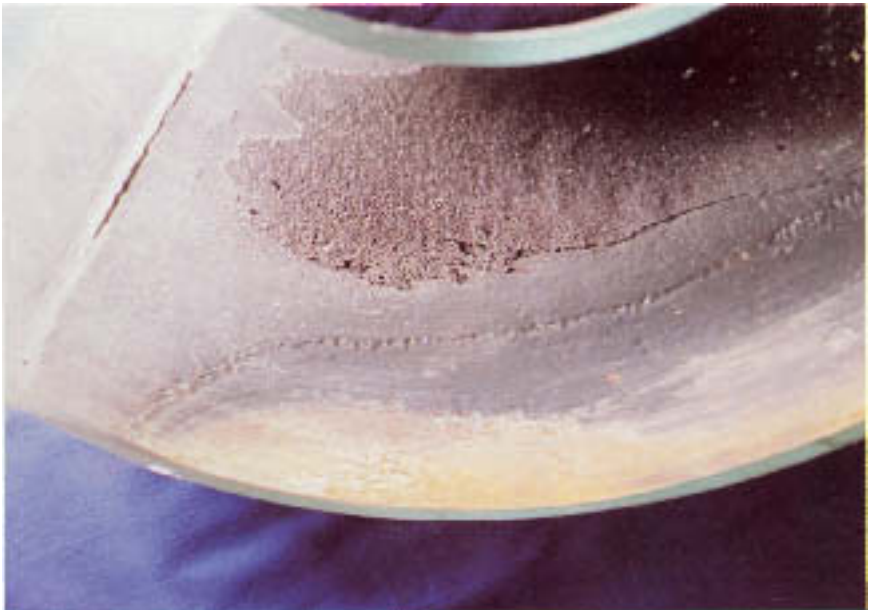
Internal surfaces were covered in some areas with a smooth, black magnetite layer. Severe metal loss was present in large, distinct patches (Fig. 17.17). The metal loss produced smooth, mildly rolling contours free of deposits or corrosion products. Flow-oriented striations were present at the perimeter of the affected area (Fig. 17.18).

Condensate lines frequently suffer corrosion by carbonic acid. However, this tube shows evidence of erosion only. Metal loss is localized and distinctly flow-oriented. Such patterns are characteristic of erosion. Evidence suggests that magnetite particles entrained in the condensate contributed to metal loss.

**Figure 17.17** Localized metal loss in a bend of a condensate return header.

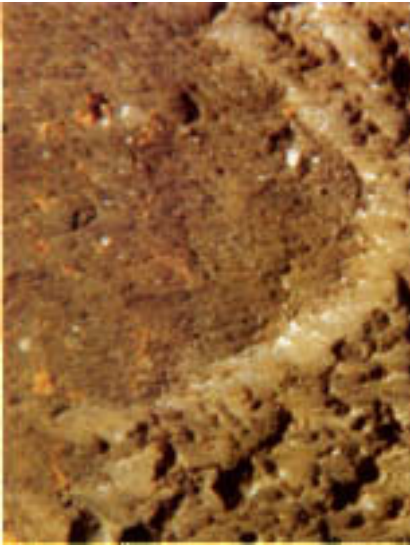
**Figure 17.18** Erosion patterns at edge of wasted area. As in Fig. 17.17. Note flow patterns. (Magnification: 7.5X.)

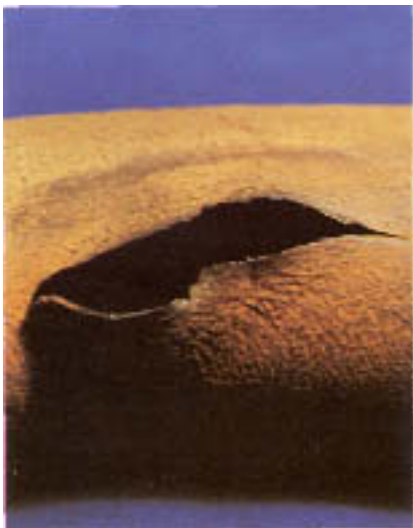
The rupture was caused by erosive wall thinning. Normal internal pressures could no longer be contained at the eroded site and the tube ruptured.

Erosion was caused by impingement of hard particulate matter entrained in flue gases. There was evidence of mild cold-end corrosion on all external surfaces.

**Figure 17.19** Rupture in an economizer tube caused by severe localized external-surface erosion associated with particulate matter entrained in flue gas.

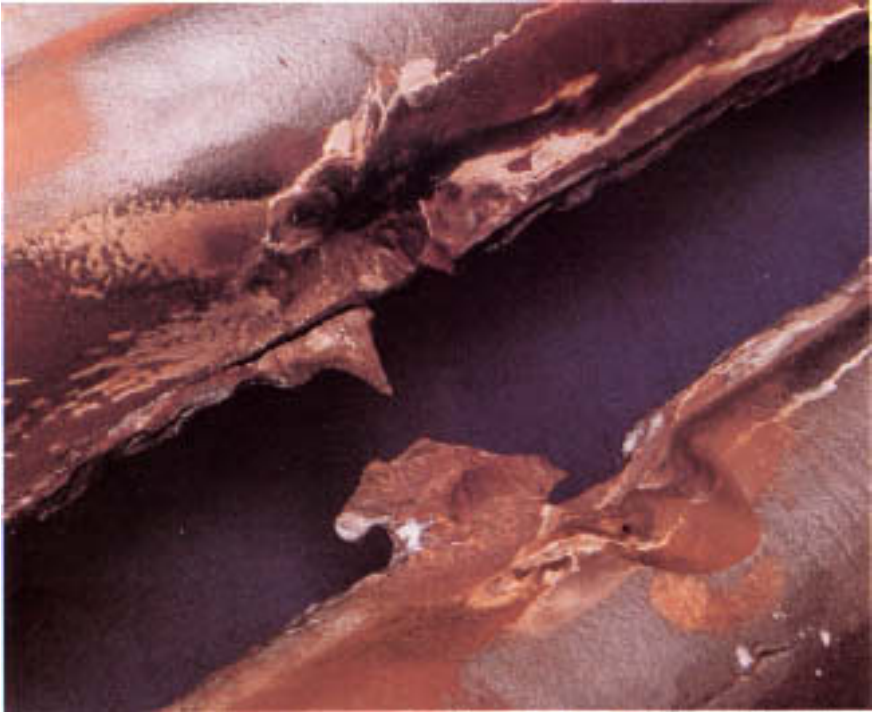
A tube failed at a weld support. Escaping water cut away the support and perforated the adjacent tube (Fig. 17.20).

The question that naturally arises in multiple failures is which failure occurred first. If erosion is severe, the original failure can be entirely eradicated. Luckily, other nearby supports were included with the received section. Careful visual inspection revealed small corrosion-fatigue cracks at poorly fused support welds. Upon sectioning and microscopic examination, small fissures were located near the original failure; these fissures were almost identical to (but deeper than) those found at adjacent braces. Hence, the original failure was likely caused by corrosion fatigue at a weld support.

**Figure 17.20** Steam cutting of utility convection tubes. The original failure occurred at a welded support bracket and was due to corrosion fatigue. The adjacent tube was breached by escaping steam from the original failure.
