## Long-Term Overheating

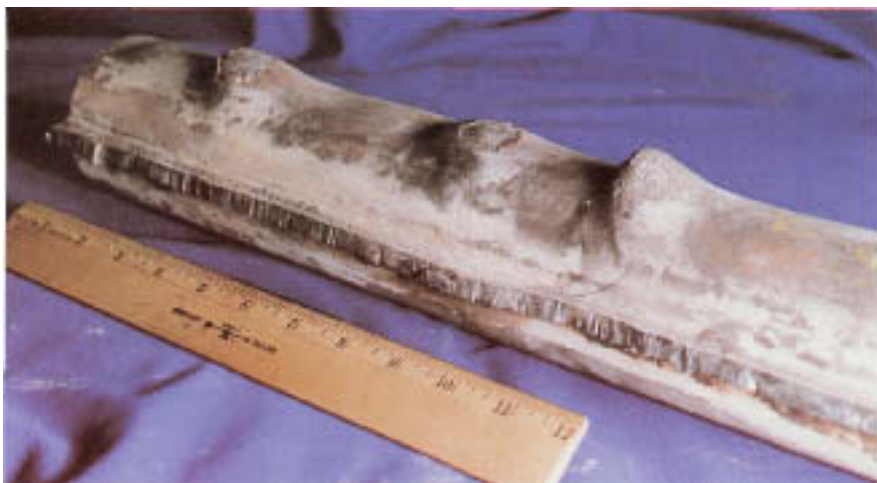
Bulging usually precedes rupture. Many times bulging results because hot-face (hot-side) temperatures are not uniform and local regions develop hot spots. Bulges can take many forms; some are shallow and sloping, while others are abrupt (Fig. 2.2). A single bulge or many bulges may occur. When many bulges occur along the hot faces, internal deposition is sometimes great.

**Figure 2.2** Multiple, abrupt bulges on the hot face of a waterwall tube of a recovery boiler.

The tube has a series of several prominent bulges longitudinally aligned along the hot-side crown (Fig. 2.2). Thick layers of hard, tenacious iron oxide cover each bulge, except where spalling has dislodged the oxide. Internal surfaces on the hot side are covered with spongy, porous deposits, which cover a hard, black magnetite layer. The back wall at the same elevation saw many failures. The boiler had frequent load swings and was operated intermittently.

The tube was overheated in a temperature range between  $950$  and  $1150^\circ\text{F}$  ( $510$  and  $620^\circ\text{C}$ ) at the bulges for a long time. Formation of deposits was due to an imbalance between coolant flow and fire-side heat input. Deposit

weights were about 5 g/ft<sup>2</sup> (5 mg/cm<sup>2</sup>) on the cold side and 26 g/ft<sup>2</sup> (28 mg/cm<sup>2</sup>) on the hot side. Deposits were caused by exceeding the solubility of inversely soluble species, by evaporative concentration, and by mechanical entrainment of particulate matter.

Because of the frequent load swings and intermittent operation, closer operational monitoring was suggested.

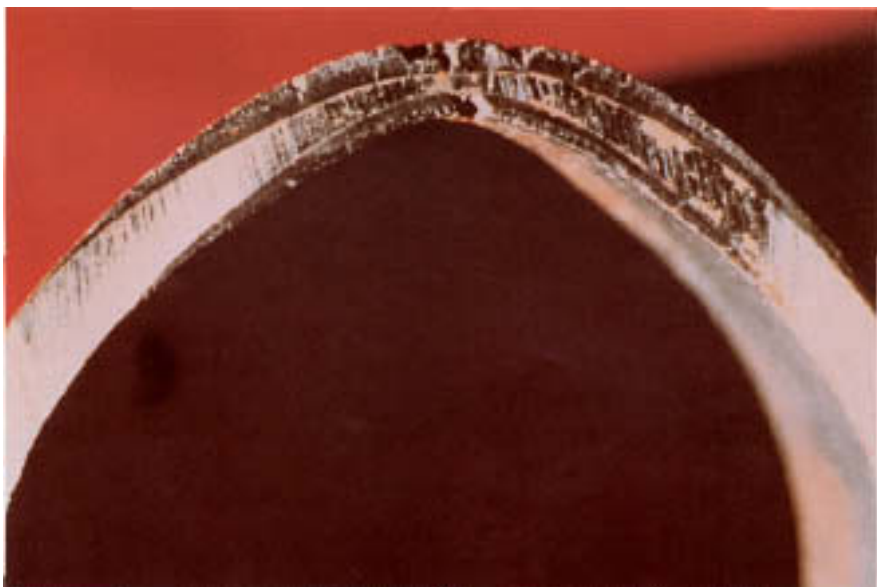
**Figure 2.3** Thick, thermally formed oxide on internal and external surfaces of a bulged wall tube. Thinning of intact metal at bulge is due to both plastic deformation and thermal oxidation.

One sign of long-term overheating can be a thick, brittle, dark oxide layer on both internal and external surfaces (Figs. 2.3 and 2.4). If metal temperatures exceed a certain value for each alloy, thermal oxidation will become excessive. The temperatures at which alloys appreciably oxidize (scaling temperatures) are given in Table 2.1. Often, the thermally formed oxide layer contains longitudinal fissures and cracks. In other areas, patches of oxide may have exfoliated (Fig. 2.5). Cracks and exfoliated patches result from tube expansion and contraction caused by deformation during overheating and/or thermal stressing. Tube-wall thinning can result from cyclic thermal oxidation and spalling. This process can continue until the entire wall is converted to oxide, creating a hole (Fig. 2.6).

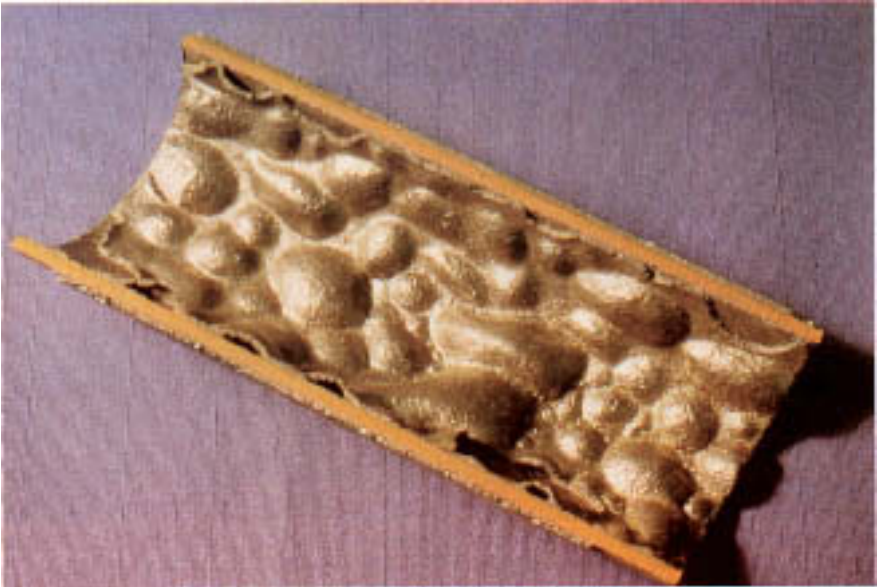
**Figure 2.4** Thick, blistered magnetite layer on internal surface of 150-psi (1.0-MPa) tube. Oxide was formed during dry firing of boiler. Metal temperatures approached 2000°F (1100°C), causing slow, “viscous” flow of magnetite.

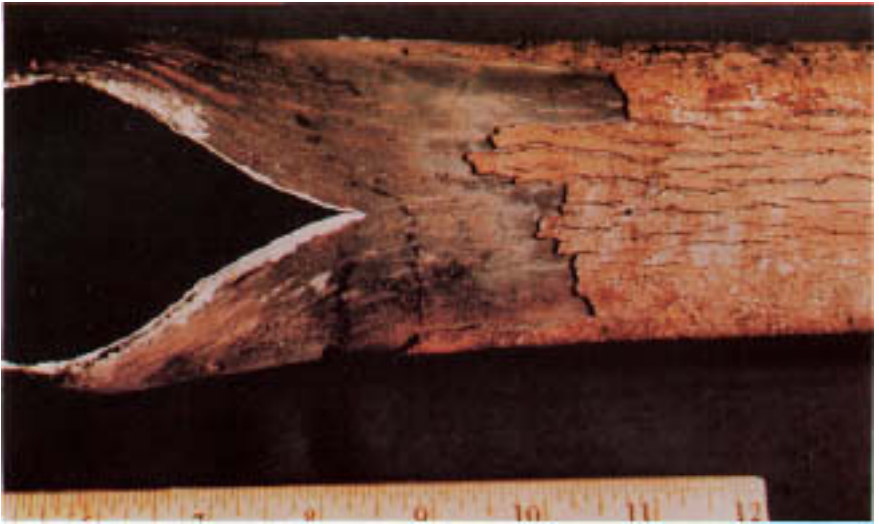
**Figure 2.5** Thermally deteriorated metal on failed wall tube of a utility boiler. Note the spalled and cracked oxide resembling tree bark caused by expansion of tube during bulging and thermally induced stresses.

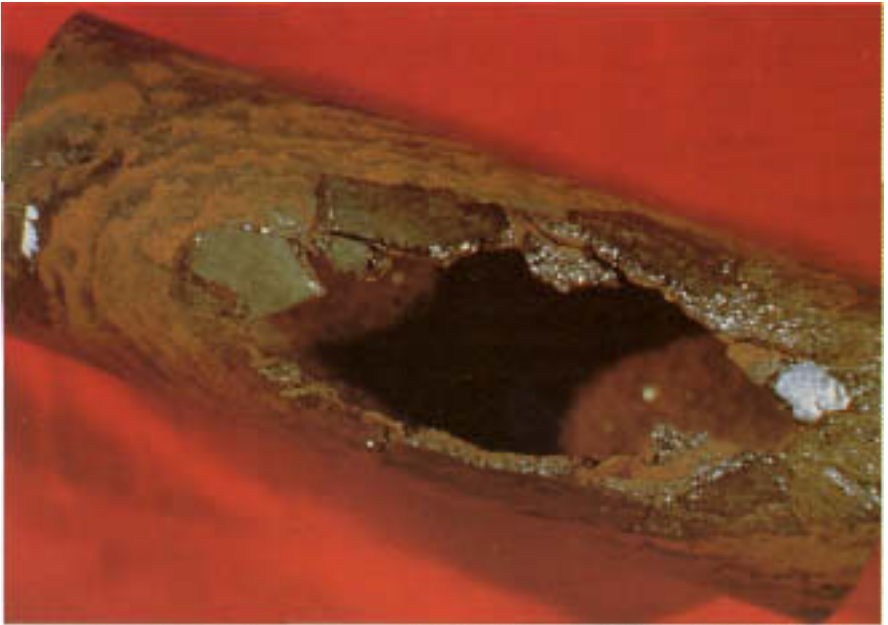
**Figure 2.6** Through-wall oxidation of a tube from a low-pressure boiler. Brittle black magnetite patches still adhere to the rupture mouth. Elsewhere the oxide has spalled. Such through-wall oxidation is most common in low-pressure boilers, where internal pressures are not sufficient to cause premature failure.

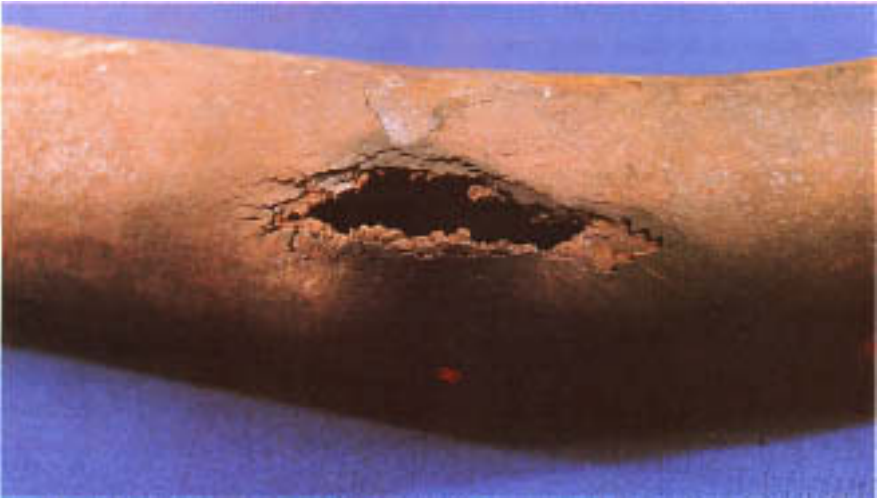
**Figure 2.7** A small, ragged creep rupture at the apex of a bulge. Note the small secondary fissures and the relatively thick rupture edges.

in metal during overheating. Often a small longitudinal fissure will be present at the apex of a heavily oxidized bulge (Fig. 2.7). In other cases, the rupture will be larger and have a fish-mouth shape (Fig. 2.8). The rupture will usually have blunt and slightly ragged edges. Similar, but smaller, longitudinally oriented ruptures and fissures may exist nearby.

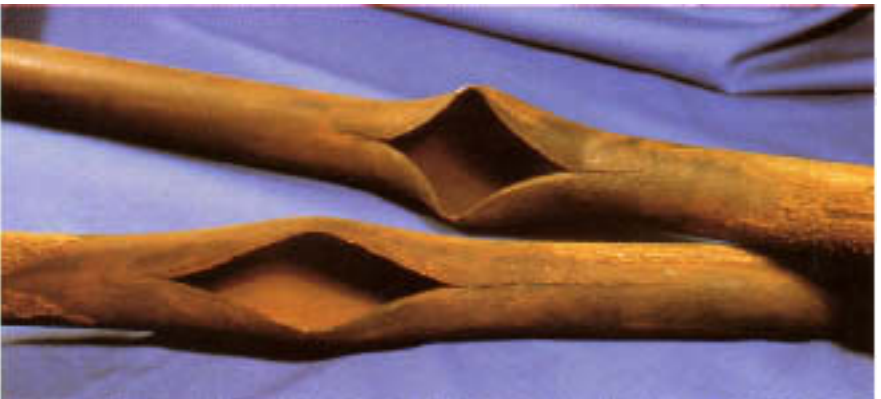
**Figure 2.8** Two superheater tubes from a utility boiler [1400 psi (9.7 MPa)], failed by creep. Note the fish-mouth ruptures. Compare with Fig. 2.7.

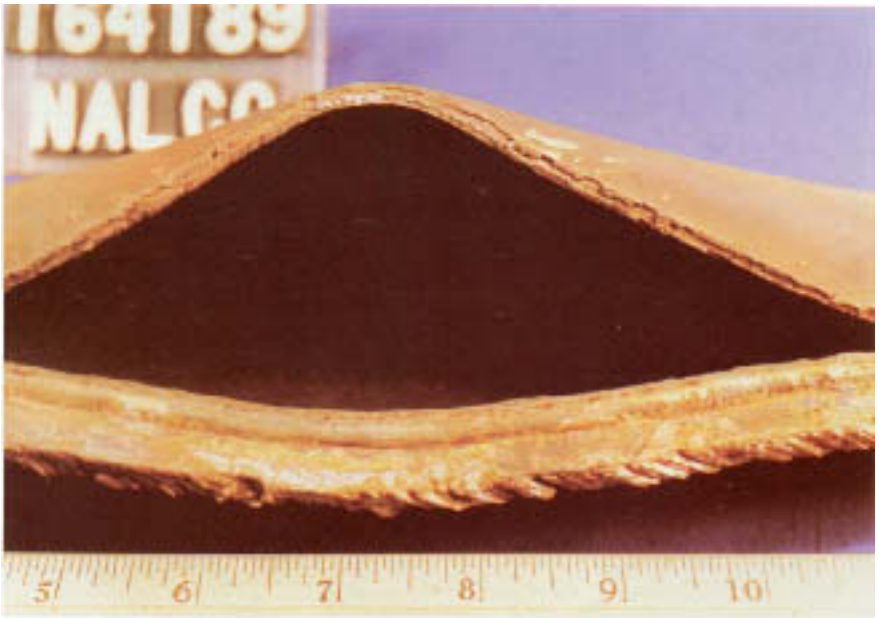
Chain graphitization is usually found at welds (Fig. 2.9). Less commonly, damage occurs away from welds and forms helical cracks spiraling around tube surfaces (Fig. 2.10). Such failures are sometimes confused with creep damage, but careful microscopic observation will reveal the presence of graphite nodules at or near fracture edges.

**Figure 2.9** Rupture at longitudinal weld due to chain graphitization. Note the blunt, rough rupture edge. Such failures occur after long-term mild overheating.

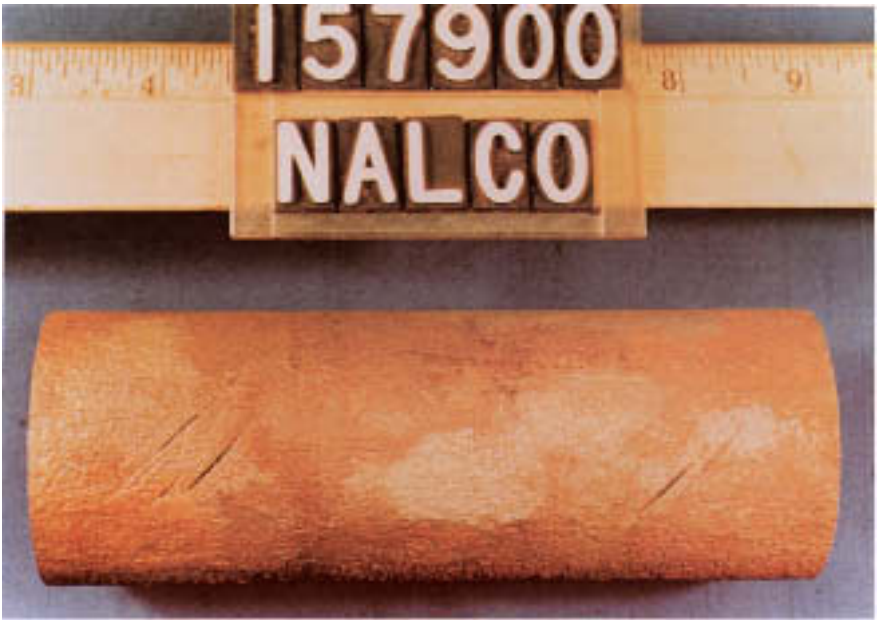
**Figure 2.10** Spiral through-fissures due to chain graphitization. These fissures formed along lines of maximum shear stress.

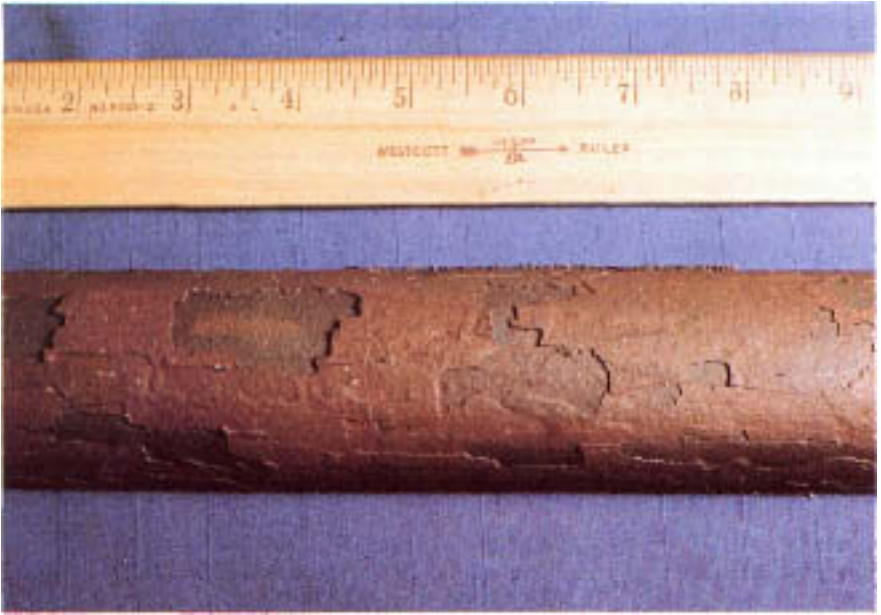
A brittle black magnetite layer covered both external and internal surfaces of this superheater tube. The thermally formed oxide fractured and spalled, substantially reducing wall thickness (Fig. 2.11). Thinning was more severe along the side of the section abutting a firebrick wall.

Most metal was lost from external surfaces and was caused by thermal oxidation at temperatures between 1100 and 1350°F (600 and 727°C). Gas channeling and higher temperatures were present along the tube side abutting the firebrick. These factors accelerated oxidation and spalling processes.

In the past, nearby tubes had ruptured as a result of thinning associated with thermal oxidation. No deposits were present on internal surfaces, and attemperation was not used. Fire-side slagging was not present in this intermittently run boiler.

Failures were a chronic problem associated with design and operation. The proximity of failures to the firebrick wall strongly linked the overheating to boiler design.

**Figure 2.11** Severe thermal oxidation and spalling of magnetite on external surface. The laminated nature of the scale indicates multiple episodes of spalling and oxide reformation.

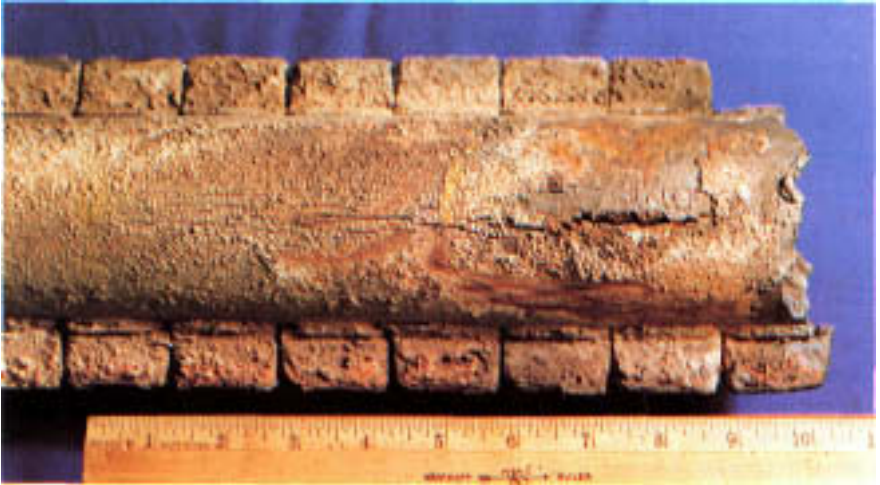
Longitudinal fissures and thick-walled, ruptured bulges were present along the hot side of this section (Fig. 2.12). Surfaces are covered with an irregular tan slag layer, and the external surface near the through-fissure is checkered.

The rupture and fissuring were caused by very long-term exposure of the metal to temperatures between 850 and 1050°F (454 and 566°C). Evidence suggests that exposure to these temperatures may have been occurring for several years. Overheating was caused by excessive heat input relative to coolant flow rate.

**Figure 2.12** Longitudinal fissures along hot side. Note the through-fissure at the bulge apex.

Nearby tubes showed similar, although less severe, attack. Deposits on hot-side internal surfaces were less than  $20 \text{ g/ft}^2$  ( $22 \text{ mg/cm}^2$ ). The boiler had been cleaned 3 years prior to failure.

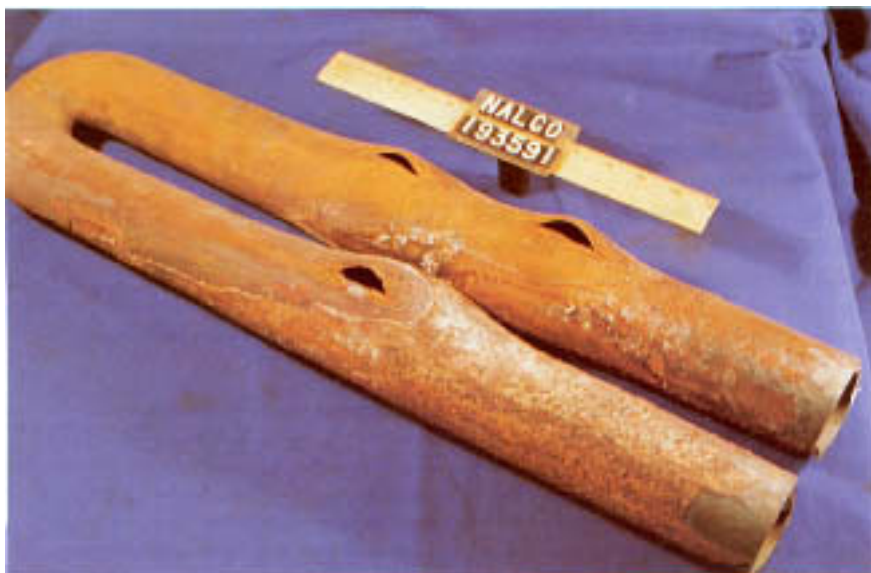
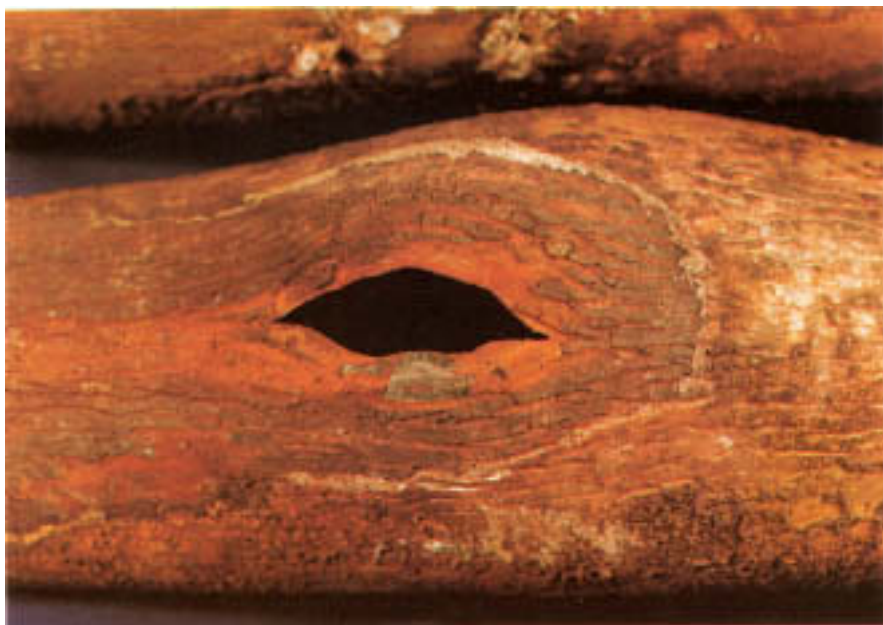
Three large bulges are present on the pendant legs of this U-bend section. Each bulge is ruptured at its apex. The legs expanded to about a 2½-in.

**Figure 2.13** Bulged and ruptured superheater U-bend. The legs are slightly expanded.

**Figure 2.14** As in Fig. 2.13. Fragmented thermally formed oxide surrounds the rupture.

(6.4-cm) outer diameter from their 2¼-in. (5.7-cm) original value. Bulges are shown in Figs. 2.13 and 2.14. Internal surfaces are free of significant deposits, while external surfaces are covered with a tenacious, fragmented oxide layer. Eighteen tubes were similarly affected. This boiler operates on waste heat from a slab furnace.

The tube was overheated for a period of several days or longer at temperatures above 1000°F (540°C), but below 1350°F (730°C). The wall strength was decreased at elevated temperatures, and tubes were thinned and weakened by thermal oxidation. As a result of these two forms of weakening, the legs bulged and then ruptured.

Operating records showed an increase of almost 100°F (56°C) in steam temperature approximately 2 months prior to failure. This increase was correlated with changes in firing associated with alteration of the slab mill's operation.

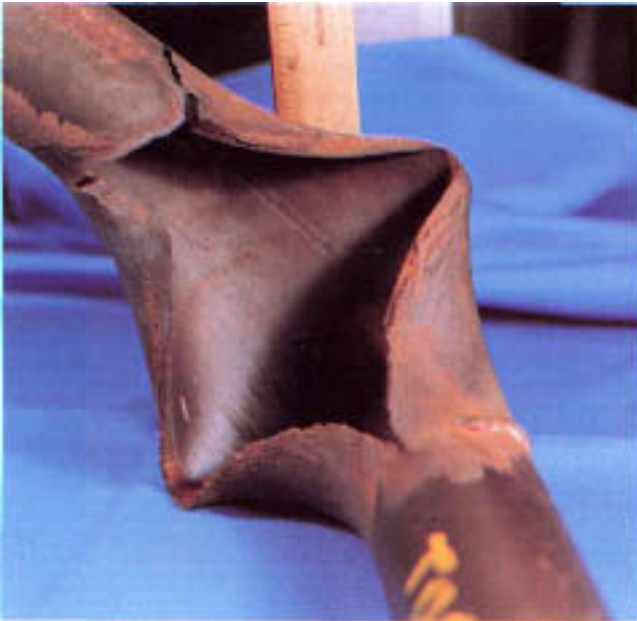
The section contains a massive, thick-walled, longitudinal rupture just above a circumferential weld. The rupture occurred immediately downstream of the weld. The tube was bent into an “L” by the burst. The rupture terminates at one end in a pair of thick-walled transverse tears (Fig. 2.15). A thick, tenacious magnetite layer covers external surfaces, except those near the

**Figure 2.15** Massive thick-walled fracture caused by creep. Note the circumferential weld just below the failure. The tube is torn and bent to a 90° elbow by the violence of the rupture.

rupture, where the oxide has cracked and spalled. Elemental copper and spotty deposits are present on internal surfaces.

Failure was caused by prolonged overheating at temperatures above 1050°F (570°C). The direct rupture was a stress (creep) rupture. Coolant flow irregularities immediately downstream of a partially intrusive circumferential weld, along with internal deposition, which reduced heat transfer, were contributing factors. Additionally, a switch from oil to coal firing likely changed fire-side heat input.

The superheater had a history of boiler-water carryover, and load swings were common. Previous failure had occurred in this region at least 2 years before the current rupture.
