## Short-Term Overheating

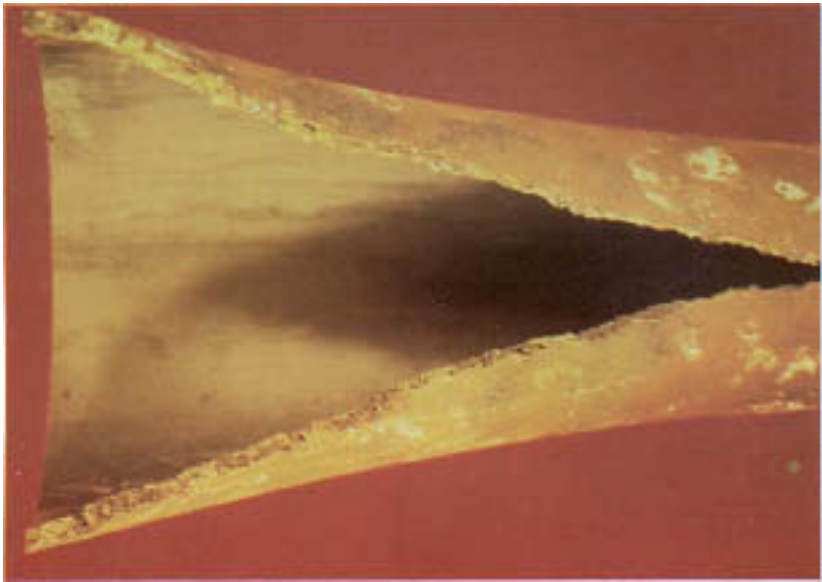
Short-term overheating may produce bulging. In very rapid overheating, a thick-walled longitudinal rupture (Fig. 3.1), or a longitudinal fish-mouth rupture (Fig. 3.2), can occur.

**Figure 3.1** Longitudinal rupture in a superheater tube caused by partial pluggage upstream of failure, which in turn caused short-term overheating. Note the thick-walled rupture edges. Virtually identical tube circumferences are present at the rupture and away from the burst. Such failures often occur when temperatures exceed 1350°F (730°C).

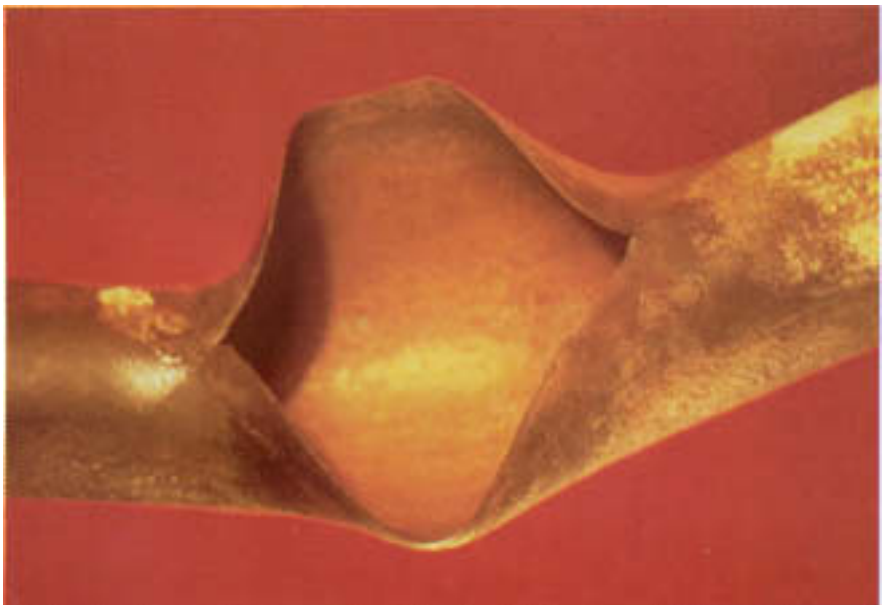
**Figure 3.2** Short-term overheating in which bulging occurred before rupture. Note the chisel-like rupture edges.

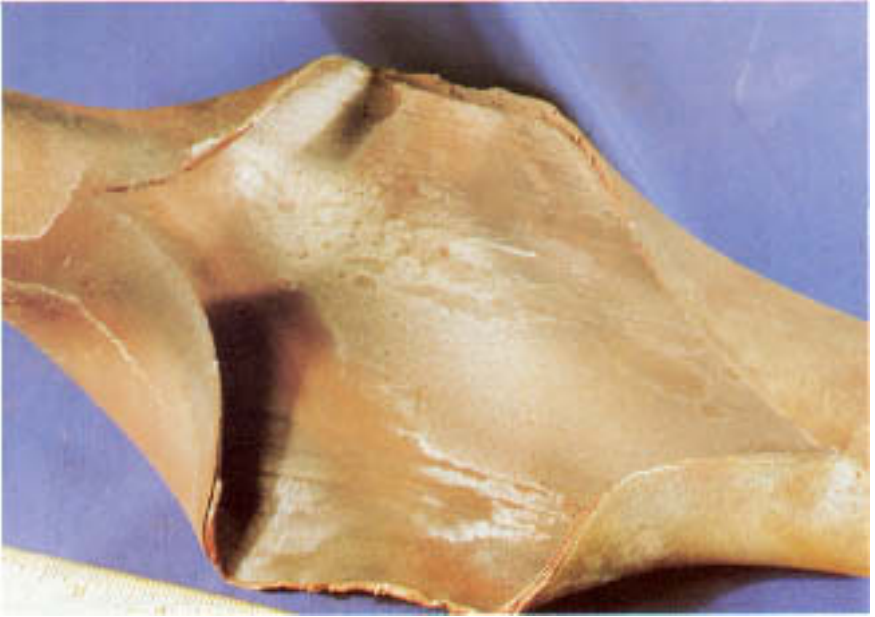
At elevated temperatures metal strength is markedly reduced (Fig. 2.1). In fact, if temperatures rise to very high levels, failure will occur quickly. If failure happens rapidly, bulging may be absent and the rupture can be violent, sometimes bending the tube almost double and causing secondary metal tearing (Fig. 3.3). In the case of thick-walled ruptures, the tube circumference at the rupture is sometimes nearly exactly equal to the tube circumference away from the rupture. Tube circumference can be roughly measured with a piece of string.

**Figure 3.3** Violent rupture caused by short-term overheating. The tube is bent almost to a right angle, caused by the severity of the burst.

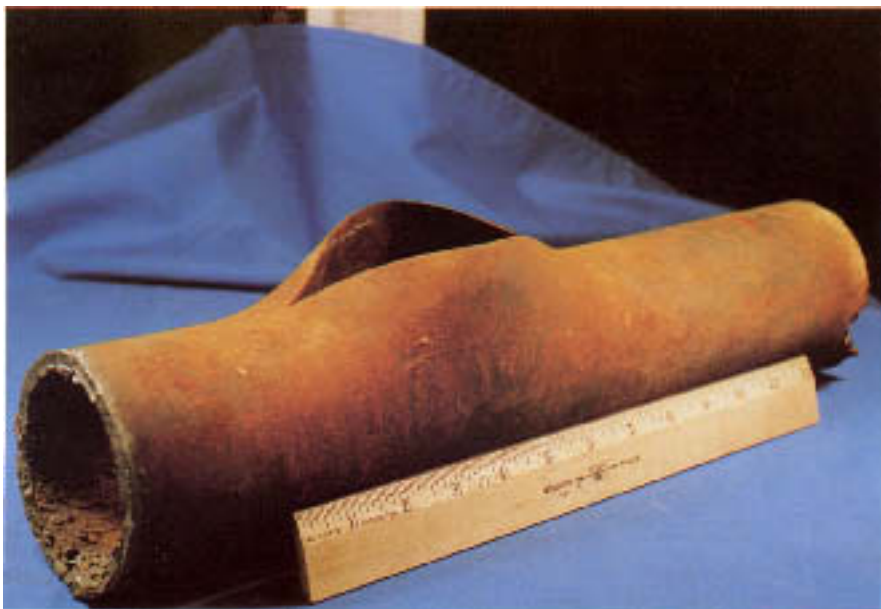
Multiple bulges are usually absent, although a single bulge containing a rupture may occur, especially if long-term overheating has occurred previously (Fig. 3.4).

**Figure 3.4** A rupture at a single bulge. The tube had experienced long-term overheating, followed by a brief episode of severe overheating.

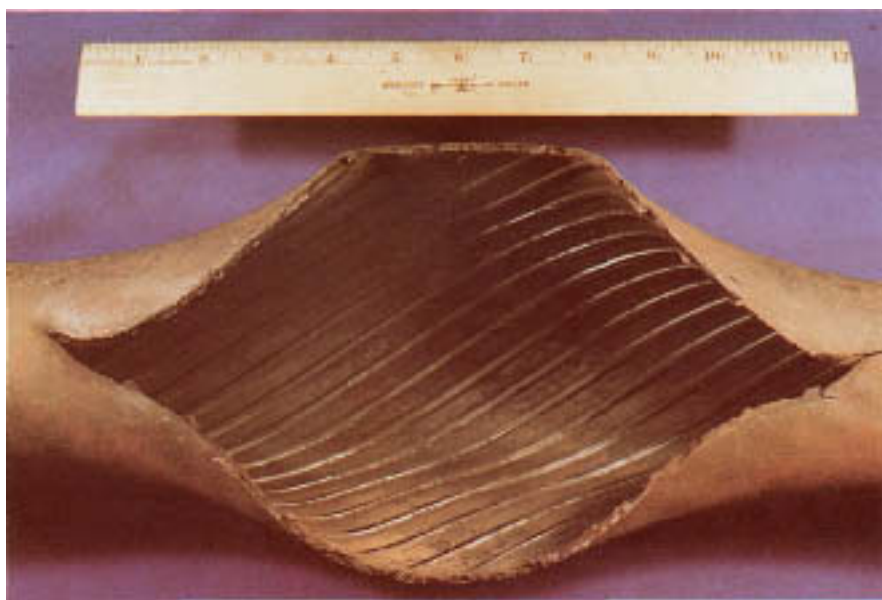
This section of the internally rifled waterwall nose arch contains a large, thick-wall rupture. Rupture edges are 12 in. (30 cm) long and have a jagged contour (Fig. 3.5). Both internal and external surfaces are smooth and are

**Figure 3.5** Large, fish-mouth rupture of rifled nose-arch tube. Rupture edges are thick, blunt, and ragged. Note the absence of significant deposits.

covered with thin, tenacious, dark oxide layers. No significant deposits are present anywhere.

Rupture occurred shortly after start-up. Microstructural evidence indicated that the tube metal near the rupture exceeded 1600°F (870°C). No significant accumulation of thermally formed oxide was found anywhere on the received section.

Internal rifling is sometimes used to reduce steam channeling and inhibit steam blanketing. No steam blanketing or liquid/vapor interface was found on internal surfaces. There was no change in microstructure on the cold side indicating that the tube contained water at the time of the rupture. Rather, the burst was caused by insufficient coolant flow on start-up.

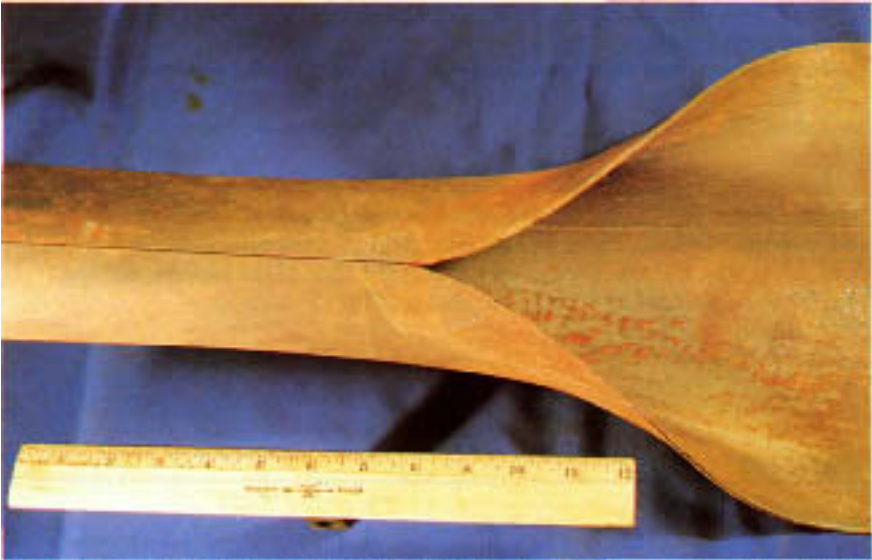
A massive thin-lipped longitudinal rupture is present. A thin, straight through-fissure runs longitudinally down the tube from the corner of the rupture mouth (Fig. 3.6). Internal surfaces are smooth, except for shallow mandrel markings. A thin, uniform layer of light-colored deposits is present away from the rupture.

Failure was caused by severe overheating resulting from coolant starvation. A minor defect (mandrel marking) guided the rupture line but was not a significant contributing factor to failure.

Figure 3.6 Longitudinal fissure running from the edge of a large, wide-open rupture.

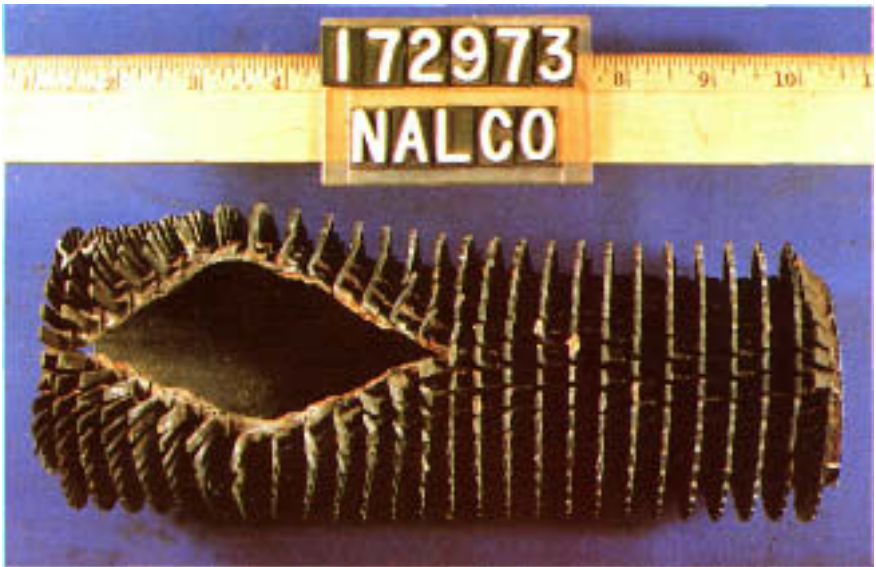
A rupture 4¼ in. (10.8 cm) long by 1½ in. (4.1 cm) wide is present at a bulge (Fig. 3.7). A thick, black layer of thermally formed oxide is present on both internal and external surfaces and is thicker along the hot side. Deposits containing sodium, calcium, silicon, and iron are present in the tube. Deposit loading is 38 g/ft<sup>2</sup> (41 mg/cm<sup>2</sup>). Carryover of boiler water into the superheater due to water-level excursions and foaming was common. The boiler had never been cleaned.

Temperatures of waste-heat gases ranged from 1200 to 1800°F (650 to 980°C). The tube failed during several other tube failures. Tubes nearby

**Figure 3.7** Large, wide-open rupture in a superheater tube of a waste-heat boiler. The tube experienced long-term overheating followed by a brief episode of short-term overheating when nearby tubes ruptured.

failed as a result of long-term overheating (creep rupture), while others failed as a result of short-term overheating. It was determined that the section had been mildly overheated for a considerable period, but had failed during a brief episode of severe overheating when temperatures exceeded 1350°F (730°C). The short-term overheating probably occurred because of coolant starvation, caused by leakage from other failed tubes upstream.
