Caustic Corrosion

CASE HISTORY 4.1

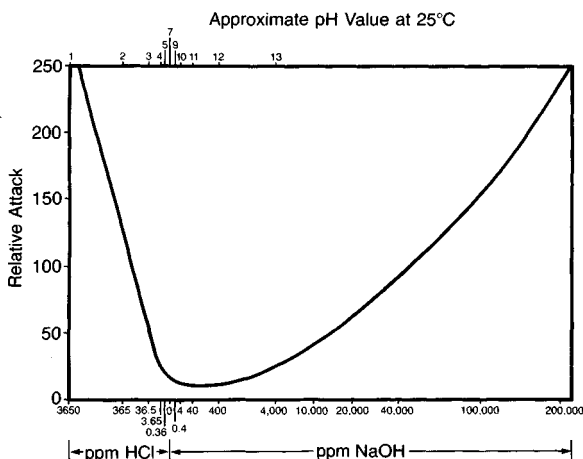
The susceptibility of steel to attack by sodium hydroxide is based on the amphoteric nature of iron oxides; that is, oxides of iron are corroded by both low-pH and high-pH environments (Fig. 4.1). High-pH substances, such as sodium hydroxide, will dissolve magnetite:

Figure 4.1 Attack on steel at 310°C (590°F) by water of varying degrees of acidity and alkalinity. (Curve by Partridge and Hall, based on data of Berl and van Taack. Courtesy of Herbert H. Uhlig, *The Corrosion Handbook*, John Wiley and Sons, New York, 1948.)

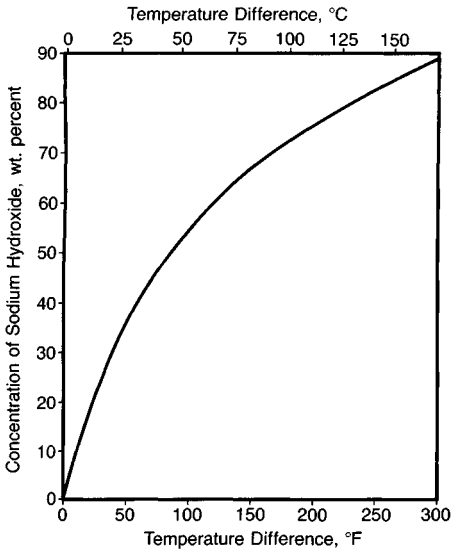
Figure 4.2 Sodium hydroxide content attainable in concentrating film of boiler water. (Based on data from International Critical Tables, 3:370(1928). Courtesy of Herbert H. Uhlig, *The Corrosion Handbook*, John Wiley and Sons, New York, 1948.)

At the onset of DNB, the rate of bubble formation exceeds the rinsing rate. Under these conditions, sodium hydroxide, as well as other dissolved solids or suspended solids, will begin to concentrate (Fig. 1.3 and Fig. 4.2). The presence of concentrated sodium hydroxide and other concentrated corrosives will compromise the thin film of magnetic iron oxide, causing metal loss.

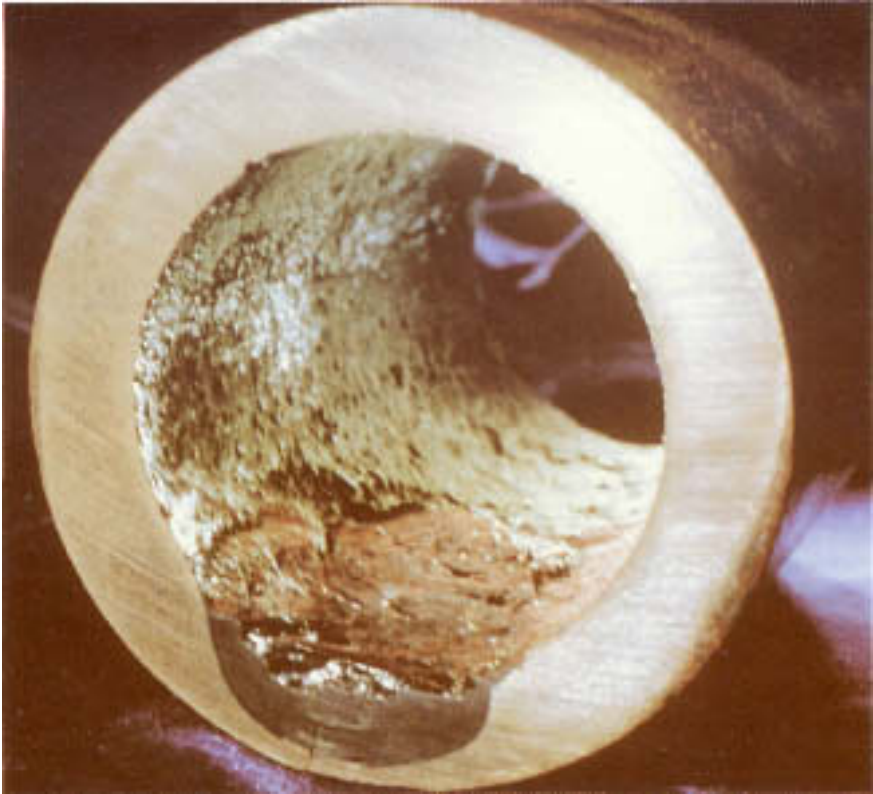
2. Deposition. A similar situation occurs when deposits shield the metal from the bulk water. Steam that forms under these thermally insulating deposits escapes and leaves behind a corrosive residue that can deeply gouge the metal surface (Fig. 4.3).

Figure 4.3 Deep caustic gouging beneath insulating internal deposits. (Courtesy of National Association of Corrosion Engineers.)

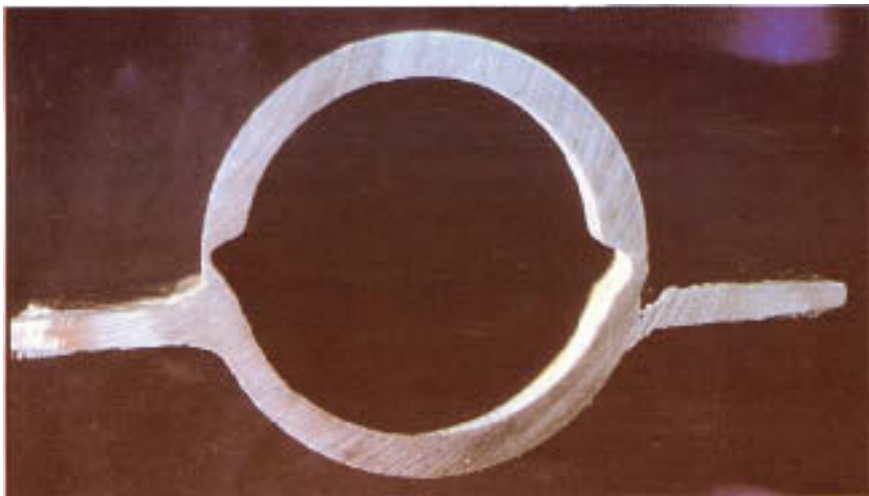
3. Evaporation at a waterline. Where a waterline exists, corrosives may concentrate by evaporation, resulting in gouging along the waterline. In horizontal or slanted tubes, a pair of parallel longitudinal trenches may form (Fig. 4.4). If the tube is nearly full, the parallel trenches will coalesce into a single longitudinal gouge along the top of the tube (Fig. 4.5). In

Figure 4.4 Caustic gouging along a longitudinal waterline. (Courtesy of National Association of Corrosion Engineers.)

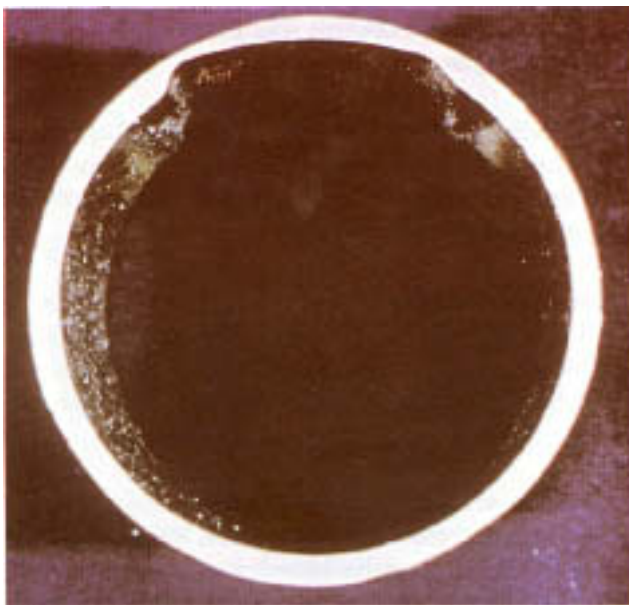
Figure 4.5 Caustic gouging resulting from evaporation at a waterline riding along the crown of the tube. (Courtesy of National Association of Corrosion Engineers.)

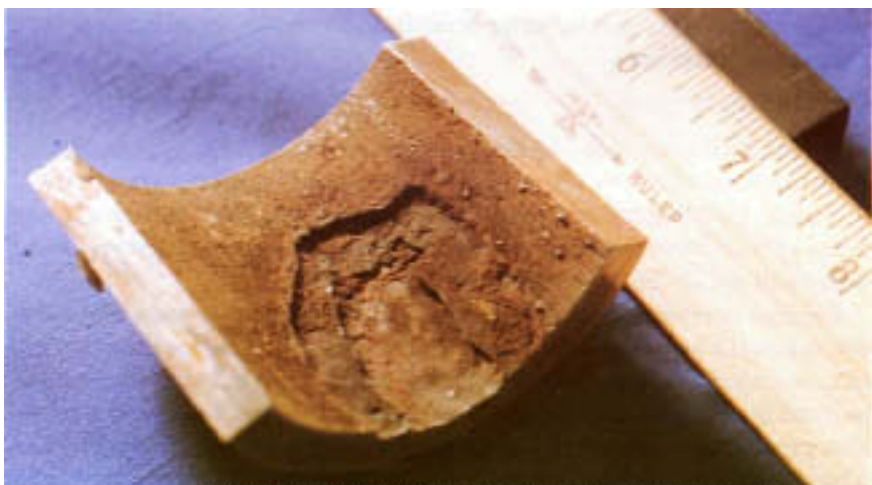
Numerous caustic attacks on the back wall of a cyclone-fired boiler (Fig. 4.6) were all observed within a month. This type of attack had occurred once previously. This boiler was acid-cleaned every 18 to 24 months. The gouge was noted 1 year after the last acid cleaning.

Visual examinations disclosed hard layers of black, crystalline corrosion products covering the attack site. Measurement revealed a 42% reduction in tube-wall thickness. Microstructural examinations disclosed moderate overheating in the gouged region. Evidence revealed that DNB, rather than deposits, was responsible for caustic concentration in this case. Overfiring during start-up and low flow rates of the feedwater were suspected.

Figure 4.6 Region of caustic gouging along internal surface.

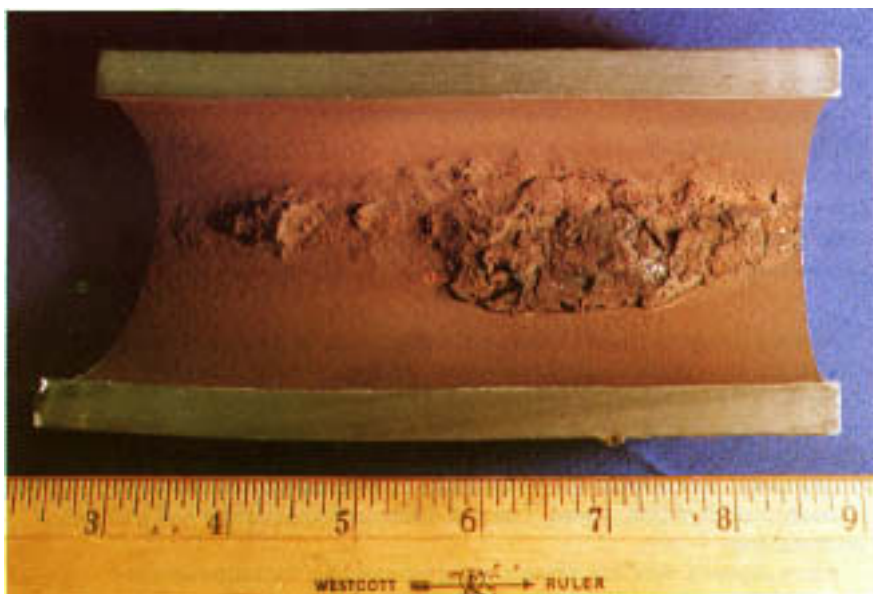
Visual examinations disclosed a thickened patch of hard corrosion products adjacent to one bend (Fig. 4.7). Perforation of the wall had not occurred, but transverse cross sections cut through the site revealed substantial metal loss (Fig. 4.8).

The gouging was caused by sodium hydroxide that concentrated to corrosive levels along the site of a stable steam blanket, or perhaps at an isolated site of thermally insulating deposits. Previous failures of this type had not occurred in this region of the boiler. The boiler had been cleaned 4 years previously with a chelant and was in peaking service. Closer control over the water-treatment program might help prevent this type of problem in the future.

Figure 4.7 Patch of hard iron oxides on internal surface.

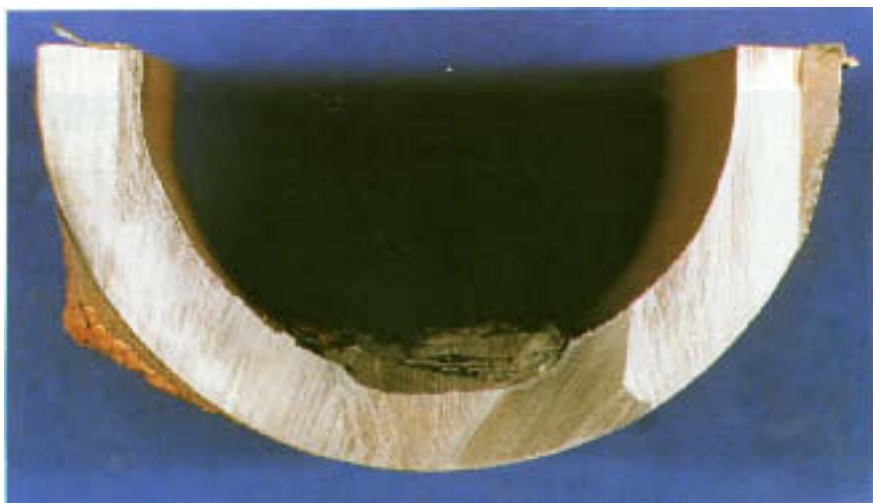
Figure 4.8 Cratered region beneath patch of iron oxides.

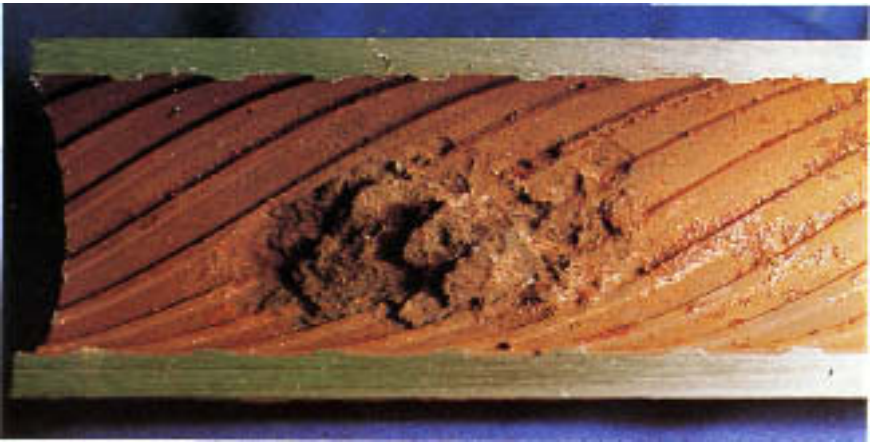
Figure 4.9 illustrates the appearance of the internal surface in the area of leakage. A small perforation of this rifled tube was observed in the center of a large, elliptical area of metal loss (Fig. 4.10). This area has a smooth, rolling metal-surface contour covered with a thick, irregular mound of coarsely stratified iron oxides. The rest of the internal surface had suffered no metal loss.

Since deposits were not present and evidence of a waterline was not observed, it can be assumed that concentration of the caustic material was caused by highly localized nonnucleate boiling (DNB). The rifling of the internal surface is designed to induce swirling of the water to prevent nonnucleate boiling and steam/water phase stratification. It is surprising, therefore, to find severe caustic gouging in this tube design.

However, this boiler was idle on weekends. It is possible that highly localized nonnucleate boiling may have occurred during start-up, before normal boiler-water circulation was fully established.

Figure 4.9 Thick, irregular mound of hard iron oxides covering perforation.

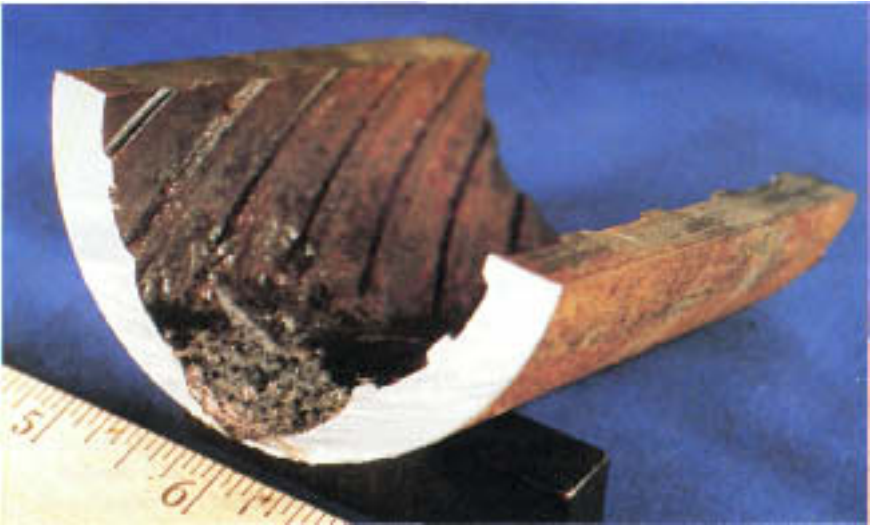
Figure 4.10 Perforation at bottom of crater.

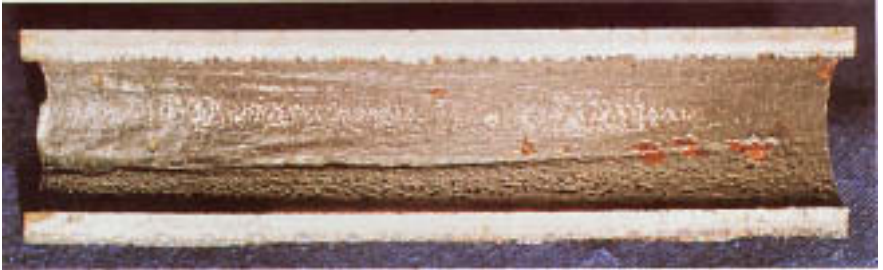
A massive longitudinal perforation was evident on this tube section. The failure resulted from wall thinning on the internal surface. Metal loss was localized to the top of the tube and the area of metal loss was approximately 19 in. (48.3 cm) long (Fig. 4.11).

Examination revealed a distinct groove along the top of the internal surface; this groove diminished gradually in both depth and width as the tube assumed a vertical orientation. Vertical surfaces were not corroded. The groove surface was very smooth, slightly rolling in contour, and covered with a uniform coating of black iron oxide. The surface at the perimeter of the groove was marked by a dense population of deep, hemispherical pits that

Figure 4.11 Groove approximately 14 in. (35.6 cm) from perforation.

The grooving resulted from the concentration of sodium hydroxide due to steam accumulation and channeling along the upper horizontal and slanted regions of the internal surfaces. In addition to the important contribution of the tube's horizontal and slanted orientation, the accumulation of steam resulted from a condition of either excessive heat input in this region or impaired coolant flow through these tubes. This problem might be corrected by reducing heat input in this part of the boiler or by increasing water velocity through these tubes.

These types of failures have also been prevented through the use of rifled tubes. Closer control of the chemical program for the boiler water also might eliminate this type of failure.

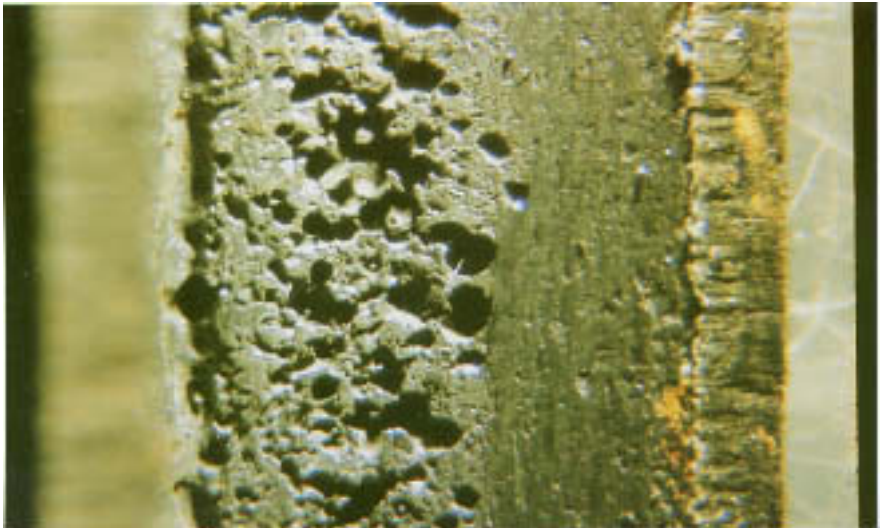
existed in a distinct band along the sides and at each end of the groove (Fig. 4.12).

Figure 4.12 Band of hemispherical pits adjacent to groove. (Magnification: 6.5X.)

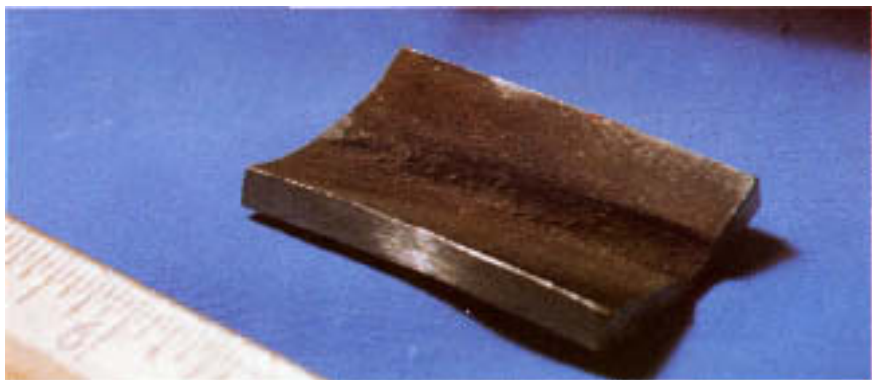
Figure 4.13 Grooved window section cut from inner bend.

Visual examinations revealed a longitudinal groove on the internal surface along the top of the tube (Fig. 4.13). Perforation had not occurred, but as much as 60% of the tube wall had been corroded.

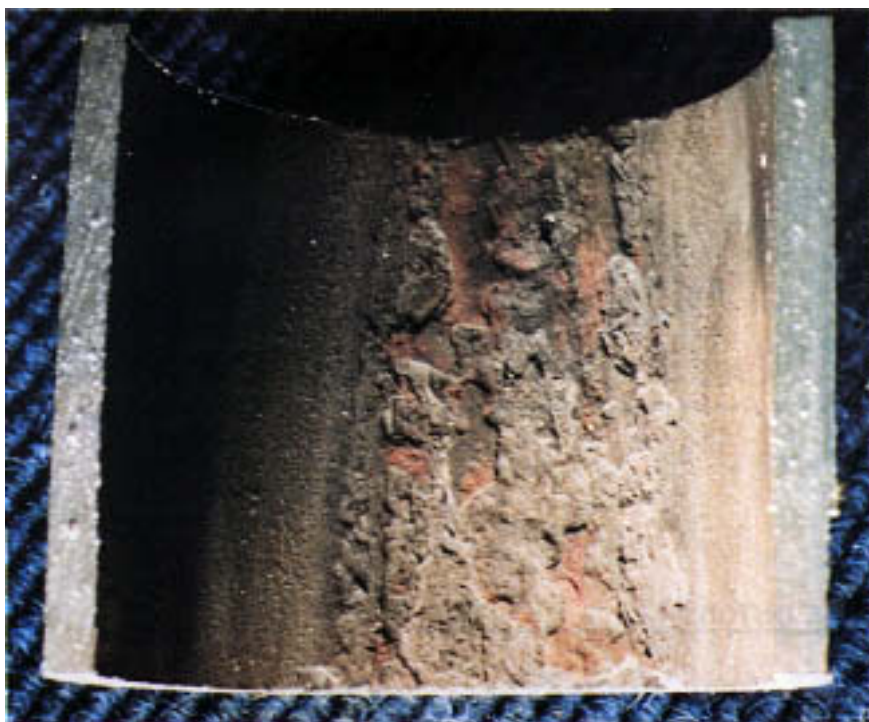
The entire top side of the internal surface exhibited shallow metal loss in a distinct band (Fig. 4.14), which narrowed and ended in a “spear point” near the end of the tube in the steam drum. Sparkling black crystals of magnetite were present in and around the groove. A total of six adjacent tubes had been similarly affected.

Steam channeling along the top of the slanted section led to concentration of sodium hydroxide. Steam channeling may indicate localized or general excessive heat input. If appropriate alteration of operating parameters does not eliminate the problem, the use of rifled tubes may be effective.

Figure 4.14 Internal surface showing wasted metal.
