Chelant Corrosion

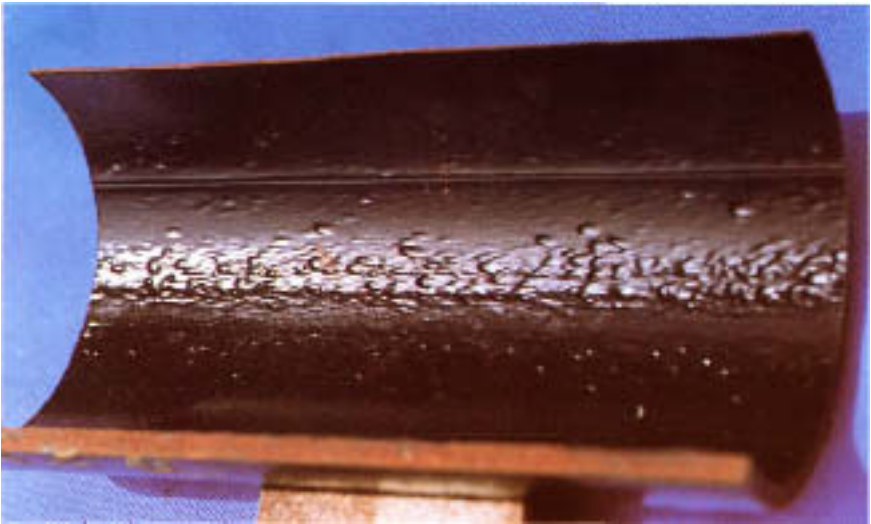
Surfaces attacked by chelants are typically very smooth and featureless. In situations where there is sufficient fluid velocity, the surfaces may have a smoothly rolling contour marked by “comet tails” and horseshoe-shaped depressions (Fig. 5.1). These features are aligned with the direction of flow. The metal surface will be uniformly covered with a submicroscopic film of

Figure 5.1 Comet-tail and horseshoe-shaped depressions.

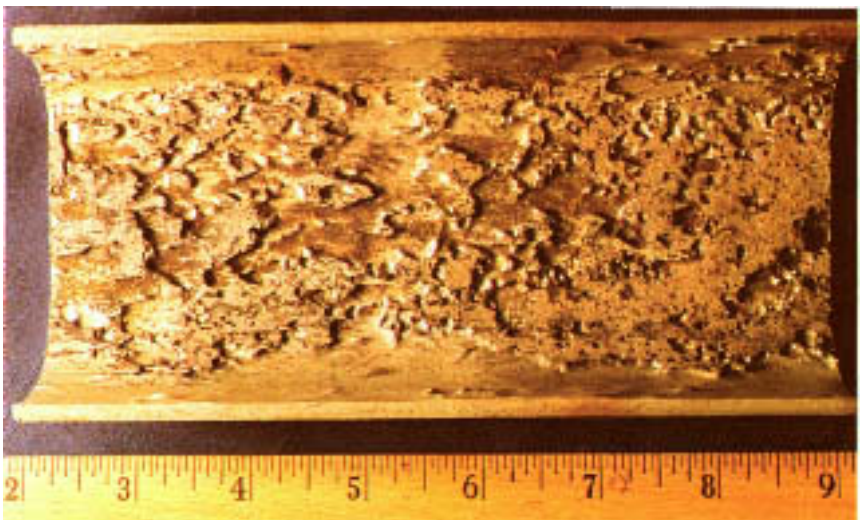
Occasionally, when excessively high levels of oxygen are present, the appearance of metal loss is altered. The surface under attack retains sharply defined islands of intact metal surrounded by a smooth plain of

Figure 5.2 Chelant corrosion altered by the presence of excessive oxygen.

metal loss (Fig. 5.2). Some observers have reported that attack by chelants has given a jagged roughness, similar to that resulting from attack by a strong acid.

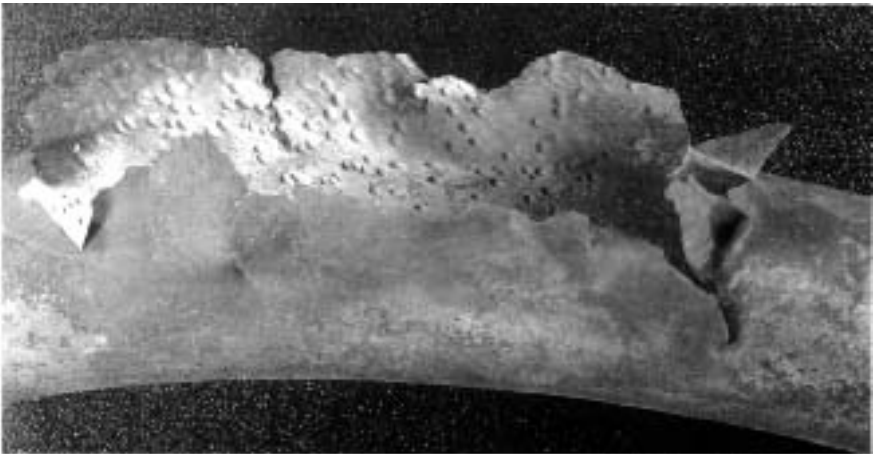
Figure 5.3 Tube rupture after severe metal loss by chelant corrosion. (Courtesy of National Association of Corrosion Engineers.)

The massive rupture of the wall tube (Fig. 5.3) was the first to occur in the boiler. The edges of the rupture are very thin, and a population of horseshoe-shaped depressions oriented in the direction of flow can be seen along the wasted internal surface. Microstructural examinations revealed that overheating had not occurred.

The rupture occurred on the cold side of the tube. The insulation installed to protect the cold side of this tube apparently had been dislodged by steam impingement from a leaking superheater tube. Hot furnace gases that reached the unprotected back side of the tube caused unstable film boiling and concentration of chelant from the boiler water.

The combination of concentrated chelant and fluid velocity caused the thinning of the internal surface apparent in Fig. 5.3. Thinning of the tube wall in this manner continued until stresses imposed by normal internal pressure exceeded the tensile strength of the thinned tube wall.

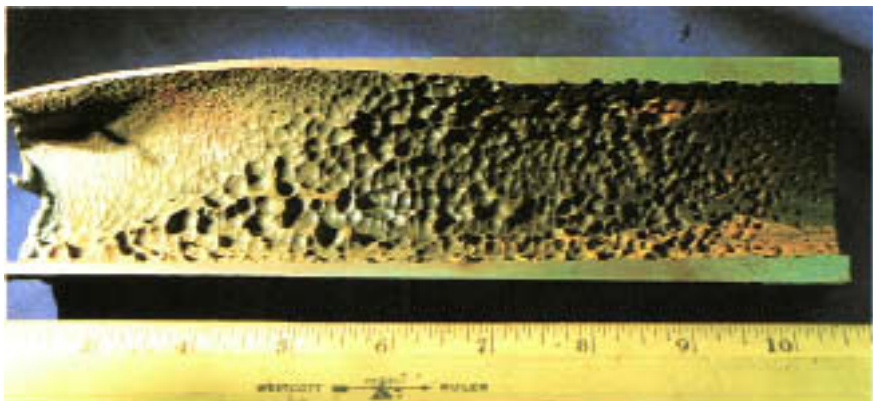
Failure of a section adjacent to the tube, illustrated in Fig. 5.4, occurred during hydrotesting. Severe internal wastage was confined to 6 to 9 in. (15.2 to 22.9 cm) of tube length in each of four adjacent tubes. Metal loss within the affected region varied. In areas of severe metal loss the appearance was smooth and wavelike. Discrete, isolated pits were evident in areas of moderate metal loss.

The highly localized attack on this section illustrates the importance of velocity and turbulence in an erosion-corrosion process involving chelants. Metal loss is severe in regions of turbulence at the inlet end of the tube from the header. The attack moderates with distance along the tube, until it ceases altogether where laminar flow is established. The chelant alone was not sufficiently aggressive to cause corrosion. Rather, metal loss resulted from the synergistic interaction of the chelant with localized turbulence.

Figure 5.4 Chelant corrosion on internal surface of inlet end.

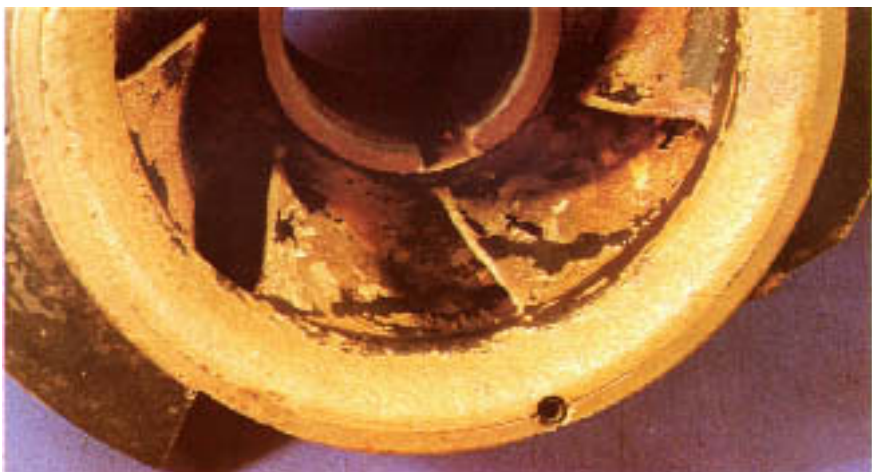
This impeller, illustrated in Fig. 5.5, was removed from the fifth stage of a feedwater pump. Broad areas of general wastage are apparent. Areas of metal loss are confined principally to regions of high turbulence such as the vane edges and discharge throat. Horseshoe-shaped depressions are visible in some regions.

Figure 5.5 Chelant corrosion on feedwater pump.

Close examination of wasted surfaces under a low-power stereoscopic microscope revealed dendrites and other microstructural features of the casting. Chelants are aggressive toward copper and copper-based alloys and should be fed well downstream of copper-alloy impellers.

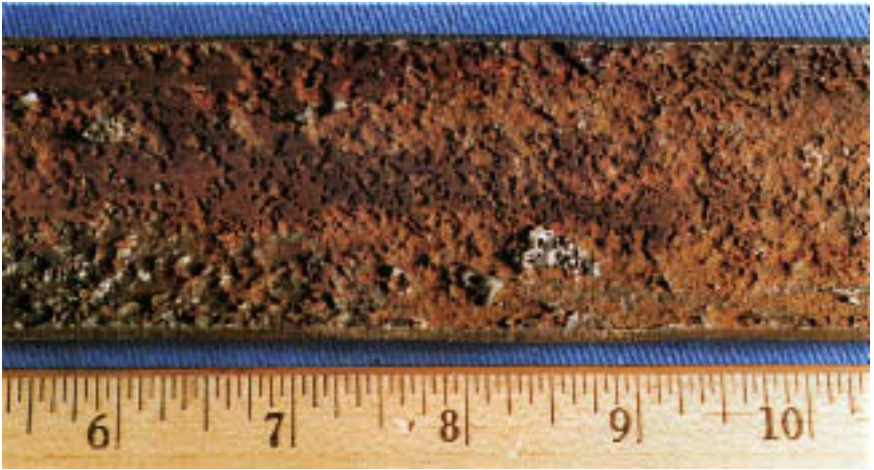
Figure 5.6 illustrates the appearance of the internal surfaces of 12 adjacent downcomer tubes that have suffered severe internal corrosion. Although the same water-treatment program had been utilized for this boiler for 17 years, this corrosion occurred within a period of 7 months.

The affected tubes were located at one end of the boiler, within 9 in. (22.9 cm) of the feedwater line in the steam drum. It is surmised that feedwater was short-circuiting through the affected area.

Figure 5.6 Internal surface of downcomer tube.

This type of failure can be prevented by gaining control of dissolved oxygen. Preventing short-circuiting of the feedwater is also a solution to this type of corrosion.

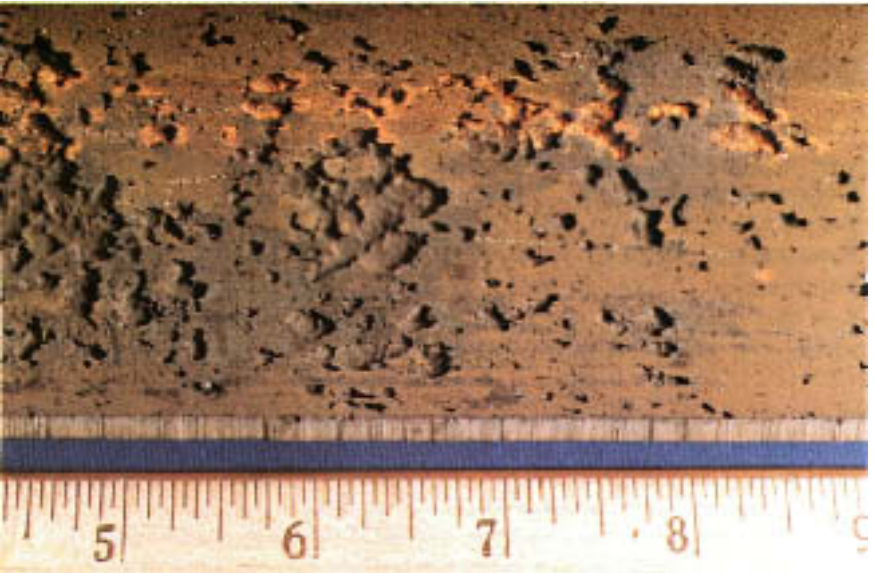
drum, and on the steam-separation canisters. This is evidence that excessive levels of dissolved oxygen were present in the feedwater. The excessive oxygen levels, coupled with the presence of the chelant, resulted in the corrosion observed. The metal loss produced smooth, rolling, wavelike surface contours and islands of intact metal in affected areas (Fig. 5.7).

Figure 5.7 Internal surface of downcomer tube showing oxygen-assisted chelant corrosion.

The entire internal surface was lightly covered with deposits and iron oxides. The corroded metal was covered with a shiny black film under these deposits and iron oxides. The layer of iron oxides and deposits covering corroded surfaces reveals that corrosion had not been active recently, and therefore was not continuous, but intermittent.
