## Low-pH Corrosion during Service

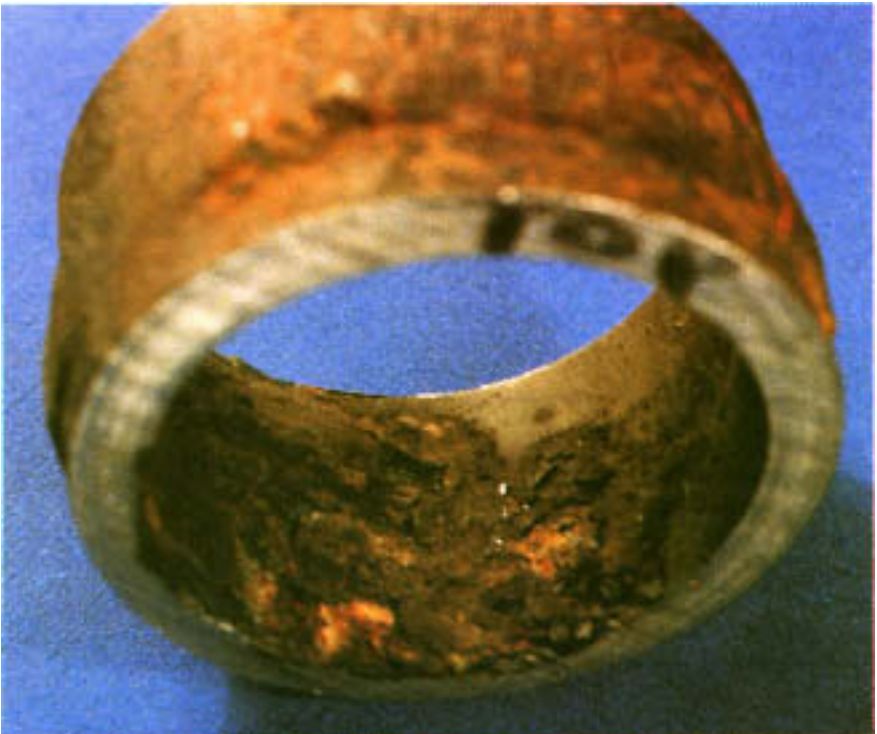
Numerous occurrences of the type of gouging illustrated in Fig. 6.1 had resulted in an extensive tube-replacement program. Most replacements were in one of the boiler's side walls. This type of corrosion was a recurring

**Figure 6.1** Low-pH gouging.

problem, but the frequency had recently increased. The boiler was in peaking service.

The large percentage of occurrences immediately downstream of circumferential welds indicates that disrupted water flow across the weld was instrumental in establishing a concentration site for corrosive substances.

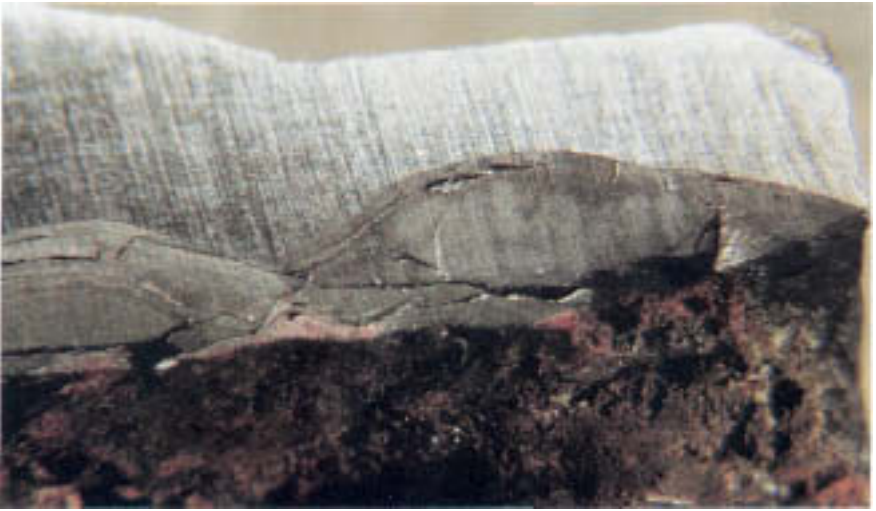
**Figure 6.2** Deep gouge on internal surface. (Magnification: 7.5X.)

Figure 6.2 illustrates the extent and appearance of the gouging. The crater was filled with thick, hard, iron oxides and elemental copper. (Most gouging had occurred downstream of circumferential welds.)

Analysis of corrosion products on the internal surface of the crater revealed significant amounts of chloride.

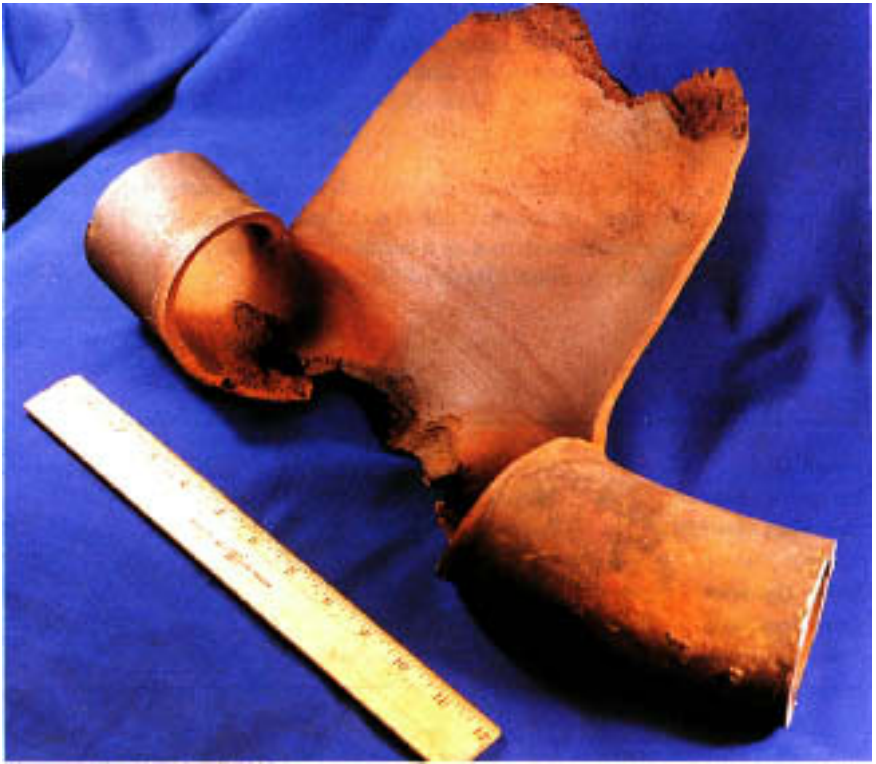
Figures 6.3 and 6.4 illustrate the massive rupture that occurred in a distinct zone of deep metal loss along the internal surface of this tube. Surrounding areas of the internal surface were unaffected and quite smooth.

**Figure 6.3** Rupture associated with low-pH gouging.

Microstructural examinations revealed extensive hydrogen damage in the tube wall immediately below the gouged zone.

The visual and microstructural appearance of the gouged region was consistent with that of low-pH exposure. The hydrogen damage that is associated with the low-pH gouging indicates that corrosion occurred during boiler operation.

Concentration of low-pH corrosive may have occurred beneath deposits that were dislodged from the internal surface at the time of rupture. It is also possible that concentration occurred as a result of the presence of a steam blanket that resulted from nonnucleate boiling.

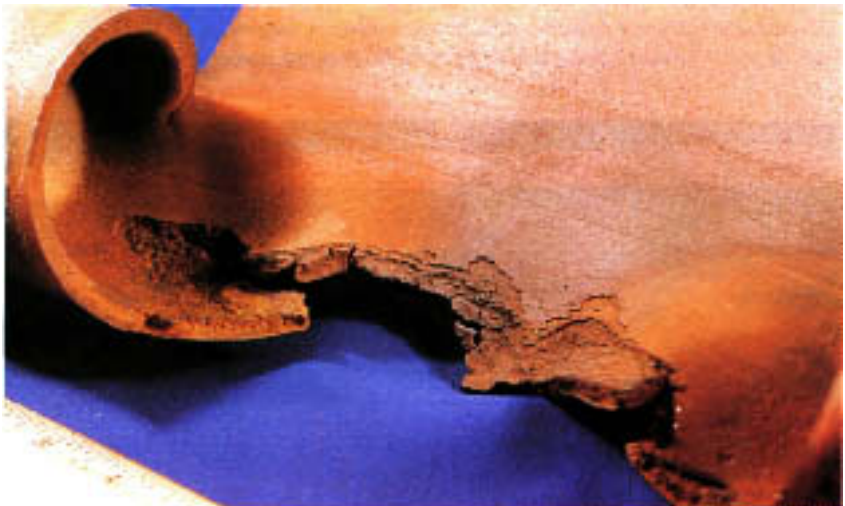
**Figure 6.4** Metal loss at the origin of rupture.

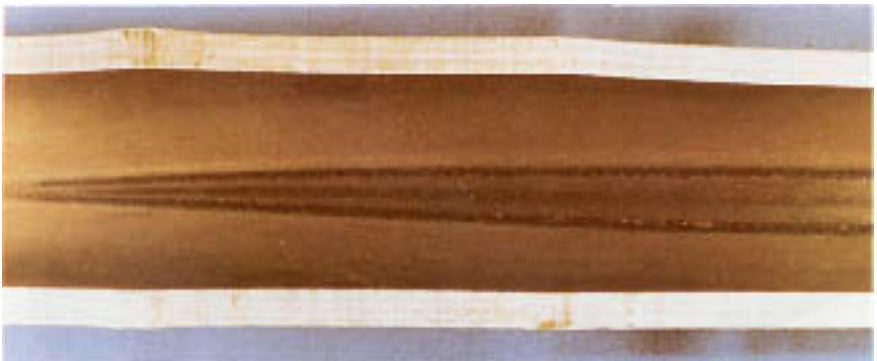
Figure 6.5 illustrates one of many tubes that had sustained similar severe corrosion. Grooves were located along the top (crown) of each tube. The convergence of the groove, apparent in Fig. 6.5, marked the position where the slanted tube assumed a vertical orientation. Metal loss was not observed downstream of this point.

**Figure 6.5** Convergence of groove.

Gravitational stratification of water and steam established relatively stable steam channels along the tops of the slanted tubes. Evaporative concentration of dissolved solids within this channel furnished the corrodent. Careful chemical analyses revealed that iron phosphate and sodium iron phosphate were confined to corroded metal surfaces.

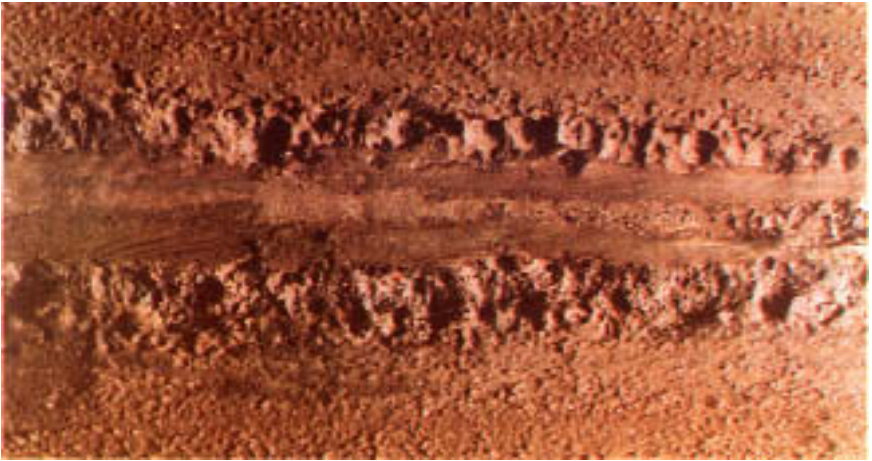
Corroded areas were covered with black, powdery deposits (Fig. 6.6). These deposits covered a second layer of light-colored material that was

**Figure 6.6** Appearance of deposits covering groove.

directly on the metal. The light-colored material was present only in corroded regions. On either side of the groove a hard coating of protective magnetite covered the smooth internal surface. The contour of the corroded surface following removal of the deposits and the light-colored material is shown in Fig. 6.7.

Microstructural analyses revealed that the grooved tube wall had sustained mild overheating. Analyses of the substances covering corroded surfaces revealed that the light-colored material on the metal surface was highly crystalline and was composed of iron and phosphorus. X-ray diffraction studies of this material revealed iron phosphate and sodium iron phosphate.

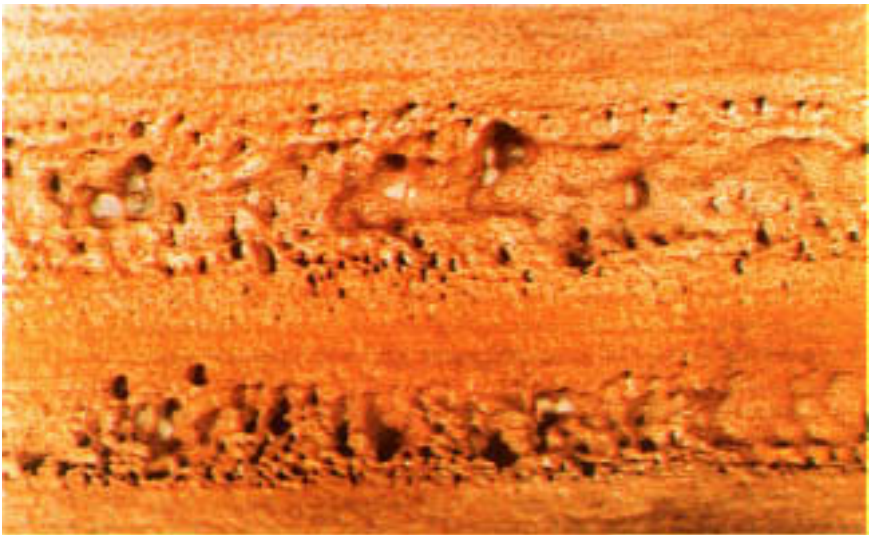
**Figure 6.7** Contour of groove after deposit removal. (Courtesy of Electric Power Research Institute.)

While a diagnosis of caustic gouging might explain this corrosion, the microstructural contours of corroded surfaces, the absence of dense iron oxide or crystalline magnetite, and the specific water chemistry of the boiler in this case all suggest corrosion by a weak, phosphorus-containing acid.

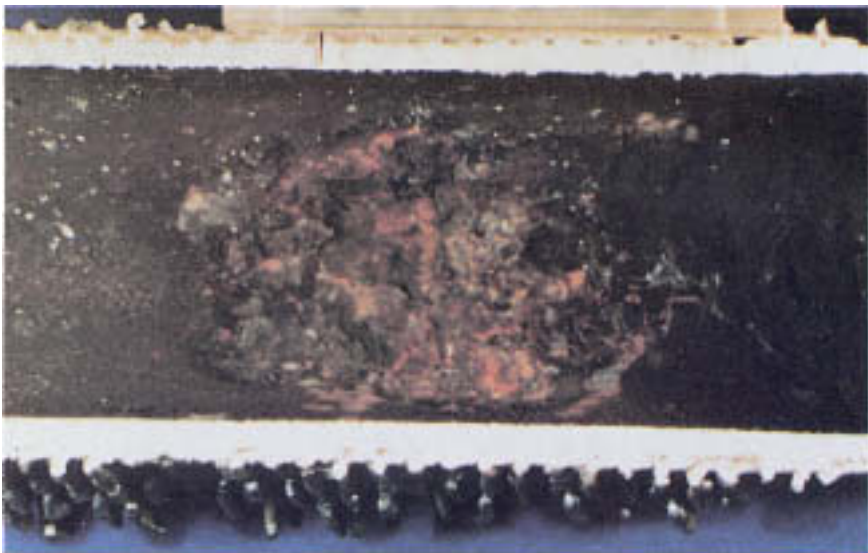
Corrosion was a recurrent problem in the economizer of this gas-fired boiler. Failures occurred only in the hot end of the economizer at the beginning of the finned area (Fig. 6.8). Heat fluxes in this area were 40% higher than design values.

Corrosion formed a large elliptically shaped gouge covered with a thick, irregular layer of hard, dark iron oxides. Microstructural examinations of the iron oxides covering this gouge revealed a laminated structure typical of low-pH gouging.

Nonnucleate boiling in this area of the economizer (caused by excessively high heat fluxes) furnished the means for concentrating corrosive, low-pH substances. The source of the acid-producing salts was undetermined, but may have been caused by leakage of sodium chloride from the regeneration of a water softener.

**Figure 6.8** Gouging along internal surface opposite fins.

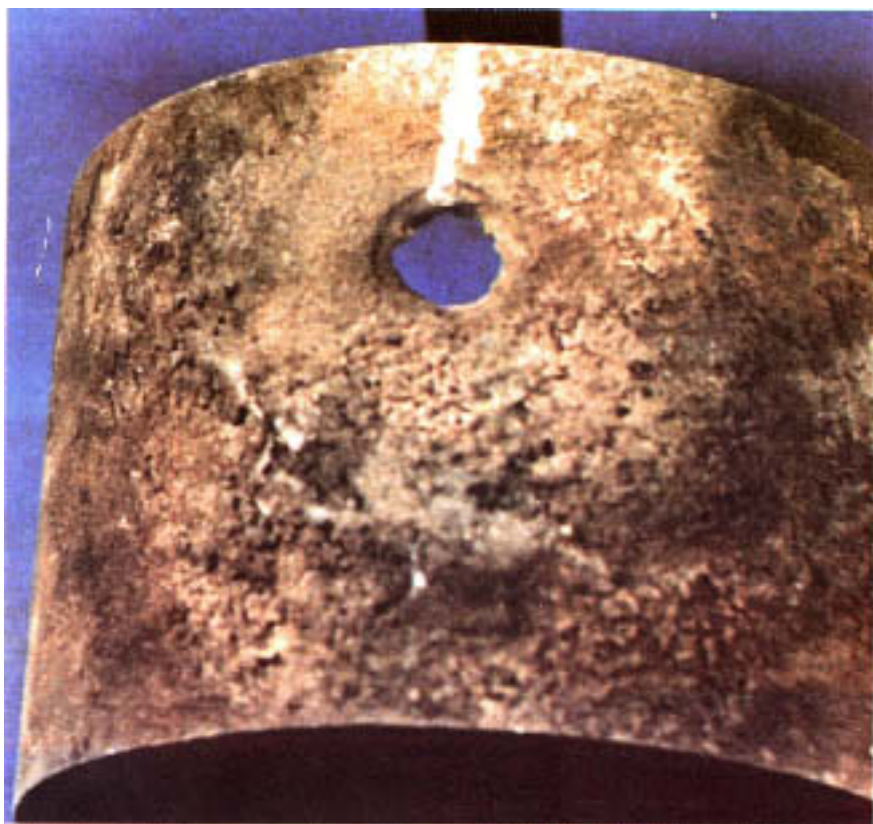
The perforation illustrated in Fig. 6.9 occurred along the bottom of the first tube pass in the convection section of the furnace. Steam and ethane, in the ratio of 1 to 3, pass through the tube.

Dark deposits, which gave a low-pH indication when wetted, surrounded the corrosion site. Analysis of these deposits and corrosion products revealed high levels of phosphorus and iron. It is possible that an acidic, phosphorus-containing substance had concentrated along the hot side of the tube, resulting in this deterioration.

**Figure 6.9** Perforation resulting from corrosion of internal surface.

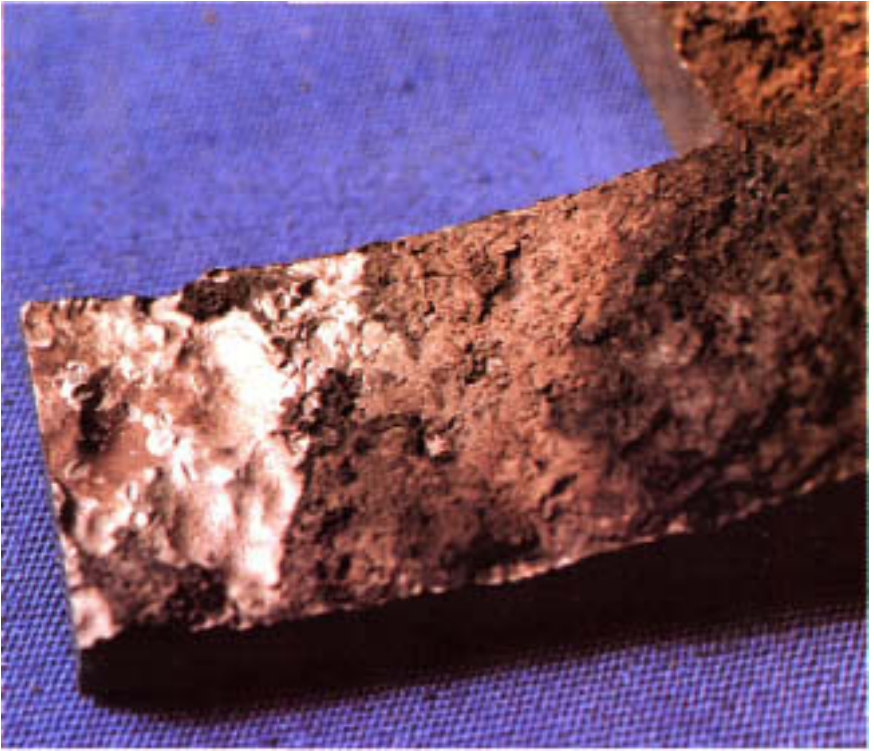
The metal loss, illustrated in Fig. 6.10, occurred on the internal surface of the tube and was responsible for the perforation. The corrosion produced a smooth, rolling surface contour.

**Figure 6.10** Appearance of metal loss on internal surface.
