Low-pH Corrosion during Acid Cleaning

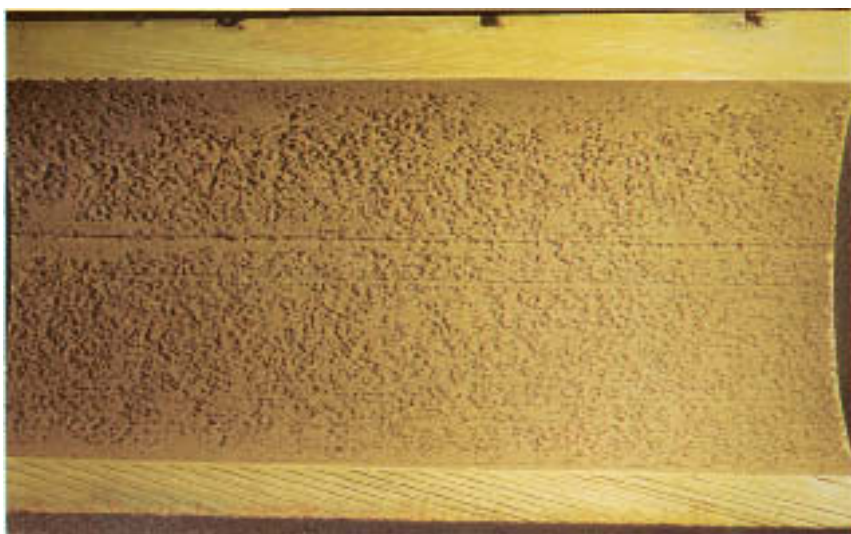
Attack of any metal surface of a boiler by strong acid is generally unmistakable. The surface usually has a rough or jagged appearance, depending on the severity of the attack (Figs. 7.1 and 7.4). A close examination will disclose discrete pits, which are frequently undercut. On boiler tubes, the pits will frequently be aligned longitudinally along the tube wall (Fig. 7.1).

Figure 7.1 Acid corrosion on the internal surface of a wall tube. (Courtesy of Electric Power Research Institute.)

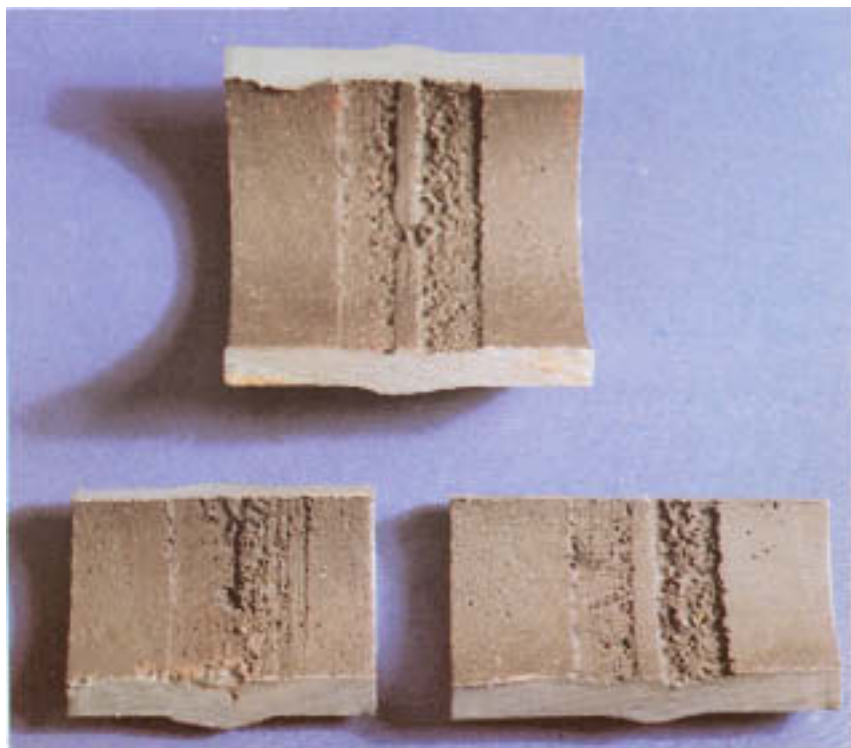
Figure 7.2 Acid corrosion at weld.

Figures 7.2 and 7.8 illustrate attack of the internal surfaces of wall tubes opposite external circumferential welds. Cross-sectional profiles of the internal surface in these attacked zones revealed undercutting and jaggedness. Residual stresses remaining from the weld make these sites subject to preferential corrosion when exposed to strong acid.

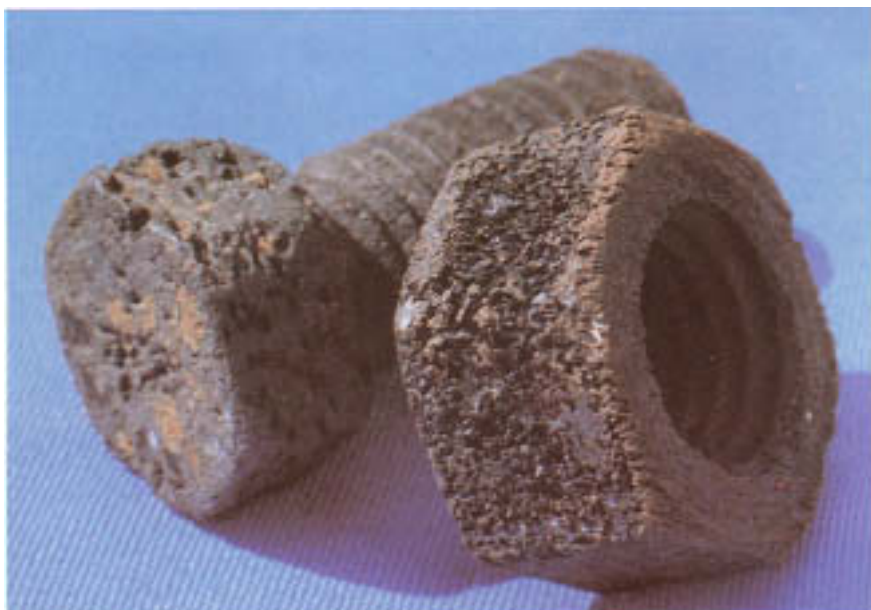
Corrosion of the internal surfaces of a boiler that results from low-pH exposure may occur during acid cleaning if proper procedures are not followed. One of the first areas to be affected is the tube ends inside the mud and steam drums. Hand-hole covers, drum manholes, and shell welds may also be affected. Heat-transfer surfaces (Fig. 7.1) and weldments (Fig. 7.2) may experience vigorous attack. Shielded regions within crevices, behind backing rings, and under remaining deposits may prevent proper neutralization of the cleaning acid. This results in vigorous localized attack of the metal once the boiler is returned to service. In general, any surface exposed to acid is susceptible (Fig. 7.3).

Figure 7.3 Acid corrosion of attachment hardware.

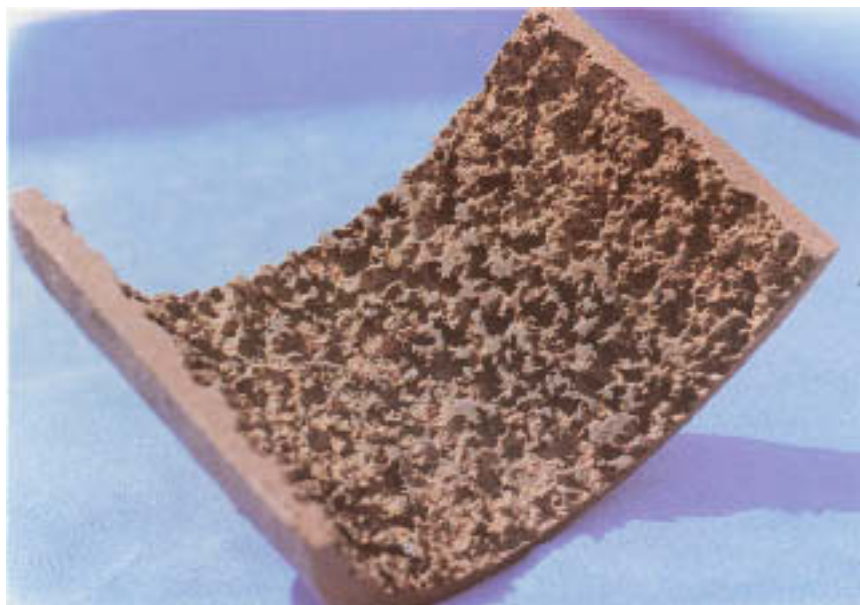
Figure 7.4 Jaggedness associated with severe acid corrosion. (Courtesy of Electric Power Research Institute.)

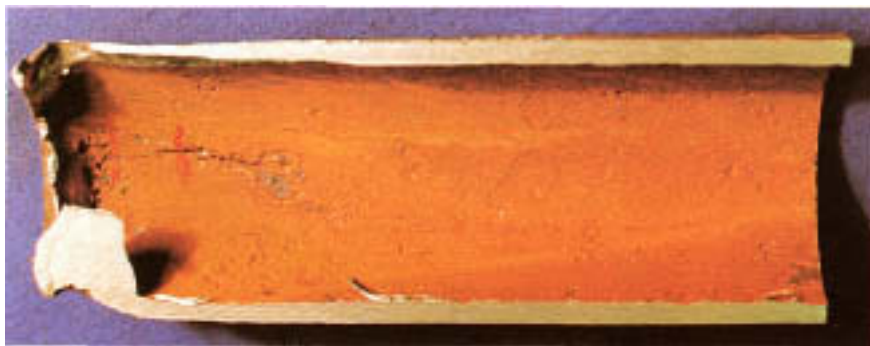
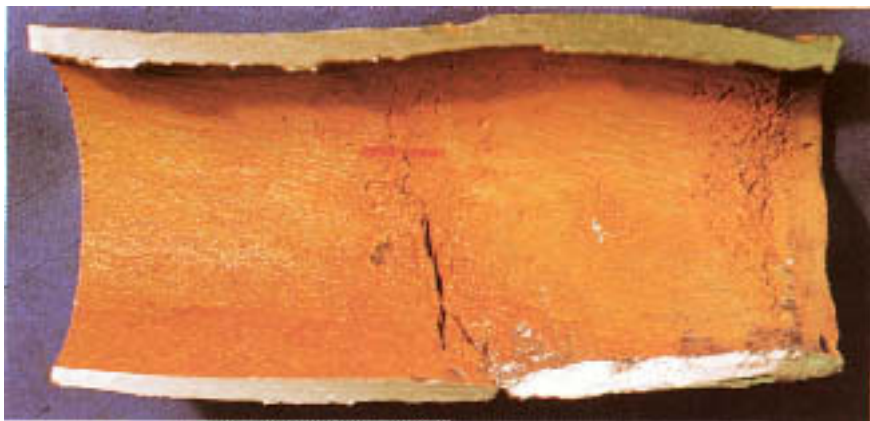
Following an acid cleaning of the boiler, the damage apparent in Figs. 7.5 and 7.6 was observed. Close visual examinations of these tubes revealed very fine, discontinuous fissures running longitudinally down the internal surfaces. These fissures, which appeared to coincide with a series of faint mandrel marks, were deeper at the end that had been rolled into the drum. The tube illustrated in Fig. 7.6 also shows deep transverse fissuring where it had been rolled into the drum. Examination of cross-sectional profiles of tube surfaces revealed they were jagged, undercut, and free of normally present iron oxides.

Attack by strong mineral acid is responsible for the delineation and deepening of mandrel marks running down the bore of the tube, as well as for the development of deep fissures near the end of the tubes that had been rolled into the drum. The delineation and deepening of the mandrel marks is associated with residual stresses in the metal at these sites from the tube-fabrication process. The presence of deep fissures of various orientations at the ends rolled into the drums is associated with residual stresses resulting from the tube-rolling process. Strong mineral acid characteristically attacks

Figure 7.5 Longitudinal fissures near rolled end.

Figure 7.6 Transverse fissures near rolled end.

stressed metal areas more aggressively than unstressed areas; this is because of the greater energy content of metal associated with residual stresses.

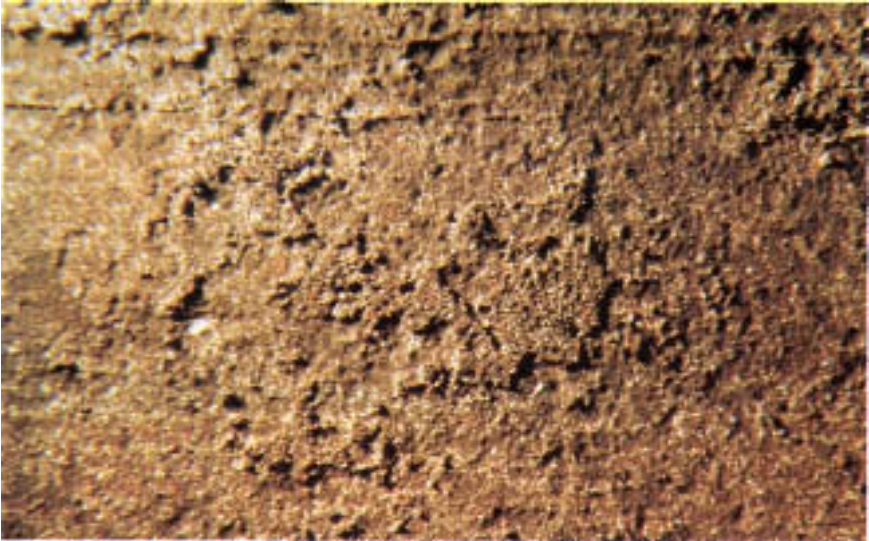
Attack by citric acid is illustrated in Fig. 7.7. Visually, the surface has an etched, bright metallic appearance. Close examination reveals irregular islands of uncorroded metal, which, in this case, stand 0.005 in. (0.12 mm) above the surrounding corroded surface. Essentially the entire internal

Figure 7.7 Appearance of attack by citric acid. (Magnification: 7.5X.)

surface, both hot and cold sides, was similarly affected. This condition is consistent with attack during acid cleaning.

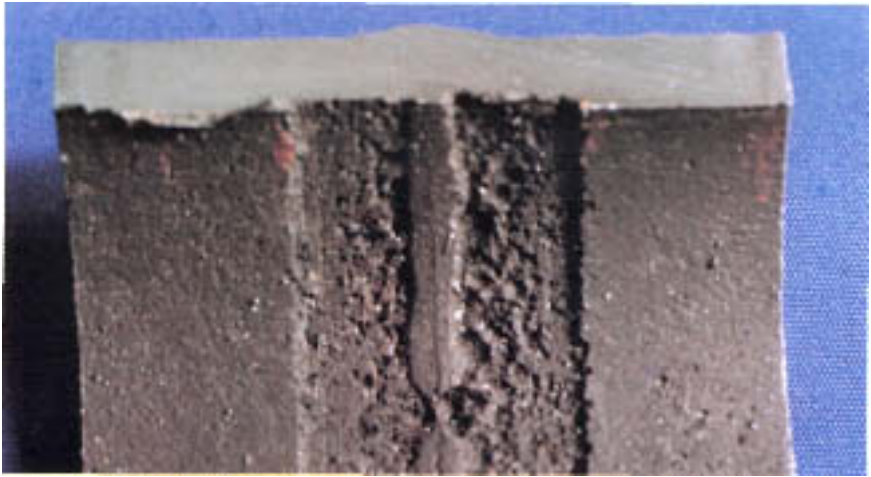
Figure 7.8 Acid corrosion at welds.

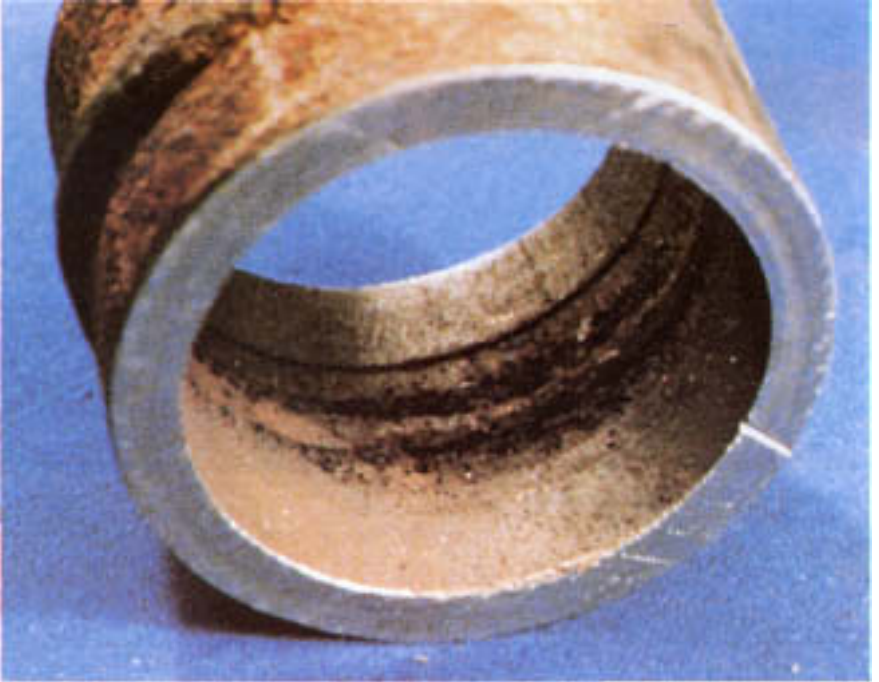
A number of fairly deep, overlapping pits were observed in a circumferential zone along the internal surface opposite circumferential welds on the external surfaces of the tubes (Fig. 7.9). Other areas of attack were noted in regions where welds were not present (Fig. 7.10). Attack in these areas was more pronounced along the tube seam.

Deposits overlying the attack sites reveal that the corrosion occurred in the past, probably during the last acid cleaning of the boiler.

Preferential attack of welds may be due to residual stresses associated with the weld, or to pores or crevices existing in the weld zone. Preferential attack of a tube seam may be due to segregated impurities in the seam, or to a crevice resulting from incomplete fusion of the seam.

Figure 7.9 Acid corrosion at weld.

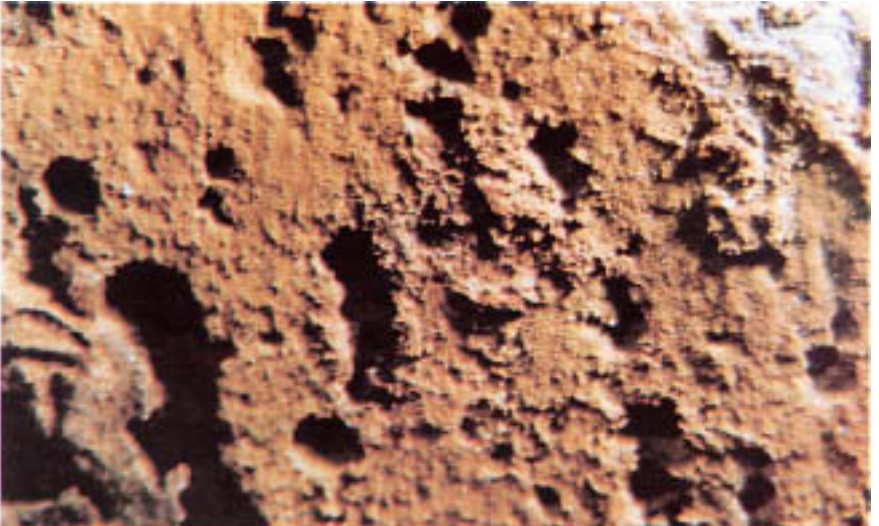
Figure 7.10 Acid corrosion along internal surface. (Magnification: 7.5X.)

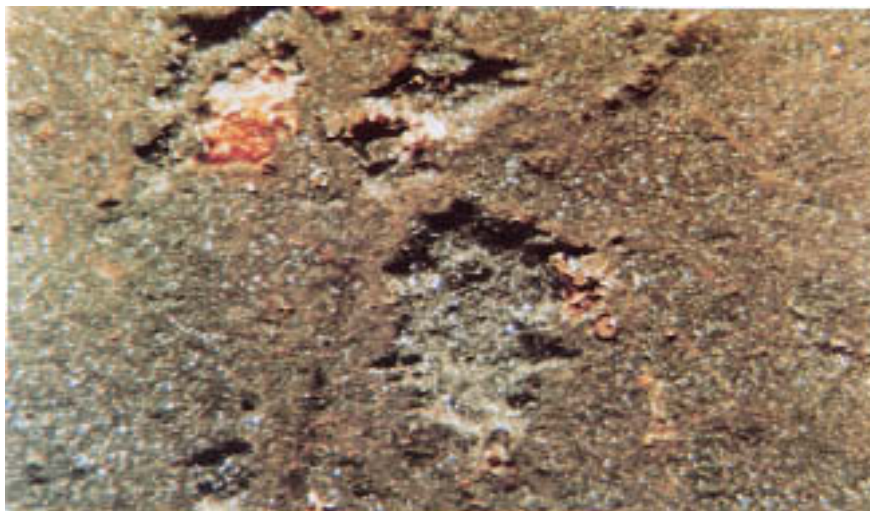
Visual examinations of belly-plate surfaces revealed shallow patches of irregular metal loss on all top and bottom surfaces. The sites of metal loss tended to be aligned in parallel rows. Figure 7.11 illustrates the appearance of the metal loss, although a thin coating of iron oxide tends to soften the normally sharp edges.

This case illustrates the importance of supporting observations in establishing low-pH corrosion as the cause of metal loss. Figure 7.11 lacks the classical, jagged, undercut surface profile normally associated with attack by a strong acid. However, the following additional observations strongly support the diagnosis:

- Alignment of attack sites in parallel rows oriented in the rolling direction of the steel from which the plate was fabricated
- Preferential attack of welds and tube ends in the steam drum
- Jagged, undercut, cross-sectional profiles of belly-plate surfaces apparent in metallographic examinations

Figure 7.11 Metal loss from strong acid. (Magnification: 7.5X.)

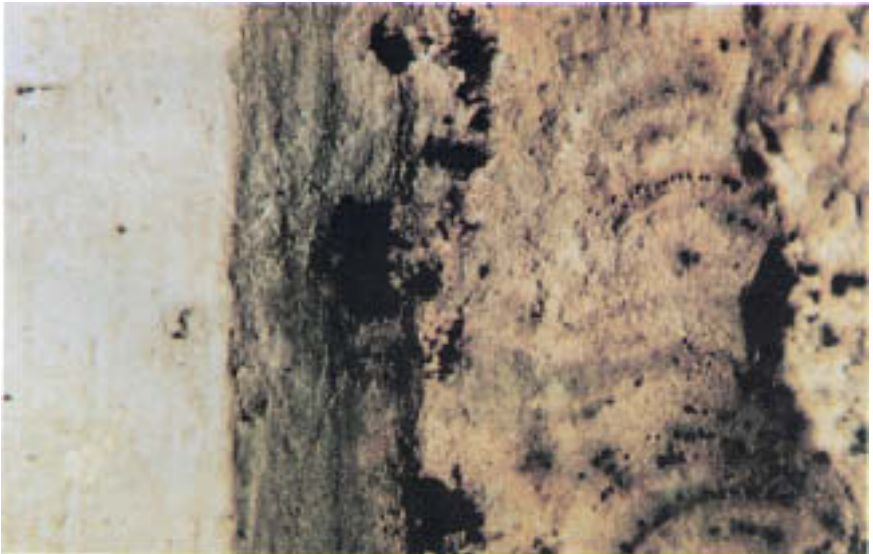
A combination of welding defects in circumferential welds, and attack of the weld area by strong mineral acid over a series of five acid cleanings during a 13-year period, resulted in tube perforations. Perforations at the weld sites led to secondary failures of adjacent tubes by erosion caused by steam escaping at high velocity.

Close examination of the internal surfaces of the welds revealed highly localized areas of corrosion, which produced jagged, undercut surface contours typical of attack by strong mineral acid (Fig. 7.12).

Open crevices, pores, and pits in weld areas are sites where acid may survive neutralization steps following acid cleaning. Acid corrosion can enlarge and deepen these sites, resulting in eventual perforation of the tube wall at the weld.

Figure 7.12 Acid attack along weld on internal surface. (Magnification: 7.5x.)

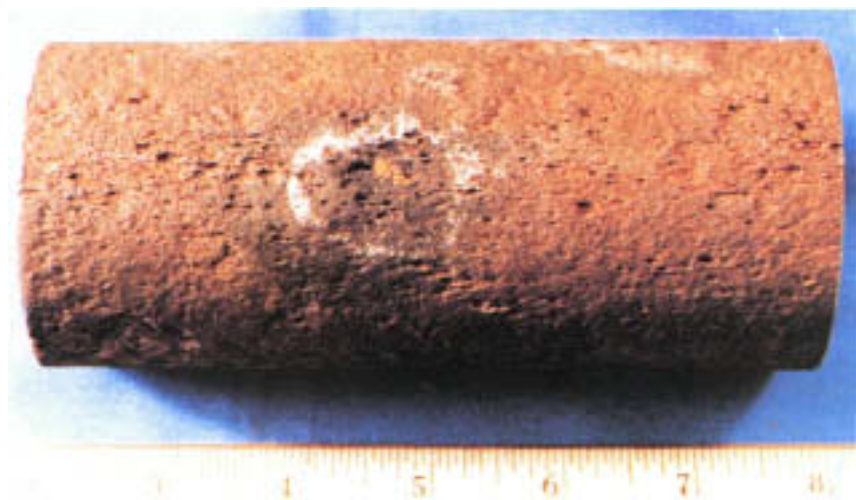
Hydrotesting following acid cleaning of the boiler revealed several leaking tubes. Examination of one of the leaking tubes revealed profuse pitting (Figs. 7.13 and 7.14). External surfaces were covered with a film of brown iron oxides.

Although some pitting may have occurred as a result of excessively high oxygen levels in the boiler water during idle times, the primary mode of attack was insufficiently controlled exposure to strong mineral acid during acid cleaning. Note the large population of pit sites, the general deterioration, and the appearance of fine longitudinal fissures characteristic of attack by a strong acid (Fig. 7.13).

Figure 7.13 Acid corrosion on the external surface of a fire tube.

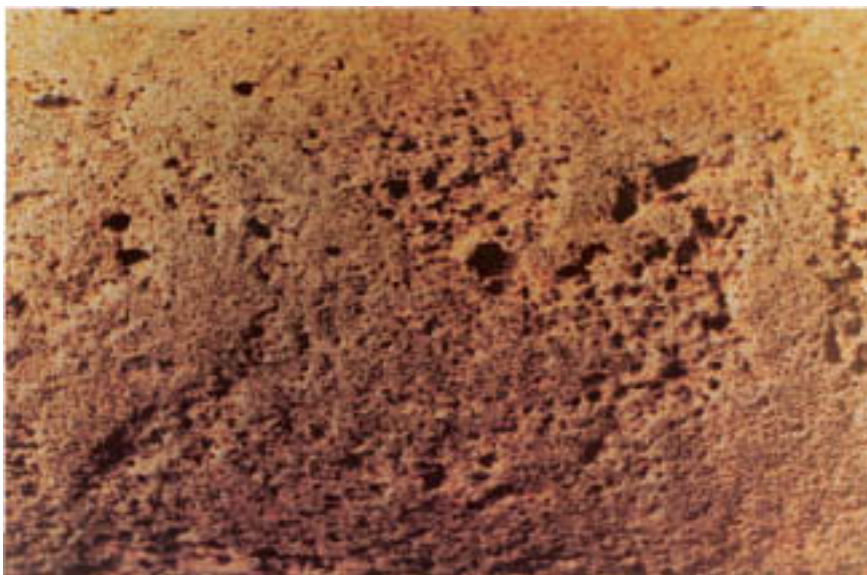
Figure 7.14 Close-up of external surface shown in Fig. 7.13.
