Oxygen Corrosion

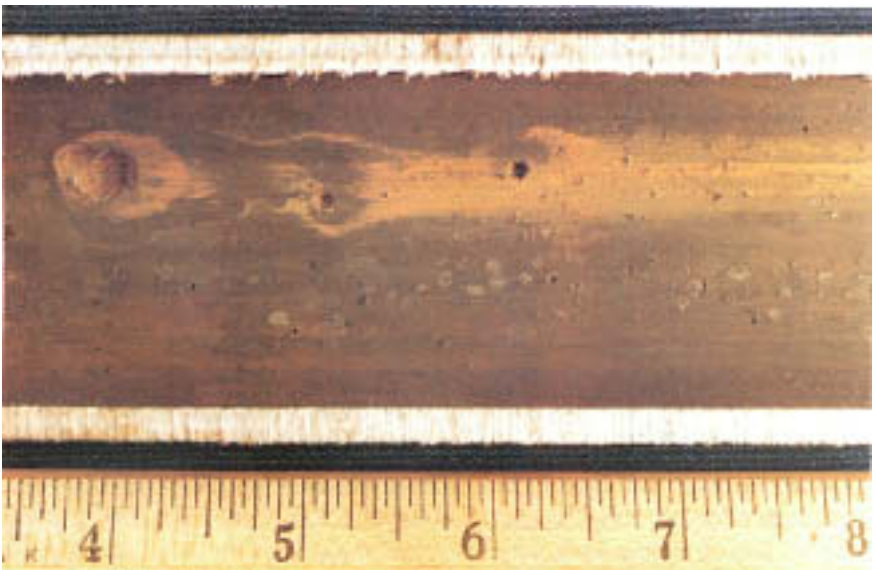
Figure 8.1 Oxygen pits in section of superheater tube. (Courtesy of Electric Power Research Institute.)

The oxygen pits illustrated in Figs. 8.1 and 8.4 were discovered during a hydrotest of a recovery boiler that had been in wet lay-up over the summer. The superheater section had been in dry lay-up under a nitrogen blanket.

Gravity-induced drainage of corrosion products from sites on vertical sections is apparent in Fig. 8.1. Elliptical rings surrounding the pit on the horizontal portion of the pendant section indicate that a pool of condensate had been present (Fig. 8.4). Close examination under a low-power stereoscopic microscope revealed contraction cracks in the protective magnetite at the pit sites. It is apparent that, despite the precautions of dry lay-up, the tube had been exposed to condensed moisture and atmospheric oxygen.

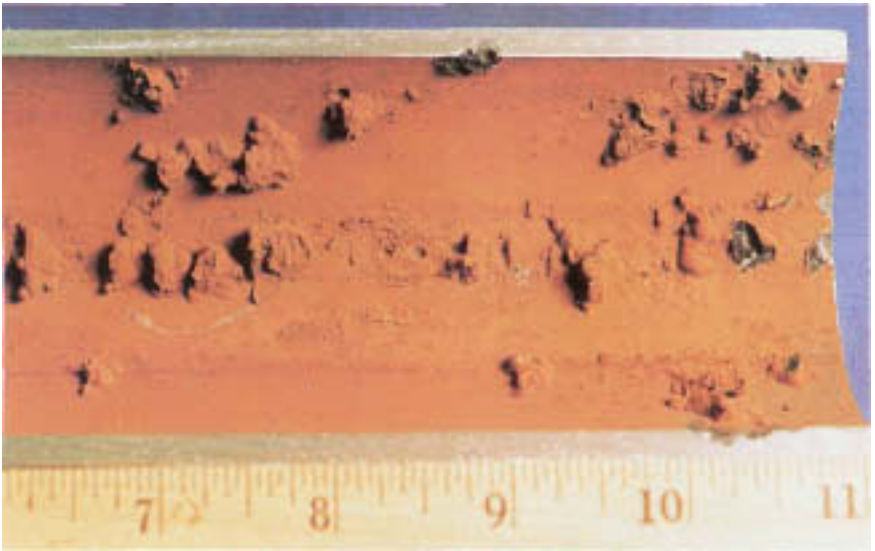
Figure 8.2 Caps of iron oxide covering pit sites.

The reddish color of the iron oxides and the presence of tubercles capping iron oxide-filled pits (Fig. 8.2) is typical of exposure of economizer steel to water containing excessively high levels of dissolved oxygen. Pitting and perforation of economizer tubes was a recurrent problem at this plant. Failures were occurring every 3 or 4 months.

Oxygen content of the water was measured at 5 to 9 ppb. Excursions to higher levels were suspected but could not be documented. The boiler was operated continuously. Although the source of the oxygen was not identified, it is clear that excessively high levels existed in the affected regions of the economizer.

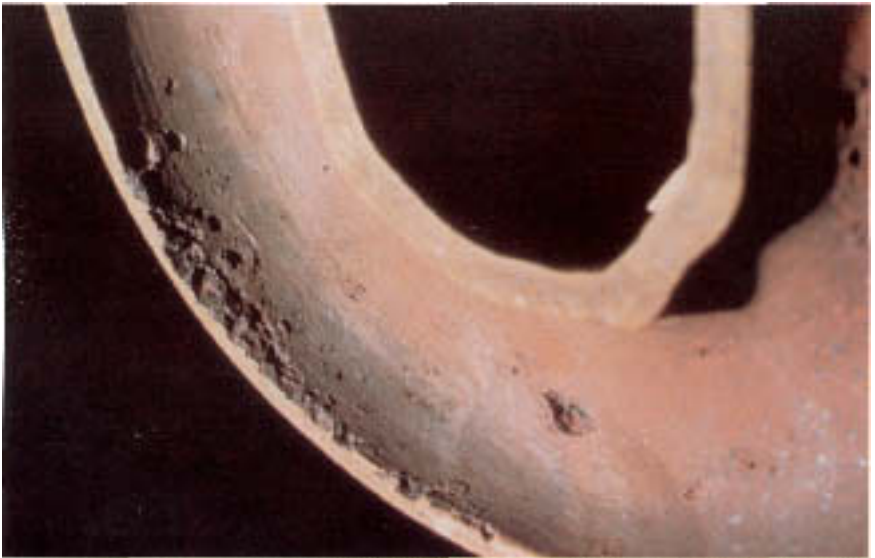
For example, moisture condensing on the walls of an idle superheater tube will dissolve atmospheric oxygen. Fractures in the protective magnetite are caused by contraction stresses as the superheater is cooled to ambient temperatures. The fracture sites furnish anodic regions where oxygen-containing moisture can react with bare, unprotected metal. The result may be deep, distinct, almost hemispherical pits (Fig. 8.1), which may be covered at times with caps of corrosion products (Fig. 8.2). Frequently, pitting will occur at the bottom of U-shaped superheater pendants where moisture can accumulate (Fig. 8.3).

Figure 8.3 Oxygen pits along bottom of superheater pendant. (Courtesy of National Association of Corrosion Engineers.)

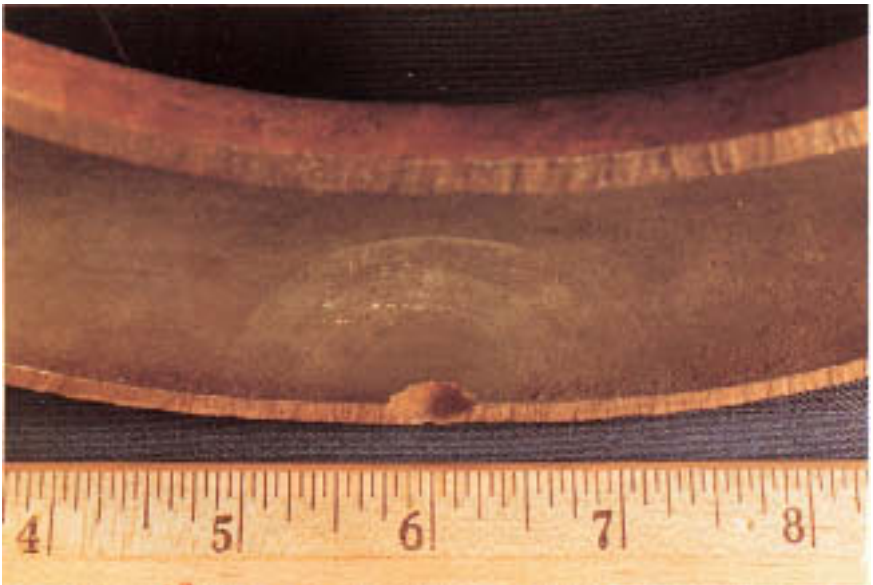
Figure 8.4 Elliptical water rings surrounding oxygen pit in a U-bend. (Courtesy of Electric Power Research Institute.)

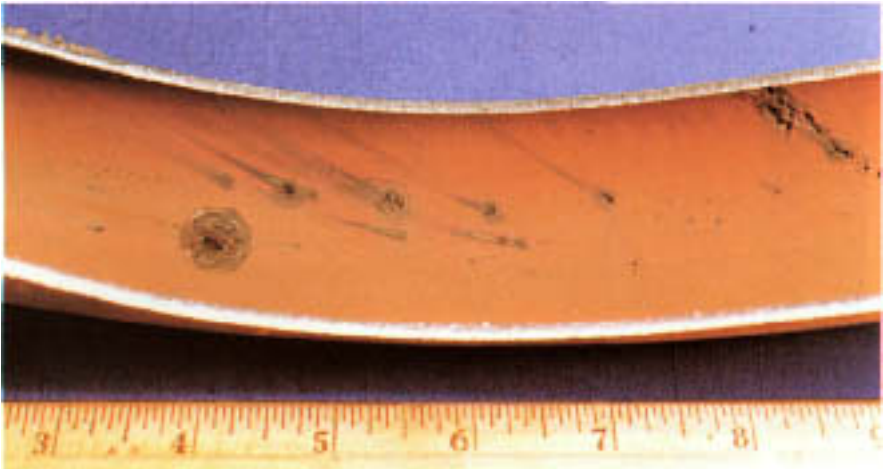
Figures 8.5 through 8.7 illustrate typical oxygen pitting resulting from an improperly executed wet lay-up. Inadequate feed of oxygen-scavenging chemicals, and/or failure to maintain proper water circulation, may have been responsible.

Gravitationally induced drainage of corrosion products is apparent in Fig. 8.5. This is evidence of stagnant or very low flow of water during lay-up. Significant water flow would have reoriented the drainage lines in the direction of water flow. Typical knoblike mounds of iron oxide corrosion products (tubercles) are shown in Figs. 8.6 and 8.7.

Figure 8.5 Oxygen pits on internal surface.

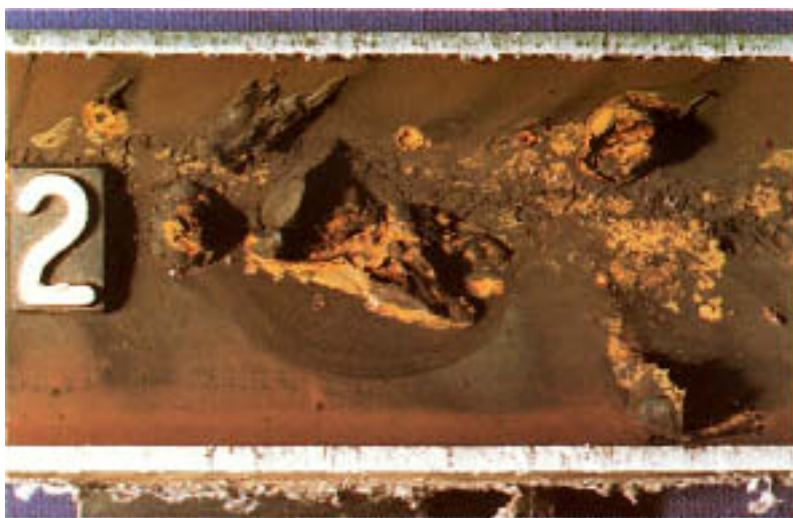
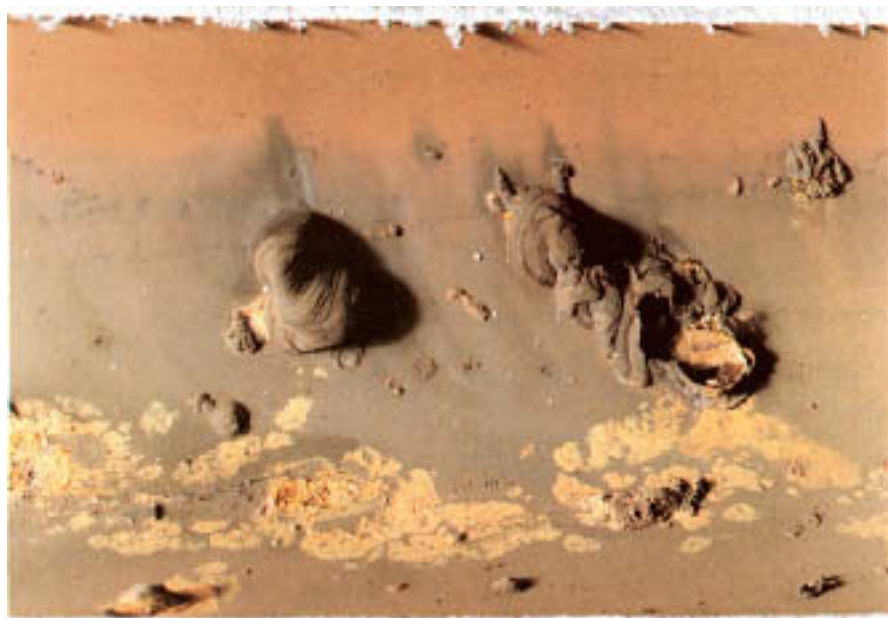
Figure 8.6 Tubercles covering oxygen pits.

Figure 8.7 Tubercles covering oxygen pits.

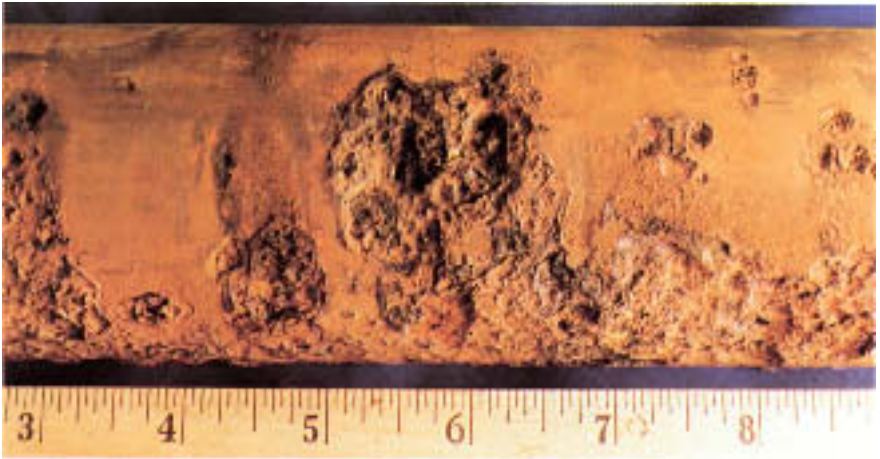
Figure 8.8 illustrates the external surface of a fire-tube boiler that has sustained severe oxygen corrosion. Interruptions of oxygen-scavenger feed lasting as long as 1 week had occurred. It is probable that the pitting initiated and progressed during these interruptions. Deposits, which can also induce pitting (deposit corrosion), were not present on the tube.

Figure 8.8 Oxygen pitting on the external surface of fire tube.

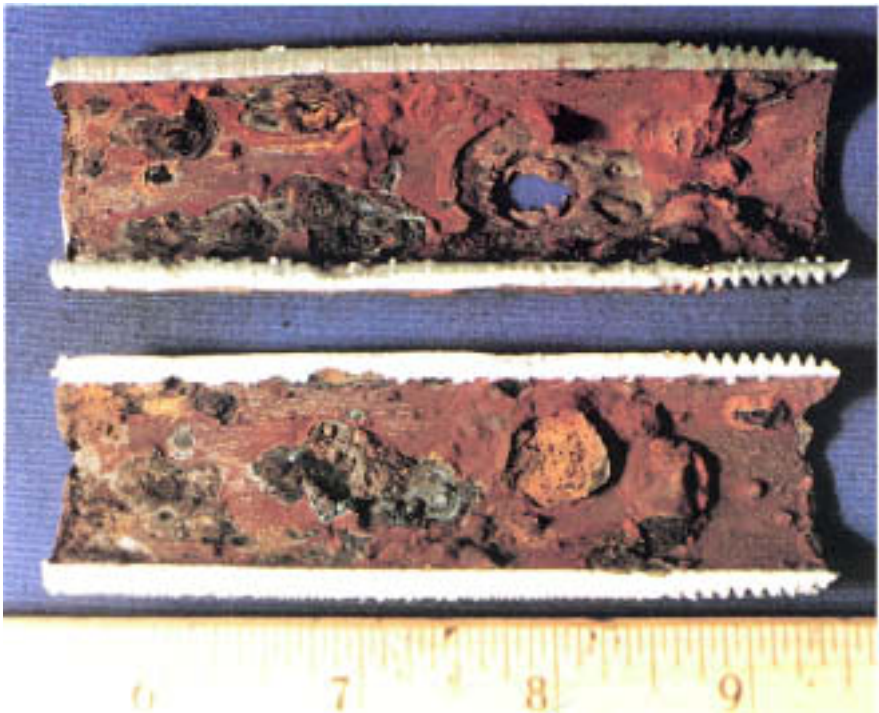
Figure 8.9 illustrates a recurring problem in one region of the condensate system of a boiler that operated 8 to 10 hours per day. The reddish color of the iron oxides and the tubercles covering the pit sites identify the deterioration as oxygen pitting.

The condensate system is pressurized during service and carries water at 220°F (104°C). Although oxygen could be present in the system under these conditions, it is more probable that the source of oxygen is air sucked into the line as the system cooled during idle periods. A treatment utilizing filming amine, rather than a simple neutralizing amine would probably be more successful in mitigating corrosion of this type.

Figure 8.9 Internal surface of condensate line.
