Coal-Ash Corrosion

CASE HISTORY 10.1

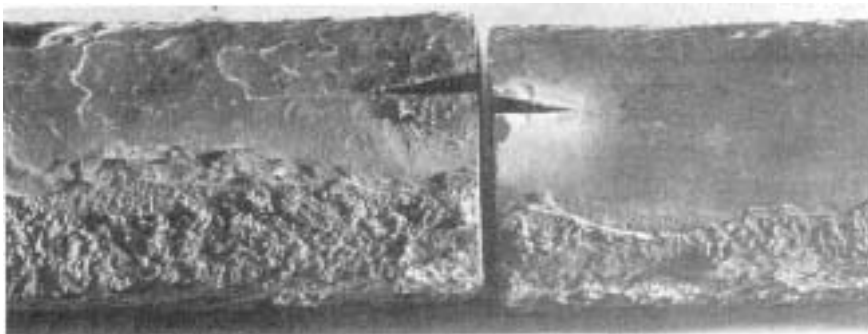
Coal-ash corrosion is identified by slag buildup on the tube wall and the associated metal loss. Austenitic stainless steel tubes may exhibit a pock-marked surface appearance. Low-alloy carbon steel tubes typically show a pair of flat zones of metal loss that are located on both sides of the leading face of the tube at orientations of 30 to 45°. Corroded surfaces have a grooved or roughened appearance (Fig. 10.1).

Figure 10.1 Superheater tube (ASME SA-213, grade T22) that ruptured due to thinning by coal-ash corrosion. (Reprinted with permission of American Society for Metals Handbook, vol. 10, 8th ed., Metals Park, Ohio, 1975, p. 537.)

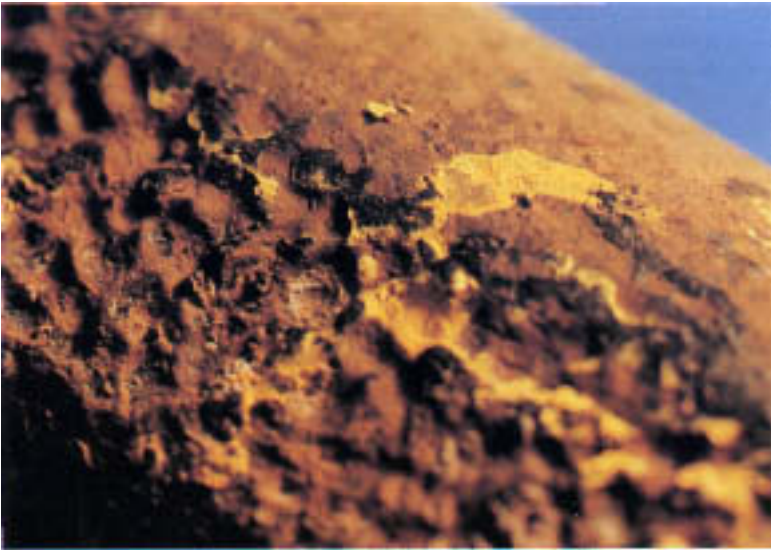
The boiler from which the tubes illustrated in Figs. 10.4 and 10.5 were removed had experienced chronic corrosion problems in the outlet pendants of the secondary superheater. Ten separate failures had occurred over a 3-year period. The boiler was operated continuously.

The tube submitted for analysis had not failed, but had sustained a 1-in.-wide (2.5-cm-wide) band of severe corrosion along one side of its external surface. Measurement indicated a reduction in tube-wall thickness of 0.085 in. (2.2 mm).

Figure 10.4 Contour of external surface in corroded zone. Note pockmarked surface appearance characteristic of attack on stainless steel.

Evidence from visual, microstructural, and chemical analyses identified the wastage as coal-ash corrosion resulting from the formation of complex alkali sulfates at the metal surface.

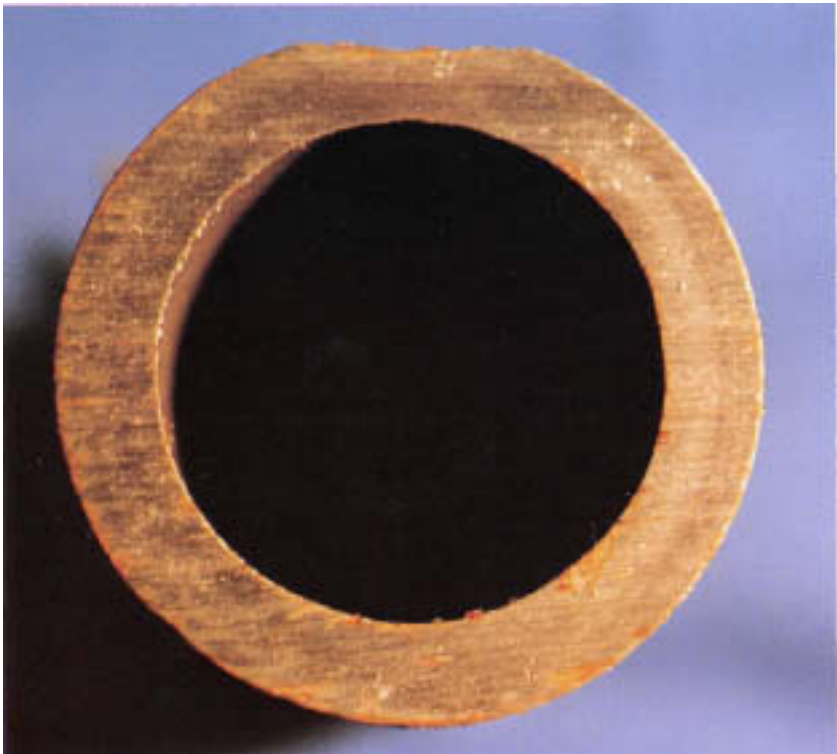
Figure 10.5 Transverse profile of tube showing metal loss.

Microstructural examinations revealed solidified eutectics of slag covering the external surface in the corroded zone. Chemical analysis of material covering the corroded region revealed large amounts of iron, sulfur, and potassium, as well as components of fly ash.
