Waterwall – Fire-Side Corrosion

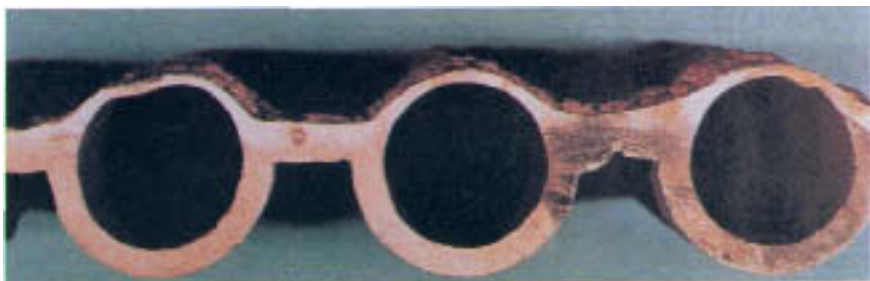
Waterwall–fire-side corrosion is frequently characterized by metal loss along the crown of the tube and may extend uniformly across several tubes in a particular location (Fig. 11.2). Corroded regions may be covered by abnormally thick layers of iron oxide and iron sulfide corrosion products. At times, flow patterns of the liquid pyrosulfates are apparent in regions of metal wastage.

Figure 11.2 Severe fire-side metal loss on waterwall tubes. (Courtesy of Electric Power Research Institute.)

Ultrasonic thickness surveys are used to determine extent and severity of existing damage. If damage is minor, patch welding of affected areas may be satisfactory. If damage is severe, installation of thicker tubes or of corrosion-resistant alloy tubes, use of thermal spray coatings, cladding of tubes, and the use of shields may be economically justifiable.

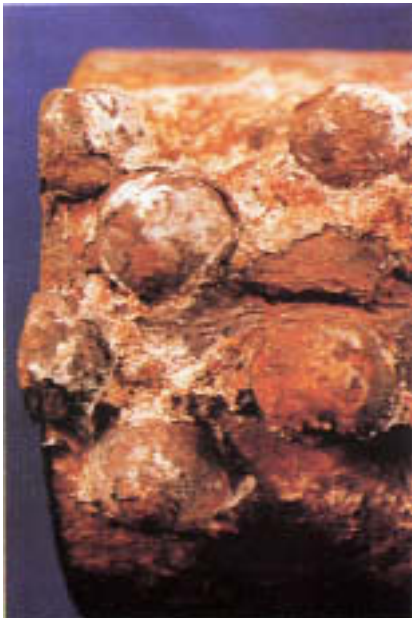
Six tube failures of the type illustrated in Fig. 11.3 occurred over a period of several weeks. Only roof tubes had failed.

Visual examination of the external surface of one of the tubes revealed a deep, longitudinal fissure at the base of a stud (Fig. 11.3). This surface was covered with a hard, tenacious, light-colored slag. Chemical analysis of this fire-side slag revealed 42% sulfur and 18% sodium. The pH of a 1% slurry of the deposit was 2.9.

Microstructural examinations revealed no thermal alteration of the tube metal. However, deep, intergranular fissures filled with a complex sulfate eutectic were observed originating on the external surface.

Figure 11.3 Longitudinal fissure adjacent to stud; fissure was caused by the combined effects of stresses imposed by internal pressure and the presence of a molten phase.

Visual and microstructural examinations, coupled with chemical analysis of the slag, revealed that the cracking apparent in Fig. 11.3 resulted from penetration of molten sodium pyrosulfate along grain boundary pathways of the tube-wall metal during boiler operation. Stresses imposed by normal internal pressure acted synergistically with the molten slag to produce the intergranular penetration. Microstructural examinations reveal that this attack was localized to a small region around the primary crack.

The presence of sodium pyrosulfates indicates that reducing conditions or incomplete combustion existed in the firebox, possibly from insufficient oxygen in the burner zone or unsatisfactory grinding of the coal. Insufficient oxygen in the burner zone may be caused by insufficient excess air.

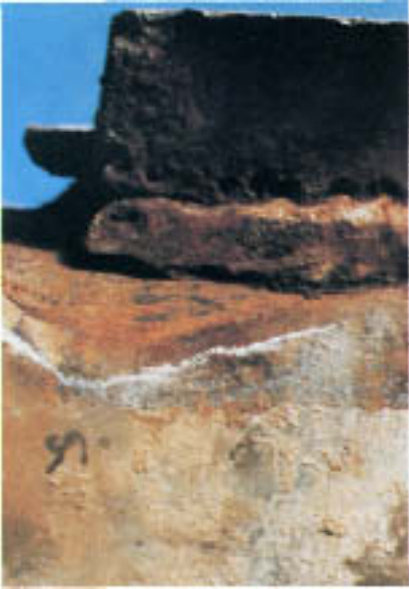
Figure 11.4 shows metal loss from the external surface near a longitudinally oriented fin. Metal loss was confined to an elliptical region centered on the fin. The stainless steel cladding as well as some underlying carbon steel was corroded away.

The corroded region was covered with a layer of brown corrosion product and deposits. Chemical analysis of this layer revealed a content of 52% iron, 24% sodium, and 14% carbonate.

Visual and microstructural evidence, coupled with analysis of the corrosion products, indicated that metal loss was caused by exposure of the metal to a molten salt of sodium. The fusion temperature of this salt may have been depressed by the presence of the carbonate.

Rates of metal loss from corrosion of this type vary depending on metal temperature and furnace design. Corrosion rates of 30 mil/y (0.76 mm/y) have been reported.

Figure 11.4 Metal loss around a fin resulting from exposure of a stainless steel-clad tube to a molten sodium salt.

Mitigation of this problem requires redesign of tube openings so that seals are tight to flue gas. In addition, crevices where corrosive substances can concentrate must be eliminated.

Repair of damage is most successful when weld overlays of high-nickel stainless steels and thermal spray coatings are used.

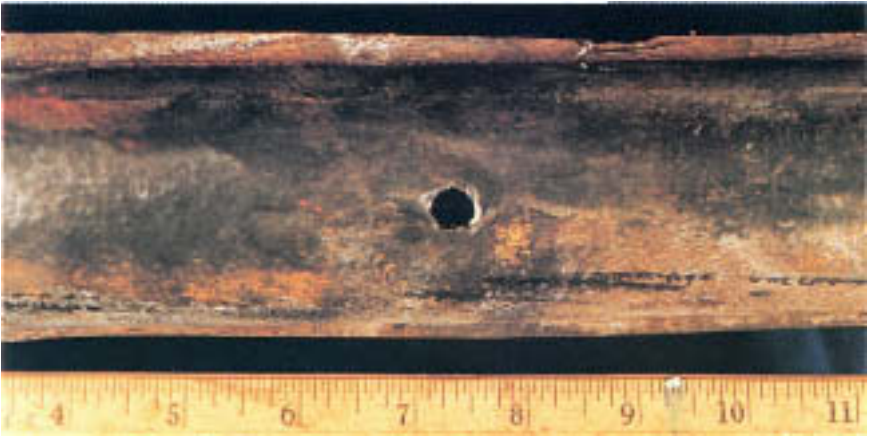
The corrosion apparent in Figs. 11.5 and 11.6 occurred over a very small area of the wall at a position 40 ft (12.2 m) above the floor and 4 ft (1.2 m) above oil guns. A failure of this type had not occurred previously.

Figure 11.5 Perforation in a region of severe metal loss.

The $\frac{3}{8}$ -in. hole in Fig. 11.5 is centered in a region of severe external corrosion along the crown of the tube. The corrosion has produced deep, broad depressions, which give the surface a rolling contour. Microstructural examinations revealed no evidence of overheating.

The fact that this corrosion was localized in the region of the oil guns suggests that a reducing environment, created locally during the operation of the guns, produced a corrosive molten phase having a low melting temperature. In this case, corrosion would occur only during oil-gun use, which is intermittent. However, the accumulated corrosion over 13 years of service was apparently sufficient to result in failure.

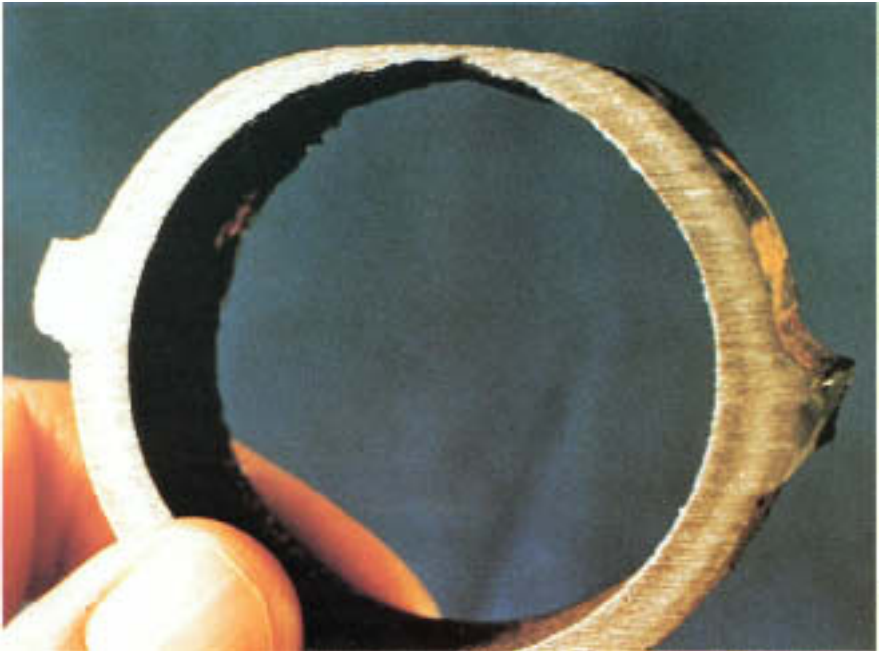
Figure 11.6 Severe metal loss along crown of tube resulting from exposure to a molten phase.
