Dew-Point Corrosion during Idle Periods

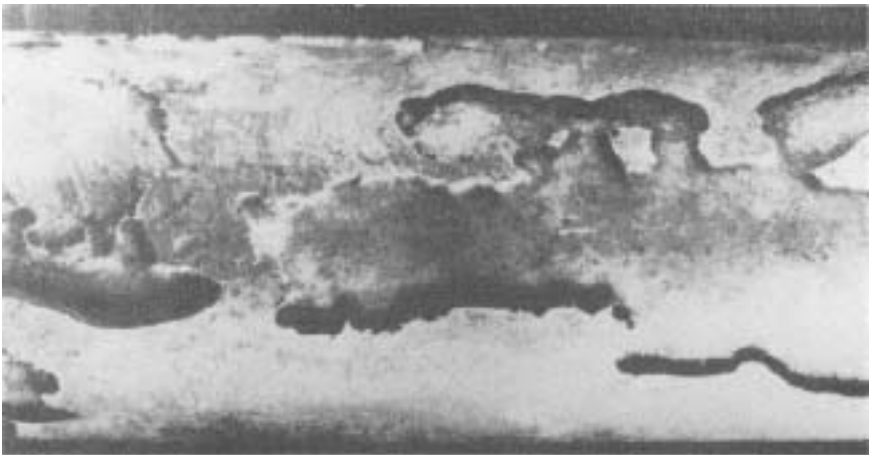
Once deposits are removed, simple visual inspection should disclose the occurrence of dew-point corrosion (Fig. 13.2). Typically, metal attack will

Figure 13.2 Severe, localized corrosion apparent after deposit removal. Areas adjacent to the deposits remain uncorroded. (Reprinted with permission from Daniel P. Hamilton, "Preventing Dew-Point Corrosion during Boiler Shutdown," *Plant Engineering*, July 22, 1982, p. 73.)

be confined to surfaces that were covered with the sulfurous ash deposits. The attack often produces well-defined regions of metal loss and leaves islands of metal relatively intact.

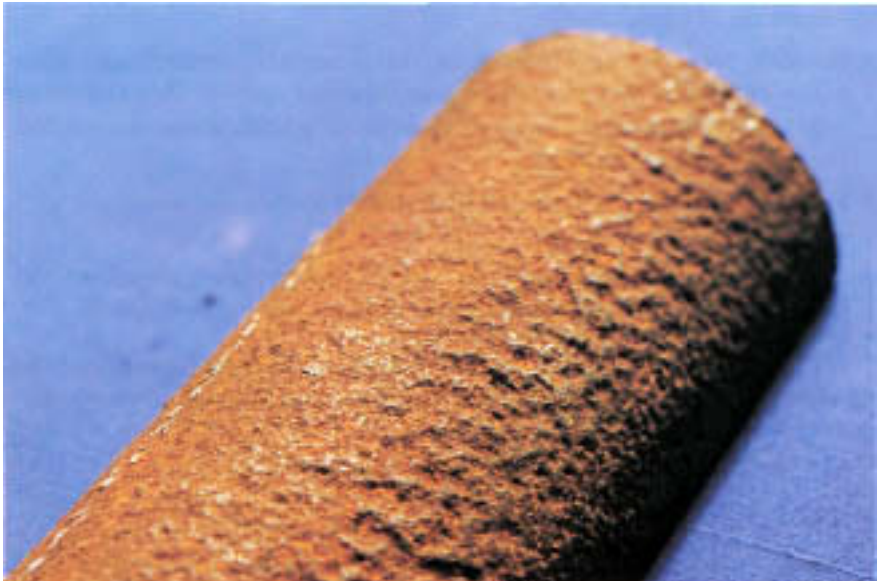
Figure 13.3 illustrates the appearance of the external surface of a screen tube. General metal loss has produced an irregular surface contour. Microstructural examinations revealed that the external surface was covered with a dense layer of iron oxide beneath a layer of iron sulfide. This corrosion occurred during idle periods when moisture, possibly from inadequate water washing, combined with external, sulfur-containing deposits, forming an acidic solution.

Figure 13.3 Appearance of the external surface of a screen tube after exposure to moisture and corrosive deposits during idle periods.

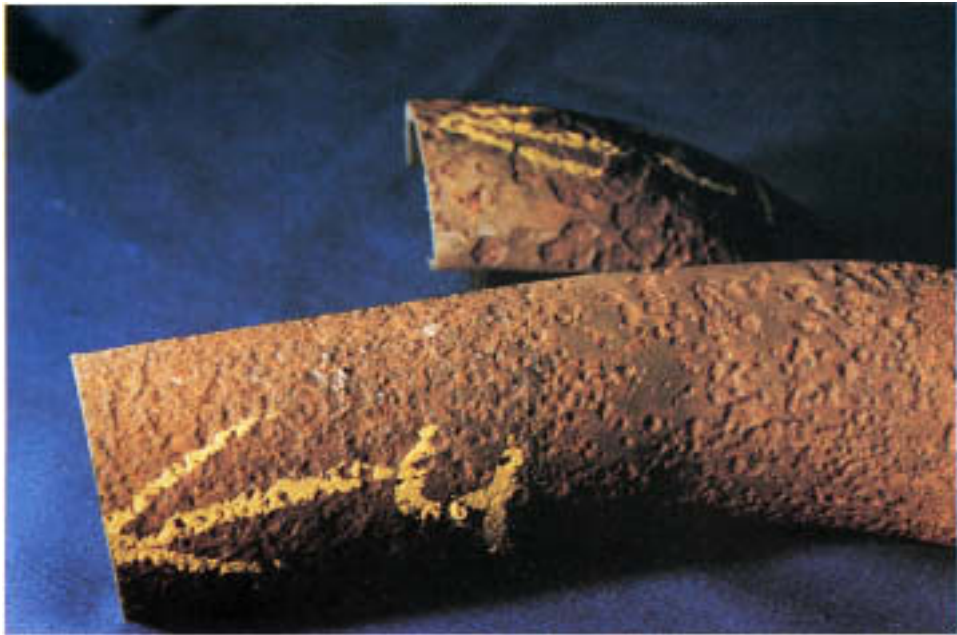
The economizer tube shown in Fig. 13.4 has an irregular, pebblelike surface contour covered with nonprotective corrosion products and deposits. The appearance of this surface is characteristic of corrosion occurring during idle periods when acid-producing salts combine with atmospheric moisture to produce a corrosive environment.

Figure 13.4 External surface of economizer tube following dew-point corrosion.

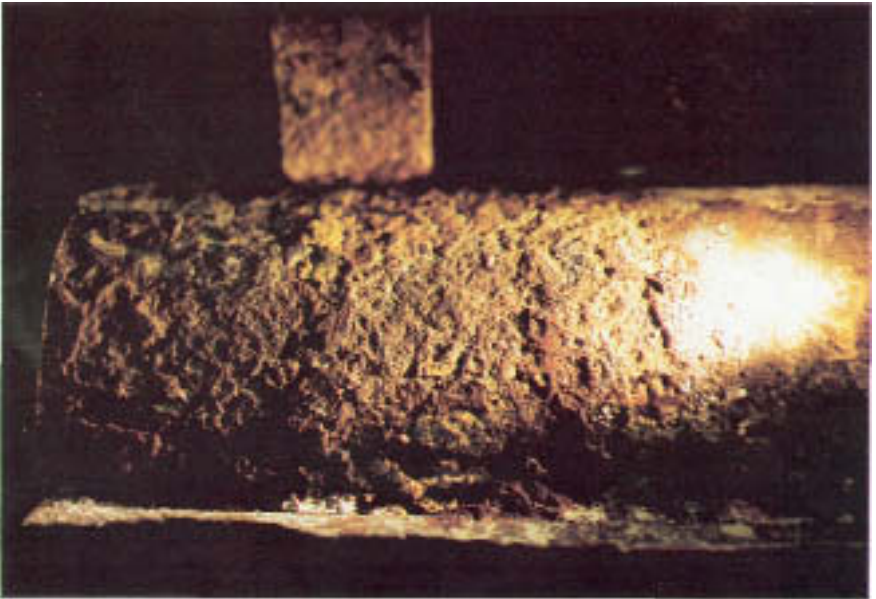
The corrosion illustrated in Fig. 13.5 was typical of that found in the boiler in the upper furnace area around openings. All corrosion had occurred under refractory. The boiler was water-washed twice annually and was not dried after washing. Measurement revealed a 16% reduction in tube-wall thickness.

The corrosion occurred as a result of the presence of sulfur-containing deposits on the metal surface that were not removed during water washes. Corrosion of this type is not uncommon in stagnant areas, such as beneath refractory. Corrosion rates of up to 50 mil/y (1.27 mm/y) have been reported in similar circumstances.

Figure 13.5 Idle-time corrosion occurring beneath refractory.

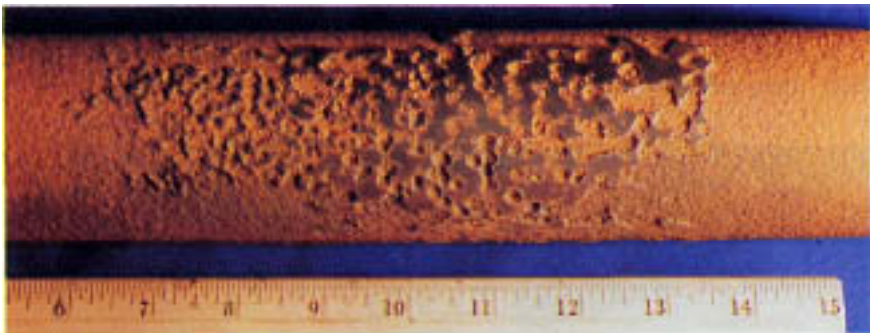
The metal loss apparent in Fig. 13.6 had affected tubes throughout the generating bank, requiring a major boiler rebuild. The problem was discovered after a major leak resulted in emergency shutdown of the boiler. The corrosion had not been observed previously. The external surfaces of the boiler were water-washed every 4 months.

Measurement revealed a reduction in tube-wall thickness of approximately 20%. The corroded surface is rough, but smooth islands of the original surface remain.

Microstructural examinations revealed no evidence of attack of the external surface by high-temperature slag. The corrosion occurred during idle periods. An inadequate water wash of the boiler can leave corrosive, sulfur-containing, acid-producing salts. The remaining salts, coupled with moisture, are capable of producing the type of corrosion apparent on this tube.

Figure 13.6 Corrosion resulting from inadequate water washing of external surfaces.

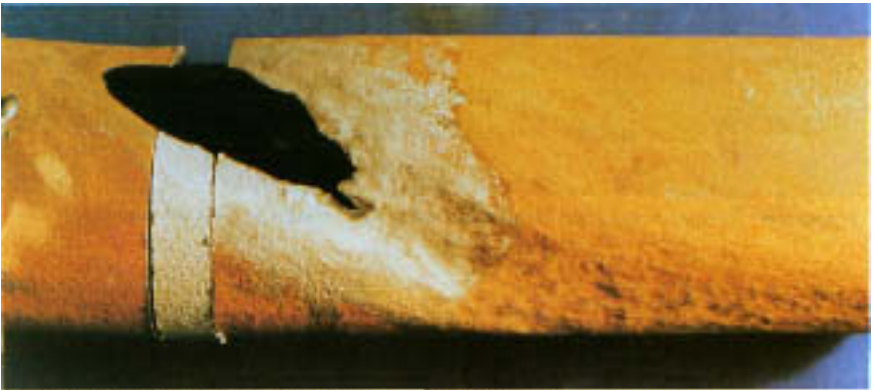
The tube illustrated in Fig. 13.7 was one of several similar tubes discovered during a fire-side inspection. The tube was positioned at a 45° angle in the boiler. The massive, perforating groove was oriented vertically. It was observed that the groove was directly aligned with water dripping from the economizer section above.

An inspection of the economizer section revealed another series of grooved tubes. The grooves in these tubes were aligned with water dripping from the air preheater section above the economizer.

An inspection of the bottom of the air preheater section, which had recently been water-washed, revealed an accumulation of wet, dripping deposits. Water dripping from these deposits had a pH of 2. Analysis of the deposits by x-ray fluorescence disclosed a high level of sulfur.

Incomplete washing of highly corrosive deposits in the air preheater furnished a source of highly corrosive water, which corroded every tube in its drip paths. Tubes in both the economizer and the boiler proper were affected.

Figure 13.7 Grooving and perforation of a slanted tube resulting from corrosive water dripping from above.
