Hydrogen Damage

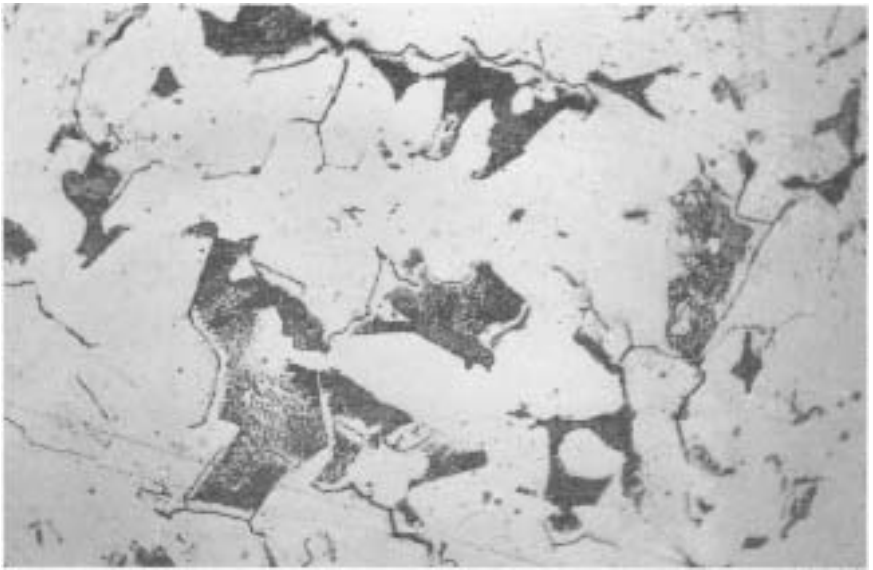
Figure 14.1 Discontinuous intergranular microcracks resulting from methane formation in the grain boundaries. Note decarburization of adjacent pearlite colonies (dark islands). (Magnification: 500X.)

Since neither molecular hydrogen nor methane is capable of diffusing through the steel, these gases accumulate, primarily at grain boundaries. Eventually, gas pressures will cause separation of the metal at its grain boundaries, producing discontinuous intergranular microcracks (Fig. 14.1). As microcracks accumulate, tube strength diminishes until stresses imposed by boiler pressure exceed the tensile strength of the remaining, intact metal. At this point a thick-walled, longitudinal burst may occur (Fig. 14.2). Depending on the extent of hydrogen damage, a large, rectangular section of the wall frequently will be blown out, producing a gaping hole (Fig. 14.3).

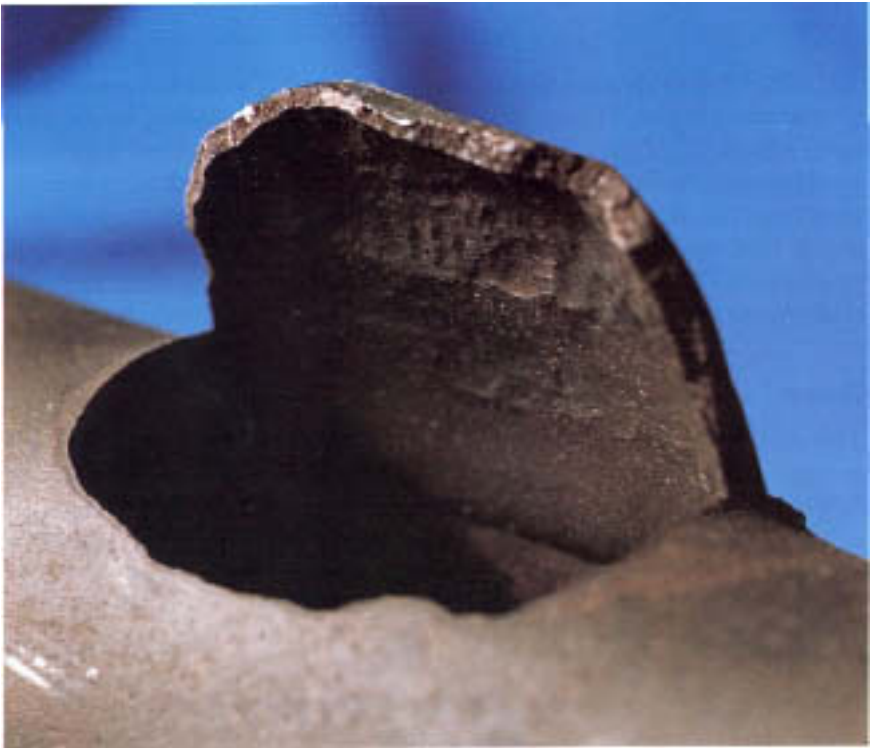
Figure 14.2 Thick-walled burst resulting from hydrogen damage. Note areas of gouging adjacent to burst on internal surface. (Courtesy of Electric Power Research Institute.)

The failure shown in Fig. 14.2 is the last in a series of four similar failures that were localized in a region above the burners. Note the thick, blunt fracture edge, as well as the shallow gouging along the internal surface. The internal surface was free of deposits.

Microstructural examinations revealed the discontinuous, randomly oriented microcracks directly beneath the corroded regions that are typical of hydrogen damage. Thermal alteration of the microstructure from overheating had not occurred. The iron oxides covering the corroded sites were highly stratified.

Records indicated that condenser in-leakage of low-level chloride salts had induced a depression of boiler-water pH. The presence of the acid-producing salts, coupled with DNB at the rupture site, caused this failure.

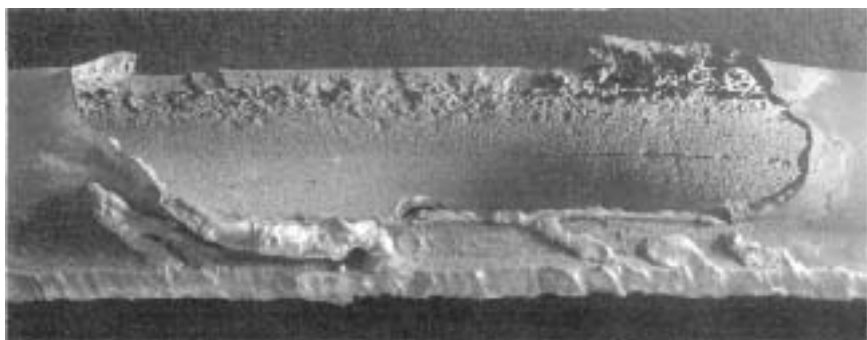
Figure 14.3 Large wall section blown out of a hydrogen-damaged tube from a 2075-psi (14.3-MPa) boiler. Note zone of gouging along fracture line. (Courtesy of National Association of Corrosion Engineers.)

The boiler from which the section illustrated in Fig. 14.3 was taken is a forced-circulation unit that produces 2½ million pounds (1,134,000 kilograms) of steam per hour. The boiler had been in peaking service for 2 years.

Failures were recurrent in the nose section and roof tubes. An acid cleaning of the boiler was conducted. The failure shown in Fig. 14.3 is one of several that occurred after the acid cleaning.

Note the large, rectangular opening remaining after a section of the tube wall was literally blown out. Fracture edges are thick, blunt, and have an irregular contour. Numerous small, secondary cracks are present along the fracture edges.

Close examination of the illustration reveals internal wall thinning along the fracture surface in the form of intersecting patches of shallow metal loss. In places, the corroded regions are covered with a thick layer of hard, black iron oxide. Where this layer is absent, deep longitudinal cracks can be observed.

Examinations of the microstructure in the fractured region reveal numerous discontinuous intergranular microcracks. Thermal alteration of the microstructure from overheating has not occurred. Iron oxides covering corroded regions of the internal surface are slightly stratified.

The severe hydrogen damage observed in this tube resulted in the blowout of a large section of tube wall. Microstructural evidence (stratification of the iron oxides) suggests that hydrogen damage resulted when the boiler water was contaminated with acid-producing salts (such as chlorides) from condenser in-leakage.

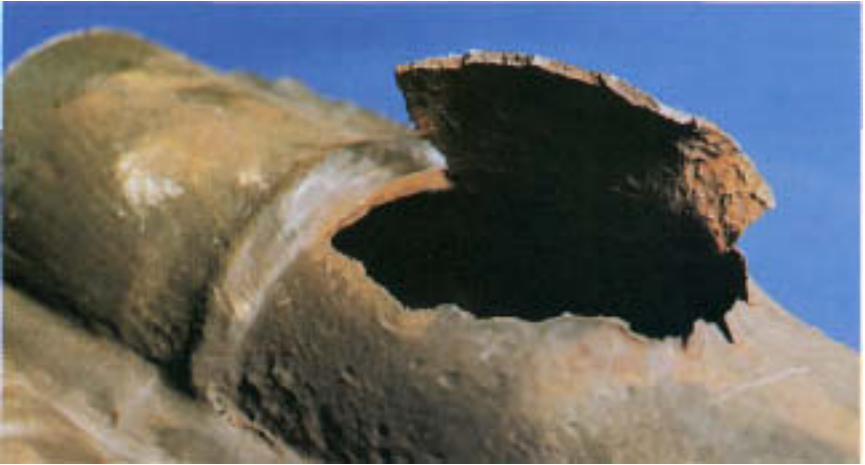
Numerous hydrogen-damage failures caused by caustic corrosion necessitated a major boiler overhaul and significant changes to the water chemistry. A coordinated phosphate program replaced a low-solids, free-alkalinity program. The failure illustrated in Fig. 14.4 occurred in a tube that had been replaced at the time this change in water chemistry occurred.

The failed tube exhibits a thick-walled rupture through a distinct area of gouging on the internal surface. The rupture is immediately downstream of a circumferential weld that protrudes on the internal surface.

Figure 14.4 Rupture resulting from hydrogen damage. Note proximity of failure to circumferential weld. (Courtesy of Electric Power Research Institute.)

structure as a consequence of overheating. However, fine discontinuous intergranular microcracks are present in the tube wall adjacent to gouged regions. Gouged regions are covered with thick, stratified layers of dense iron oxide.

Highly localized concentration of a corrosive substance on the metal surface caused gouging and hydrogen damage. Concentration of such substances occurred during DNB, which resulted from disrupted water flow past the protruding circumferential weld. The stratified character of the iron oxides that cover the gouged regions indicates that gouging and hydrogen damage were caused by a low-pH environment that resulted from the concentration of acid-producing salts.

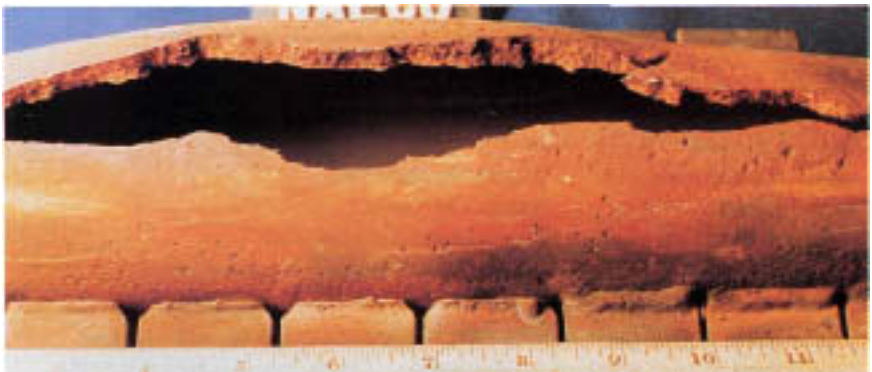
The thick-walled rupture shown in Fig. 14.5 is one of numerous similar failures recurring in both the nose-arch section and roof tubes, requiring this area of the boiler to be rebuilt. The boiler is in peaking service.

Figure 14.5 Thick-walled rupture.

Examination of the microstructure revealed no thermal alteration. Numerous randomly oriented intergranular microcracks were present in the tube wall just below the corroded region.

Localized DNB resulted in concentration of sodium hydroxide, which caused deep caustic gouging at this site. The hydrogen damage and resulting fracture were a direct consequence of the caustic gouging.

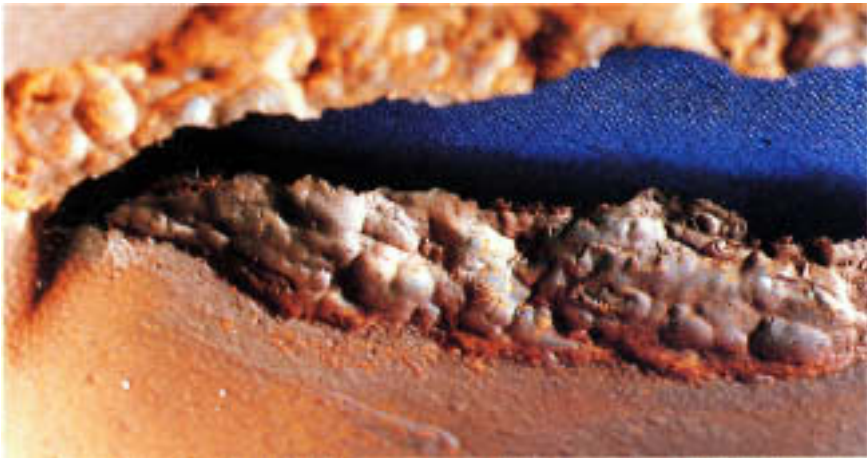
The rupture coincides with a distinct zone of deep metal loss on the internal surface (Fig. 14.6). The wavelike contour of the corroded region is covered with black iron oxide.

Figure 14.6 Smooth, wavelike contours of internal surface resulting from caustic gouging.
