Stress-Corrosion Cracking

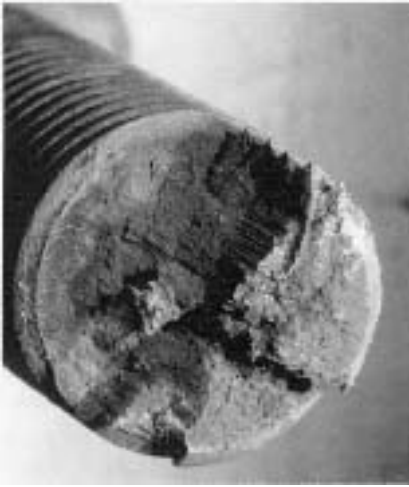
In principle, stress-corrosion cracking could occur wherever a specific corrodent and sufficient tensile stresses coexist. Because of improved water-treatment programs and improved boiler design, the occurrence of caustic stress-corrosion cracking* is much less frequent now than it was years ago. However, stress-corrosion cracking continues to appear occasionally in water tubes, superheater tubes, and reheater tubes. Stress-corrosion cracking may also occur in stressed components in the steam drum, such as bolts (Fig. 16.1).

Figure 16.1 Steam drum bolt that failed by caustic stress-corrosion cracking. Note the typical brittle character of the fracture. (*Courtesy of National Association of Corrosion Engineers.*)

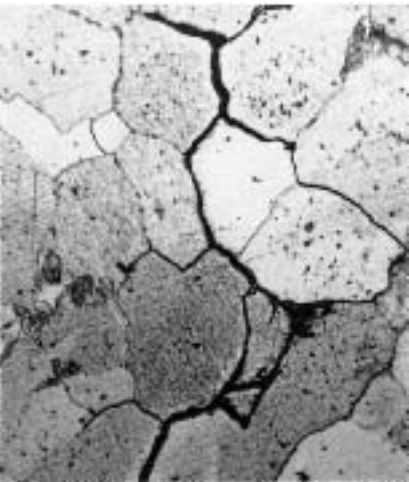
Gross attack of the metal is not necessary for this phenomenon and, in fact, does not characteristically accompany it. The combination of concentrated sodium hydroxide, some soluble silica, and tensile stresses will cause continuous intergranular cracks to form in carbon steel (Fig. 16.2). As the cracks progress, the strength of the remaining intact metal is exceeded, and a brittle, thick-walled fracture will occur.

Figure 16.2 Caustic stress-corrosion cracking: continuous intergranular cracks running through a tube wall. (Magnification: 500X.)

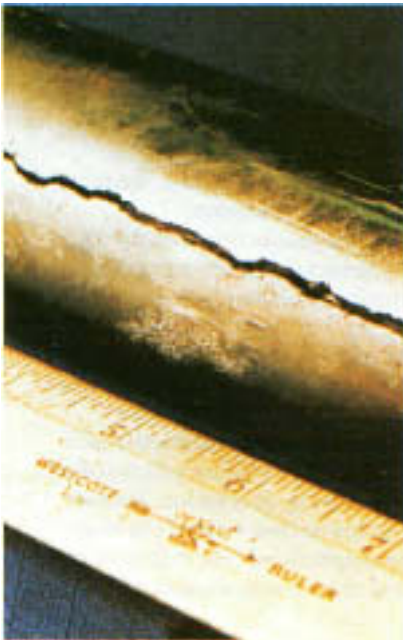
Figure 16.3 shows one of several stainless steel soot-blower lines that had cracked. Failures of this type can be quite dangerous, since steam can be released into occupied areas.

The line contained several thick-walled cracks that ran as long as 25 in. (63.5 cm) down the tube. Note that the cracks are not tight but have spread apart, an unusual feature for stress-corrosion cracking.

Close visual and microstructural examinations revealed that the cracks originated on the external surface. Microstructural examinations also revealed severe cold working of the metal.

Figure 16.3 Extensive longitudinal crack in a stainless steel soot-blower line. Note that the crack edges have spread apart.

Elemental analysis of substances covering the crack face revealed the presence of chlorine.

The line failed by stress-corrosion cracking resulting from exposure of the external surface to chlorides of unknown origin. The longitudinal direction of the cracking reveals that circumferential (hoop) stresses were responsible. It is apparent from the spreading apart of the cracks and the evidence of cold-worked metal in the microstructure that the tube contained high residual hoop stresses resulting from tube-forming processes. The level of residual stresses was calculated to be 29,000 psi (200 MPa). The residual stresses, added to service stresses generated by internal pressure, acted synergistically with the chlorides to produce the cracks illustrated.

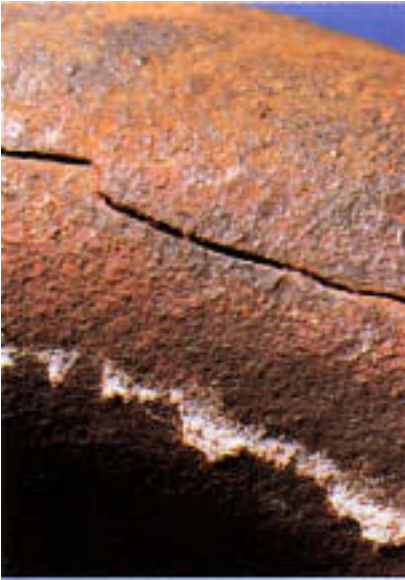
A section of an economizer tube having a 90° bend at its midpoint contains a pair of thick-walled cracks on opposite sides of the tube (Fig. 16.4). The tube had an oval rather than a circular cross section through the bend, and the cracks were located at opposite ends of the long axis of the oval.

The internal surface had sustained shallow, general metal loss. Sparkling crystals of black magnetite were associated with this corrosion.

Microstructural examinations revealed that the cracks originated at the bottom of shallow pits. The cracks exhibited branching as they propagated through the tube wall. Crack paths were principally across the metal grains (transgranular).

Stress-corrosion cracking in carbon steels requires the joint action of concentrated sodium hydroxide and tensile stresses. The sodium hydroxide apparently concentrated beneath porous iron oxide deposits that were present on the internal surface. The presence of crystalline magnetite indicates exposure to concentrated sodium hydroxide. The shallow pits acted as stress concentrators, elevating the normal stress level. In addition, stresses from internal pressure would be highest along the narrow ends of the oval cross section, where the cracks formed. The longitudinal orientation of the cracks reveals that internal pressure provided the stresses necessary for stress-corrosion cracking.

Figure 16.4 Longitudinal crack along the side of a 90° bend in an economizer tube. A similar crack is located along the opposite side.

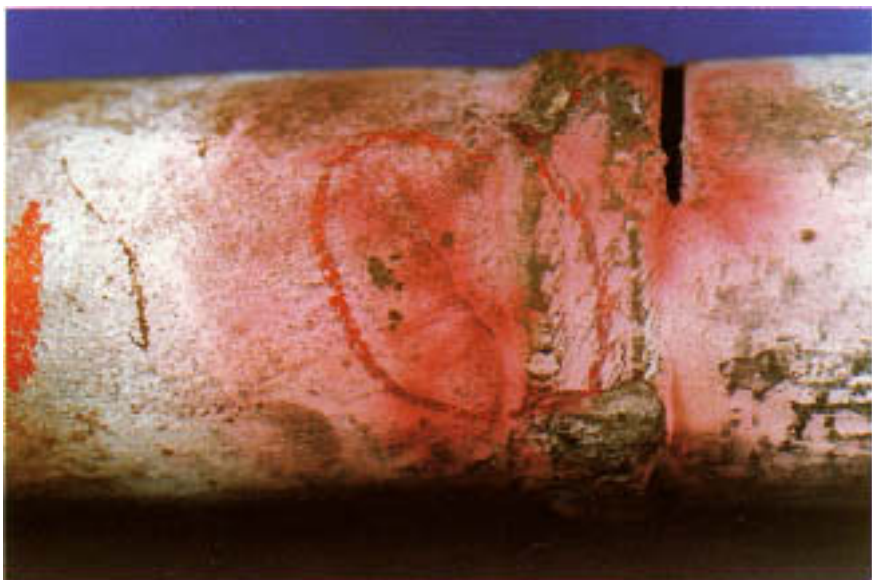
Recurrent failures of the type illustrated in Figs. 16.5 and 16.6 plagued the superheater section of this boiler. Note the fine cracks adjacent and parallel to the weld. Surface branching of the crack is apparent in Fig. 16.6.

Microstructural examinations revealed branched cracks running across the grains (transgranular) and originating on the internal surface. The cracks are located in the heat-affected zone immediately adjacent to the weld.

This failure is caustic stress-corrosion cracking. The source of sodium hydroxide is probably carryover from the steam drum. Stresses are residual welding stresses, as indicated by the circumferential crack propagation and the proximity of the cracks to the weld. Cracks resulting simply from stresses imposed by internal pressure would be longitudinally oriented.

Figure 16.5 Appearance of stress-corrosion crack on the external surface. Crack is located within the red circle.

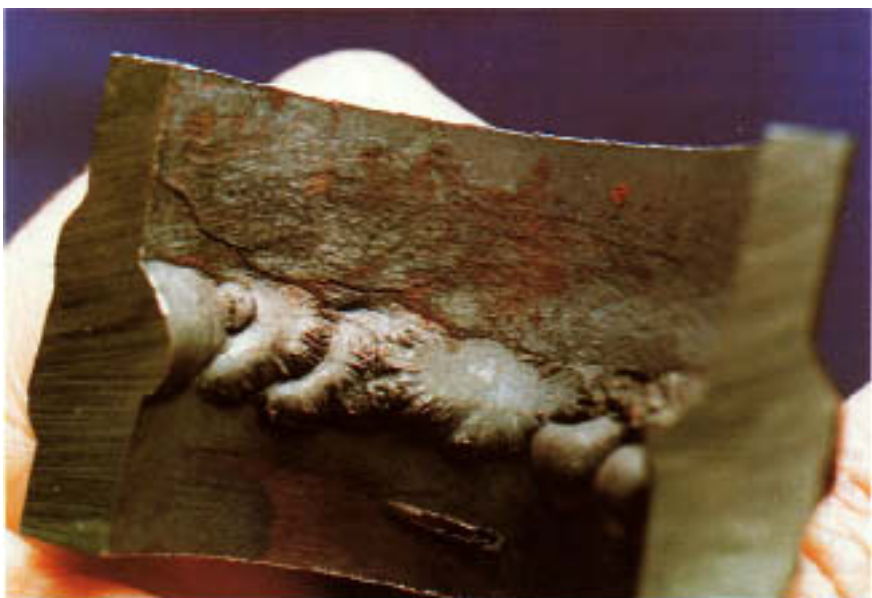
Figure 16.6 Appearance of crack on the internal surface. Note the branching and proximity to the weld bead.

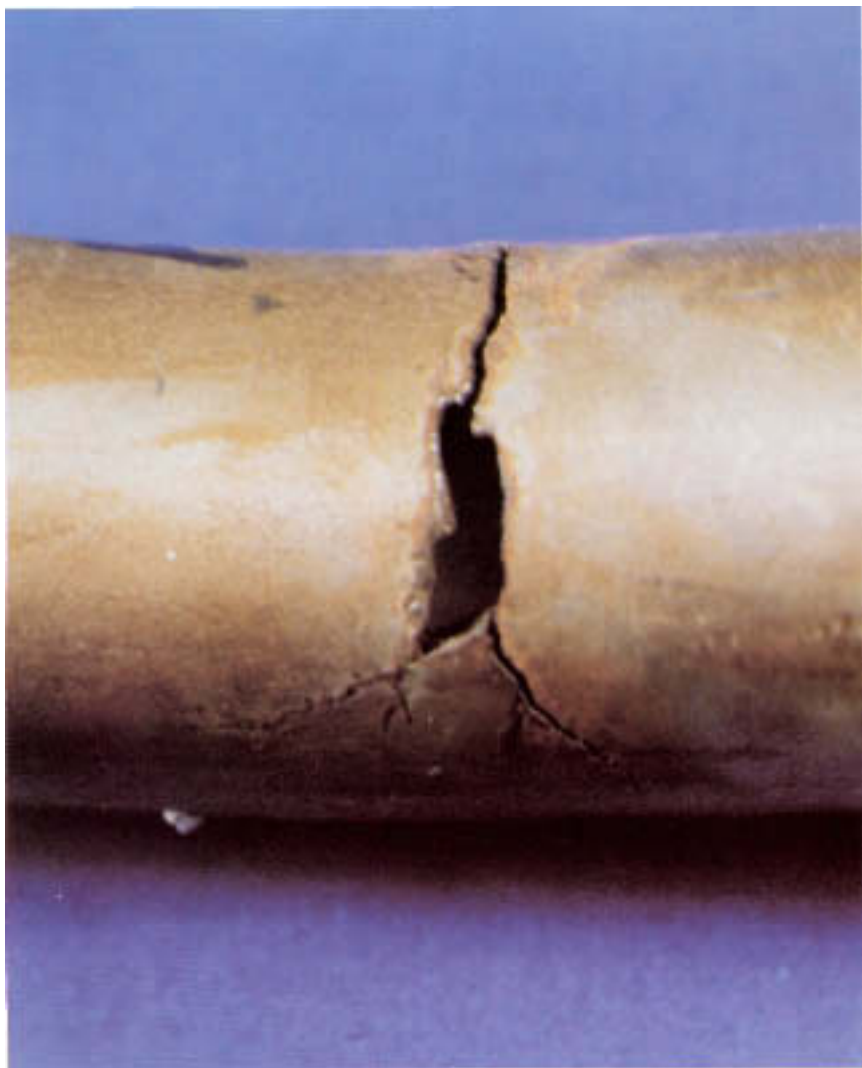
The tube illustrated in Fig. 16.7 is one of numerous tubes that failed in this boiler. The tubes had been moderately cold-bent during installation, and were not stress-relief-annealed. The steam drum lacked adequate devices for separation of steam and water, and load swings were frequent, possibly causing carryover of boiler water.

Microstructural analysis revealed plastically deformed grains from the cold bending. The cracks were highly branched and ran between the grains (intergranular) as they passed through the tube wall. They originated on the internal surface.

The source of stress in this case was residual stresses from the bending operation. This is apparent from the circumferential orientation of the cracks, the fact that the cracks have spread apart, and the proximity of the cracks to the bent zones of the tubes. The corrodent was sodium hydroxide from boiler-water carryover.

This case is an excellent example of the value of understanding failure mechanisms and performance of materials. Stainless steel superheater tubes in a boiler of this pressure are unusual. The original tubes were carbon steel that cracked after 9 months of service. Two steps were taken to improve service life. First, stainless steel tubes were specified to replace the carbon steel. Second, moderate bends were put in the tubes, apparently to relieve the thermal expansion and contraction stresses that had caused cracking in the carbon steel tubes. Unfortunately, despite the greater general corrosion resistance of stainless steels, they are also susceptible to caustic stress-corrosion cracking. In addition, the bends placed in the tubes to relieve thermal stresses provided high residual stresses instead. The stainless steel tubes failed after 3 weeks.

Figure 16.7 Transverse crack resulting from caustic stress corrosion in a bent stainless steel superheater tube. Note small “window” that has been blown out of the wall.
