Cavitation

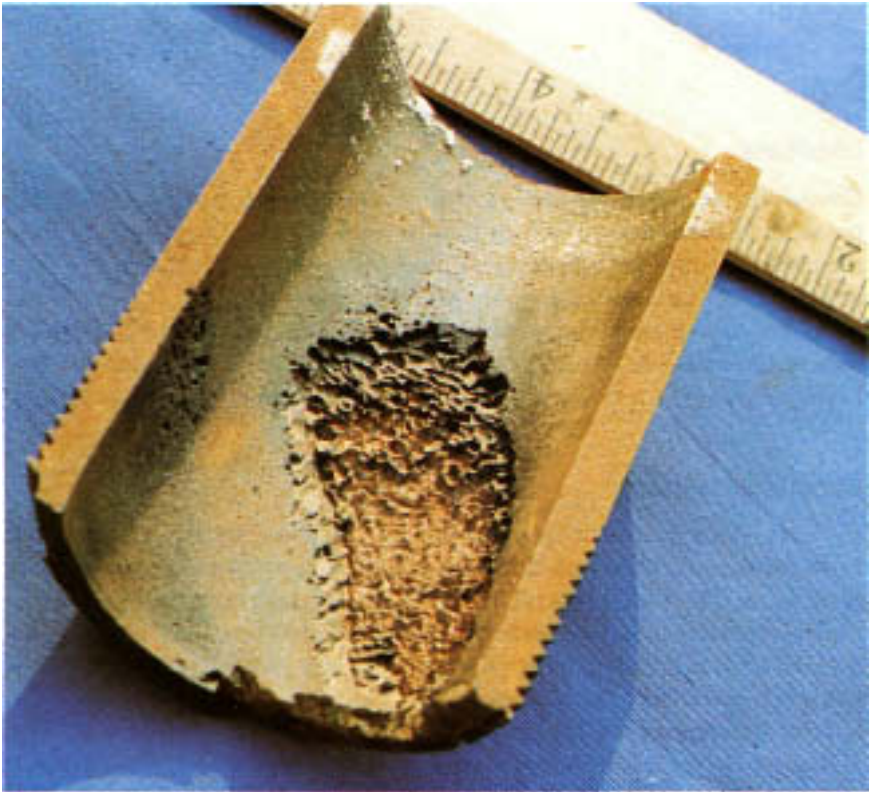
Figure 18.1 Longitudinally split blowdown line with severe localized metal loss caused by cavitation.

Blowdown lines are especially susceptible to damage if flow is excessive and the discharge direction abruptly changes. Attack usually occurs during intermittent manual blowdown when flow direction is severely changed in pipe tees and elbows. Attack can be intense if blowdown rate is high and lines are undersized (Fig. 18.1).

Severe, localized wastage on internal surfaces caused a blowdown line to fail. A perforation occurred near the attachment of the pipe to a tee (Fig. 18.1). Attack was confined to spongy, jagged patches of loss; surrounding surfaces were free of significant deterioration.

Failure occurred during manual blowdown. Blowdown had been increased due to feedwater contamination from the preboiler system.

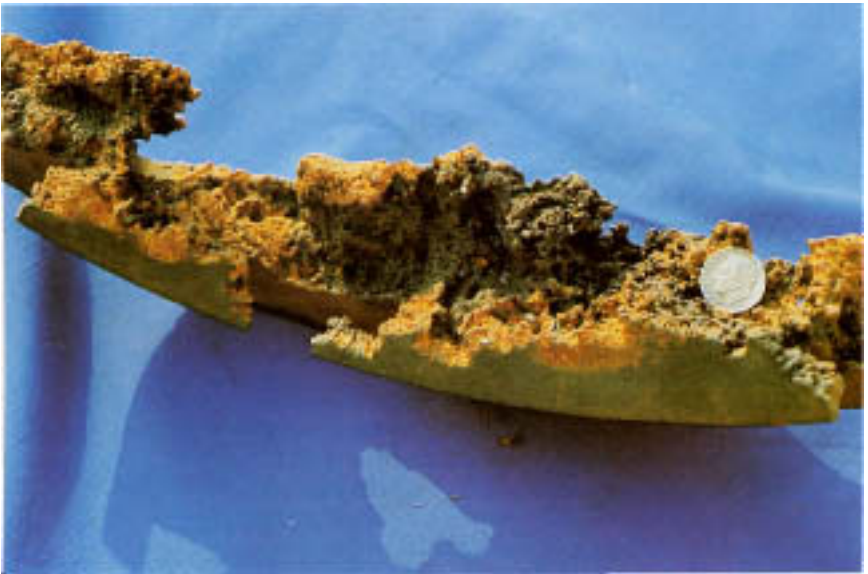
Alloy composition also influences attack. Soft, ductile metals and brittle, low-strength alloys such as gray cast iron are easily attacked (Fig. 18.2). Alloys such as chromium stainless steels are resistant to attack in many environments.

Figure 18.2 Pump-housing section severely attacked by cavitation. Material of the pump-housing section is gray cast iron.

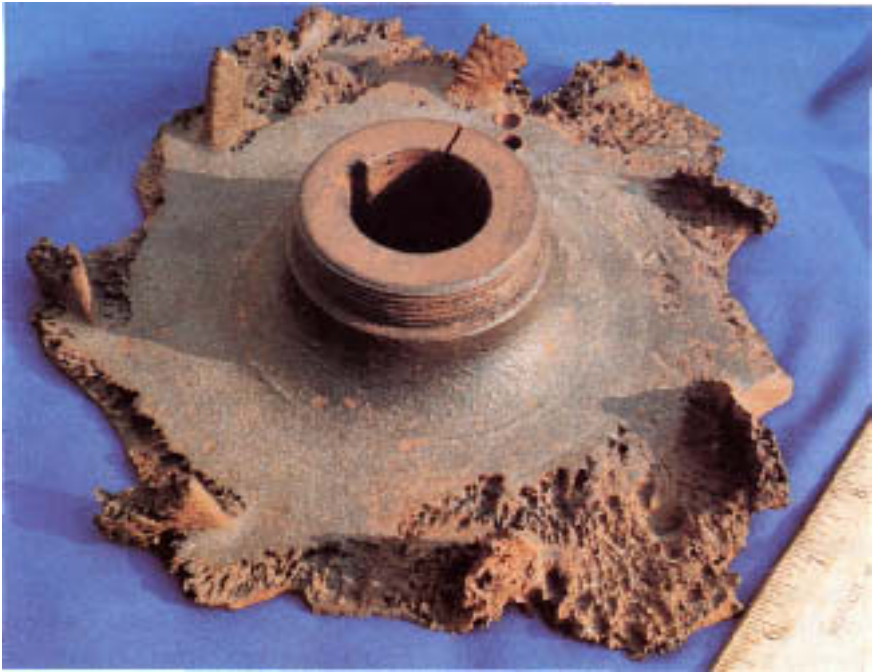
Figure 18.3 A cast steel feedwater-pump impeller severely damaged by cavitation. Note how damage is confined to the outer edges of the impeller where vane speed was maximum.

A striking feature of cavitation damage is the localized nature of attack. Wastage is most severe on pump impeller vanes near the outer periphery where impeller speed, and presumably turbulence, is highest (Fig. 18.3). Attack is most severe on trailing vane edges, where low-pressure areas are formed (Fig. 18.4). Pump shafts, for example, can be attacked locally where surfaces are exposed to turbulent conditions (Fig. 18.5). Adjacent surfaces are usually only lightly polished or apparently totally free of damage. Edges, corners, and projections all intensify turbulence, provide bubble-nucleation sites, and become preferred damage regions.

Feedwater supply could not meet boiler demand. The feedwater impeller was severely wasted, and the vanes were almost gone. Attack was confined to the periphery of the impeller (Fig. 18.3).

Wastage was apparently caused by cavitation induced by insufficient head pressure.

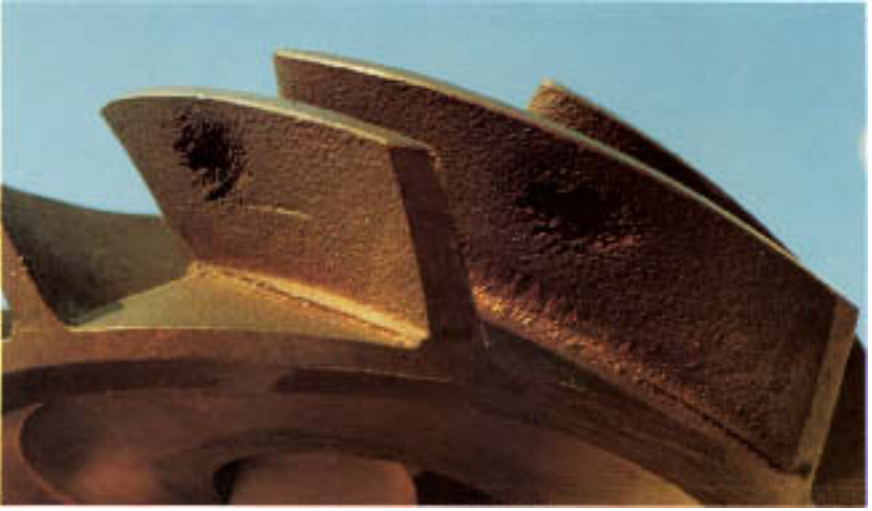
Figure 18.4 Vane damage on low-pressure sides of small, special-purpose, bronze feedwater-pump impeller. Some vanes have been penetrated.

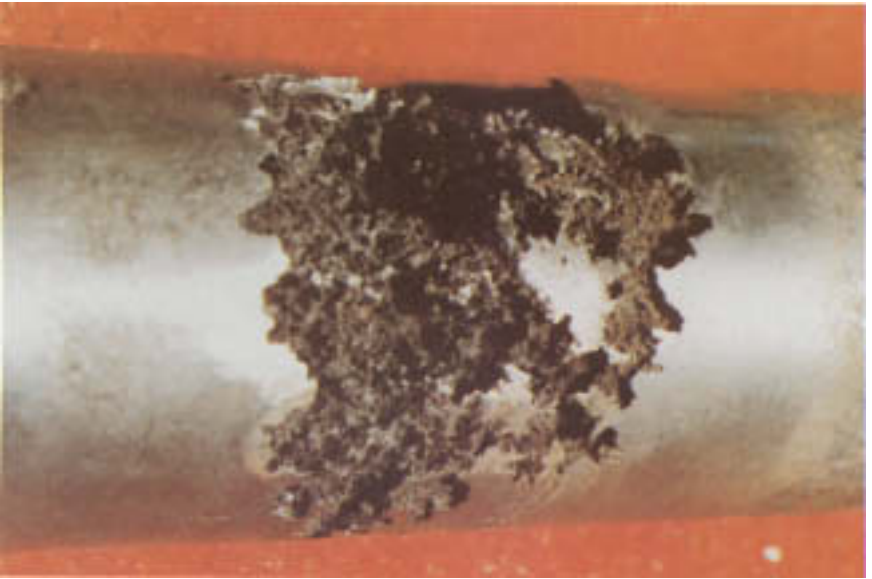
Figure 18.5 Highly localized cavitation damage on steel feedwater-pump shaft. Adjacent regions are free of metal loss.

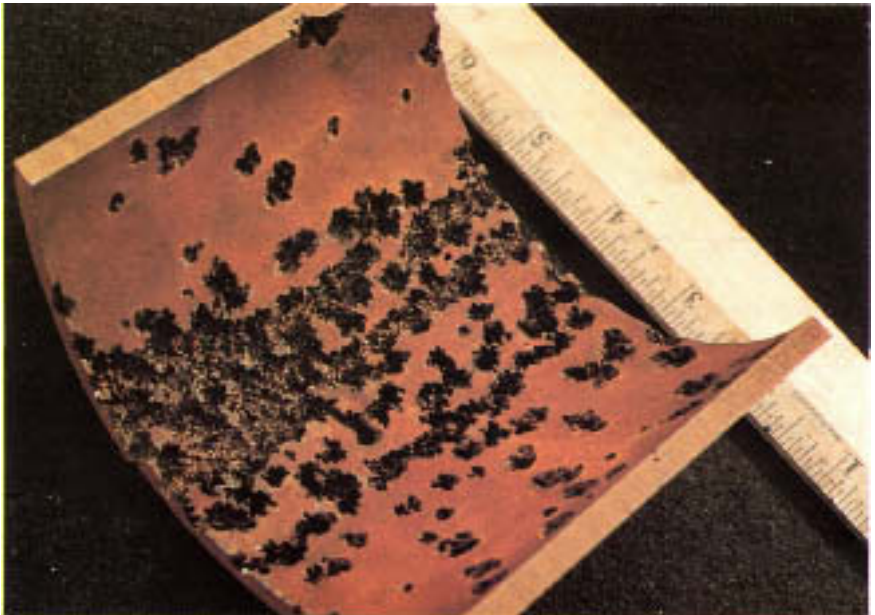
A condensate line developed several small perforations. When opened, the line was riddled with many irregular pits (Fig. 18.6). Some pits mutually intersected, forming more general areas of metal loss. Close visual inspection of pits revealed jagged, irregular internal-surface contours.

Pits strongly resembled oxygen corrosion (See Chap. 8, "Oxygen Corrosion"). However, microscopic examination showed evidence of severe plastic deformation and mechanical shock within, and only within, pits. Further investigation revealed a history of steam hammer and other mechanical vibration of this line.

It is possible that oxygen pits were present before cavitation became severe. However, it is clear that cavitation played a role in deepening these pits and causing final perforation.

Figure 18.6 Heavily pitted condensate line. Attack resembles oxygen pitting, but was caused (at least in part) by cavitation.
