## Forming Defects

**CASE HISTORY 19.1**

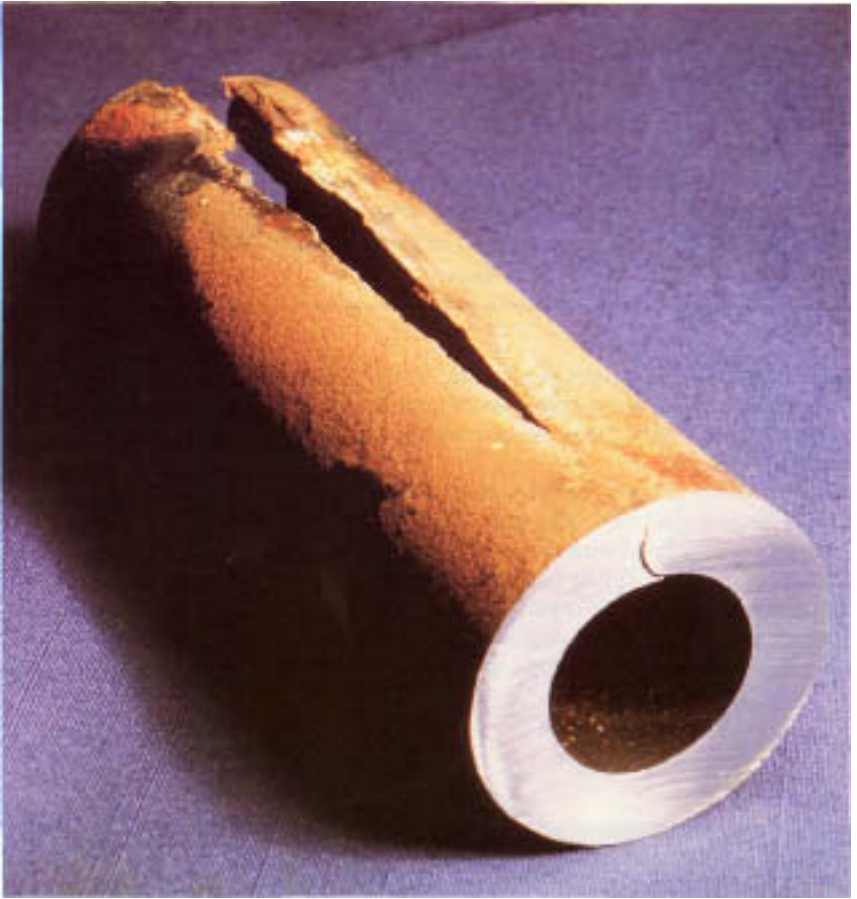
Seam or lap defects appear in a transverse cross section as straight or gently curving cracks, which may run longitudinally for some distance along the tube wall (Fig. 19.1). Although the defect commonly originates at a surface, it may be difficult to see since the surfaces of the defect are commonly covered with a layer of iron oxide or nonmetallic inclusions.

**Figure 19.1** Curved defect originating on the internal surface of a seamless tube. This defect ran for 18 in. (45.7 cm) along the length of the tube. (Courtesy of National Association of Corrosion Engineers.)

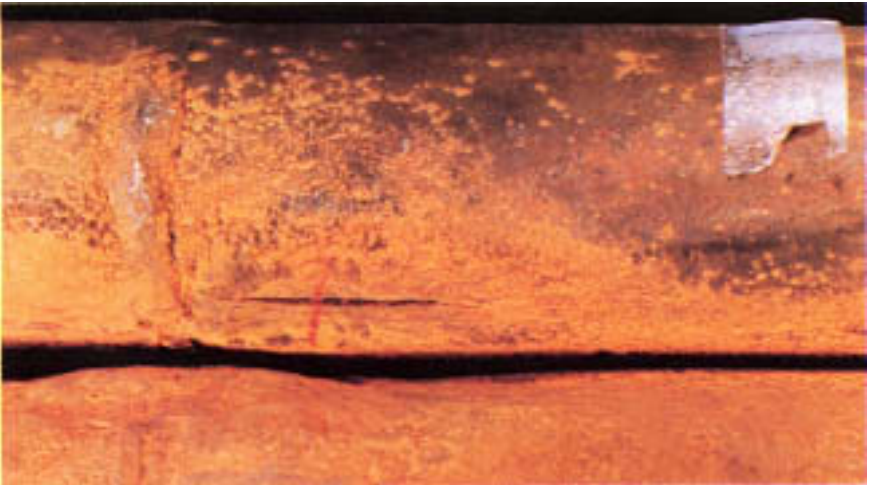
The longitudinal tube rupture apparent in Fig. 19.2 is 1½ in. (3.8 cm) long. Both visual and microstructural examinations reveal that the rupture occurred along a weld seam. Seam contours were clearly visible along the length of the tube.

**Figure 19.2** Seam defect (top tube). External metal loss on the bottom tube is the result of erosion from mixed steam and water escaping through the rupture.

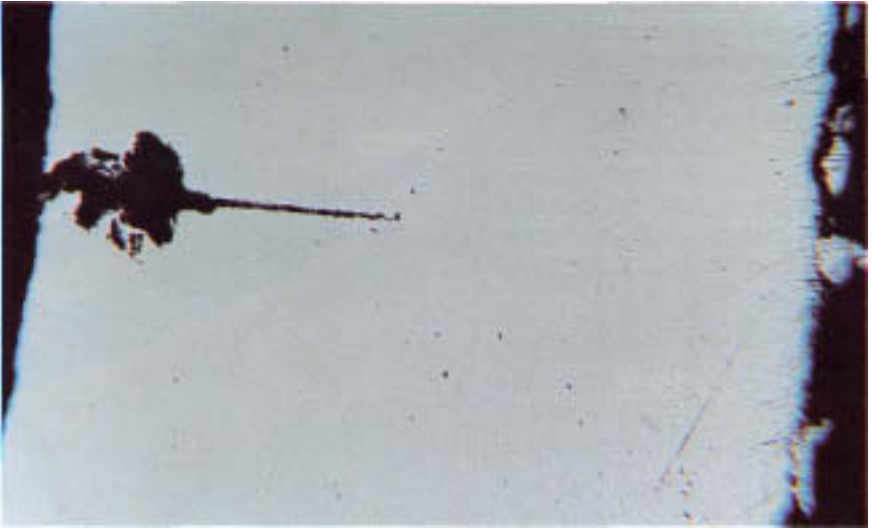
Examination of cross sections taken at a distance from the through-wall rupture reveals that the unfused weld seam penetrates 40% of the tube-wall thickness, and is lined with dense iron oxide (Fig. 19.3). This is a weld-seam defect that occurred during tube manufacturing. An acid cleaning of the boiler caused the cavernous metal loss apparent near the surface in Fig. 19.3. External metal loss on the adjacent tube due to erosion from steam and water escaping from the through-wall rupture is apparent in Fig. 19.2.

**Figure 19.3** Cross-sectional view of weld-seam defect originating on the internal surface. Note enlargement of opening due to past acid cleaning of the boiler. (Magnification: 20 $\times$ .)

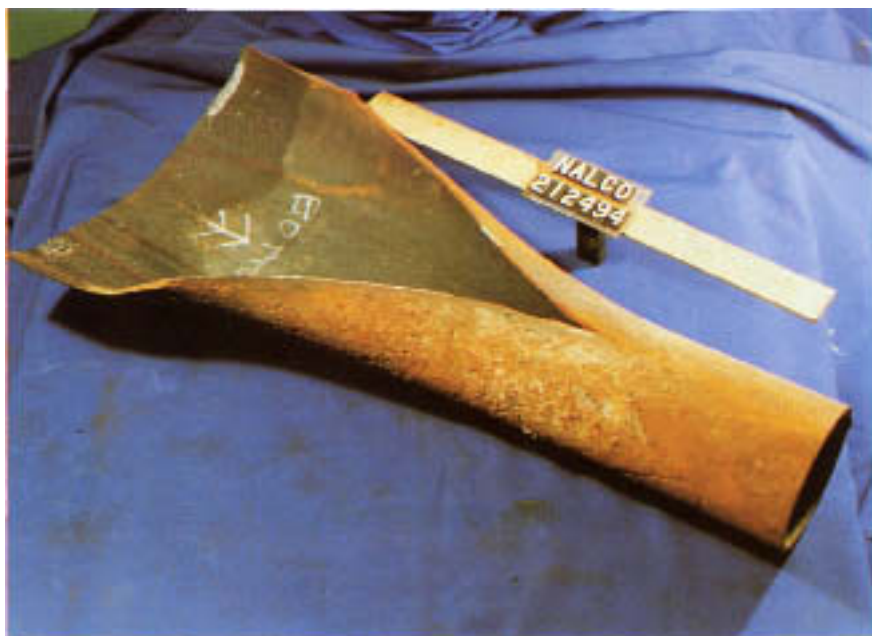
The massive failure illustrated in Fig. 19.4 occurred as the boiler was being brought on line. Drum pressure at the time of failure was 800 psi (5.5 MPa). An identical failure occurred a year earlier under the same conditions. The boiler is used intermittently and had been out of service for 5 months previous to this failure. The tube supplies a lower header in a waterwall.

**Figure 19.4** Massive rupture of tube along a weld-seam defect.

Apparently, the weld seam had not completely fused during tube fabrication. Acid collecting in the narrow crevice escaped neutralization. Consequently, when the boiler was restored to service following the acid cleaning, severe corrosion occurred along the seam, causing it to deepen. Eventually, stresses imposed by the cyclic operation of the boiler caused the crevice to grow by a corrosion-fatigue mechanism. When the crevice achieved a critical depth, fracture occurred through the remaining intact tube wall, which was incapable of supporting stresses imposed by internal pressure. Overheating had not occurred.

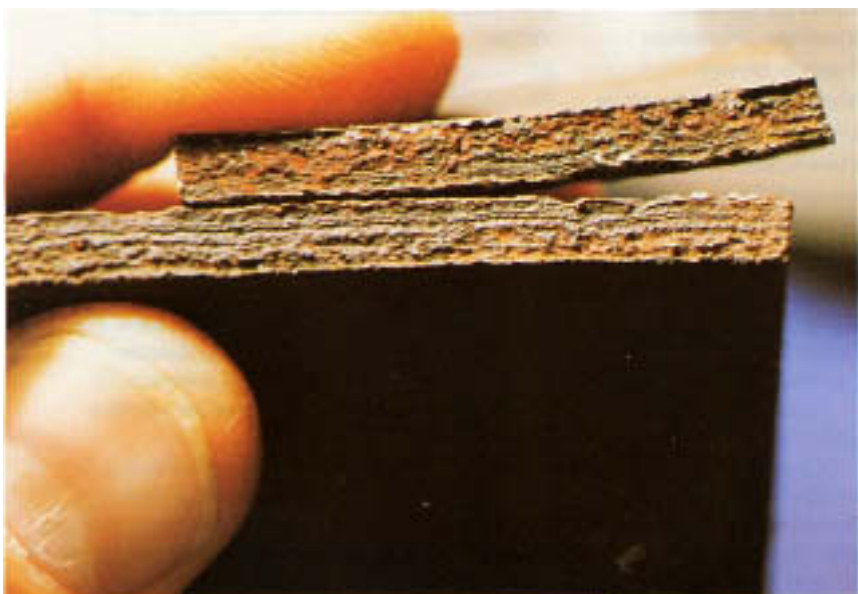
Figure 19.5 illustrates the brittle rupture. Note the numerous parallel striations running along the fracture face.

Visual examinations of the internal surface revealed fissures along a welded seam aligned with the rupture. Microstructural examinations revealed that the rupture occurred along the weld seam. These examinations also disclosed deep fissures and pits along the seam resulting from exposure to acid during acid cleanings of the boiler.

**Figure 19.5** Edges of brittle rupture.

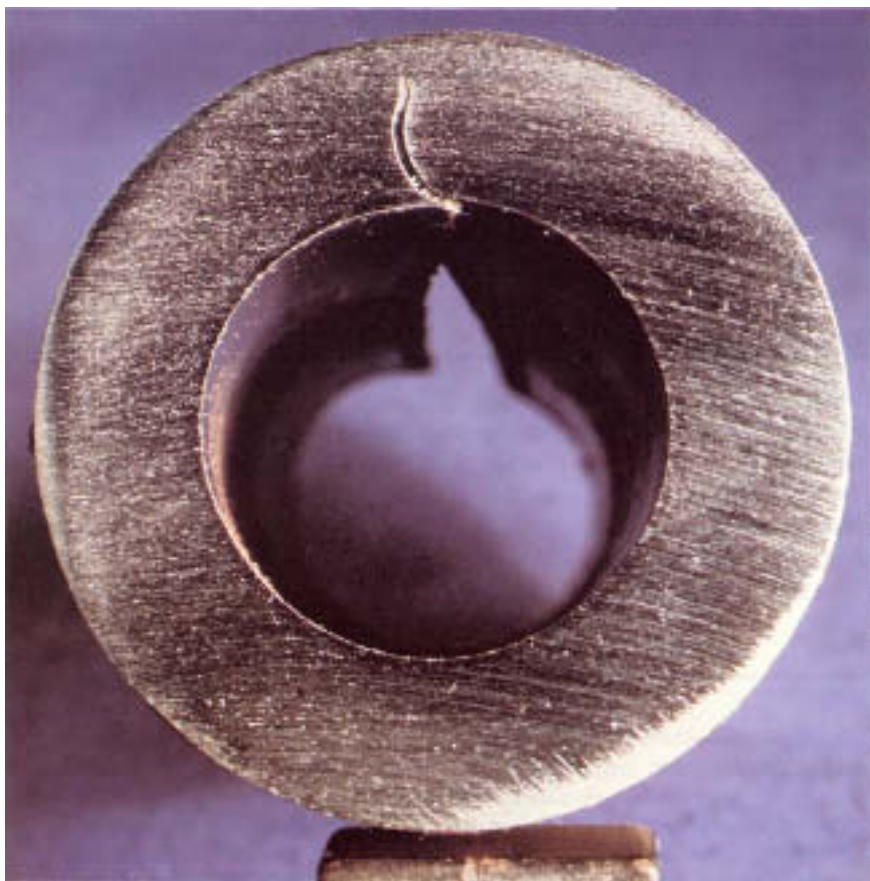
The failure illustrated in Fig. 19.6 is an 8-in.-long (20.3-cm-long), thick-walled fracture that originated on the internal surface (Fig. 19.1). Examination of the fracture face reveals a very smooth contour curving toward the external surface (Fig. 19.7). The extent of this smooth area is approximately 60 to 80% of the tube-wall thickness and runs 18 in. (45.7 cm) of the tube length. The fracture is covered with a very uniform layer of black iron oxide. The remaining 20 to 40% of the fracture surface adjacent to the external surface is irregular and lacks a distinct iron oxide covering.

This failure is a direct result of a manufacturing defect that extended for 60 to 80% of the original tube-wall thickness. Elevated stresses through the reduced tube-wall cross section, coupled with moderate overheating, caused final failure by stress rupture through the remaining intact tube wall. The defect appears to be an internal lap or seam, possibly associated with remnants of pipe (internal voids) in the steel ingot from which the tube was formed.

**Figure 19.6** Failure along a massive manufacturing defect in the tube wall. (Courtesy of National Association of Corrosion Engineers.)

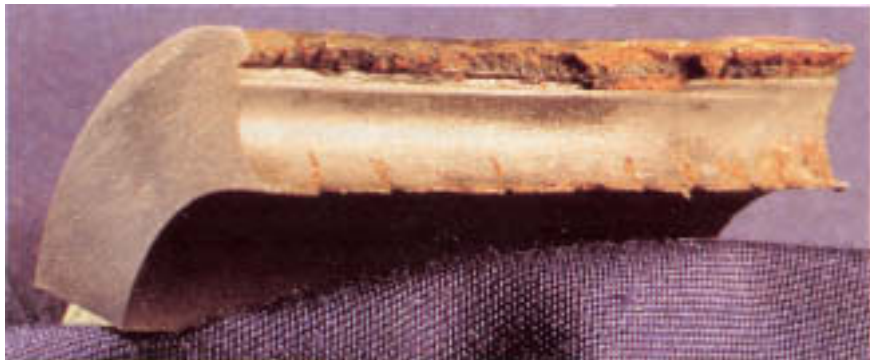
**Figure 19.7** Smooth curved contour of defect. (Courtesy of National Association of Corrosion Engineers.)

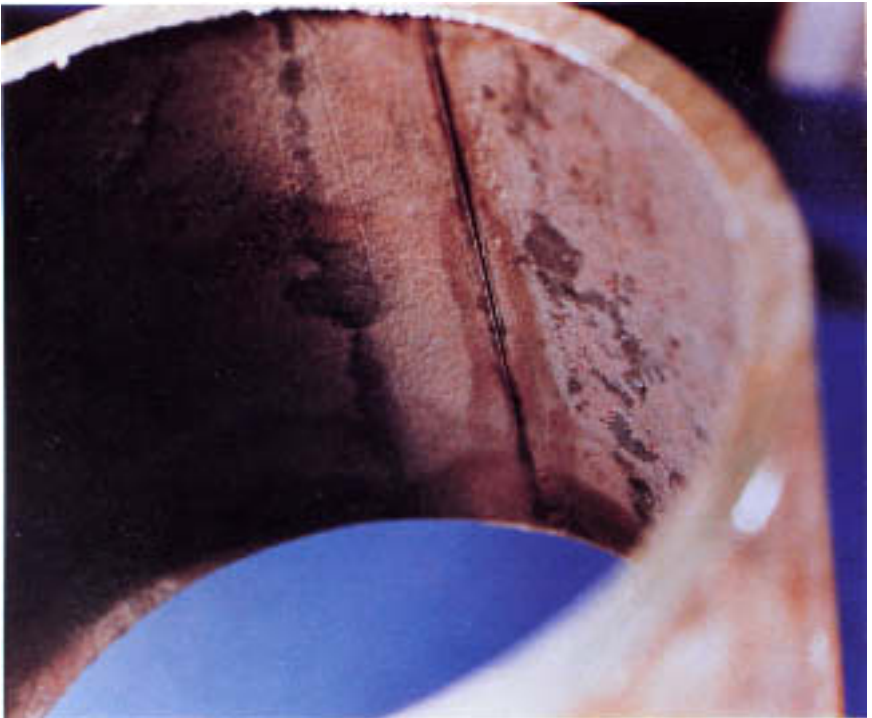
The seam defect apparent in Fig. 19.8 required the replacement of a 25-ft (7.6-m) section of steam line. Ruptures in a similarly defective line had occurred a year earlier. A crack, which originated at the seam, penetrates the external surface for most of this 4-in. (10.2-cm) section.

Microstructural evaluations revealed decarburization of the metal, as well as the presence of iron nitride needles and nonmetallic inclusions in the weld-seam area. The through-wall crack followed the pathways of the nitride needles.

**Figure 19.8** Seam defect in steam line.

The incompletely fused seam formed a narrow crevice that served as a stress-concentrating notch. Under the influence of cyclic pressure variations, corrosion-fatigue cracks propagated from the tip of the notch. The progress of these cracks was accelerated by the embrittling effect of the nitride needles present along the weld-seam zone. The combination of the diminished wall cross section resulting from an incompletely fused seam, the propagation of corrosion-fatigue cracks originating at the root of the open seam, and the presence of iron nitride needles resulted in a through-wall longitudinal failure of the line.
