Welding Defects

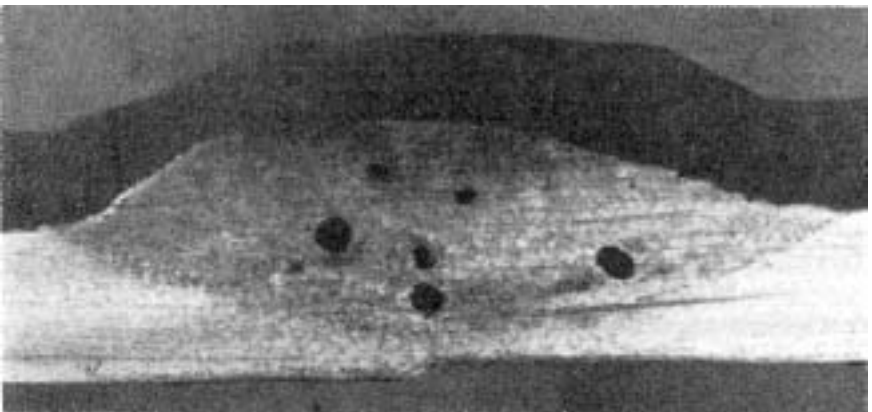
Identification. Porosity refers to the entrapment of gas bubbles in the weld metal resulting either from decreased solubility of a gas as the molten weld metal cools, or from chemical reactions that occur within the weld metal (Fig. 20.1). Generally, porosity is not apparent from the surfaces of the weldment. The distribution of pores within the weldment can be classified as *uniformly scattered porosity*, *cluster porosity*, or *linear porosity*. Porosity near surfaces seems to have a significant effect on mechanical properties of the weld.

Figure 20.1 Cross section through weld showing severe porosity. This weld had been in low-pressure service for 40 years without failure. (Magnification: 2X.) (Reprinted with permission from Helmut Thielsch, *Defects and Failures in Pressure Vessels and Piping*, New York, Van Nostrand Reinhold, 1965.)

Elimination. Porosity can be limited by using clean, dry materials, and by maintaining proper weld current and arc length.

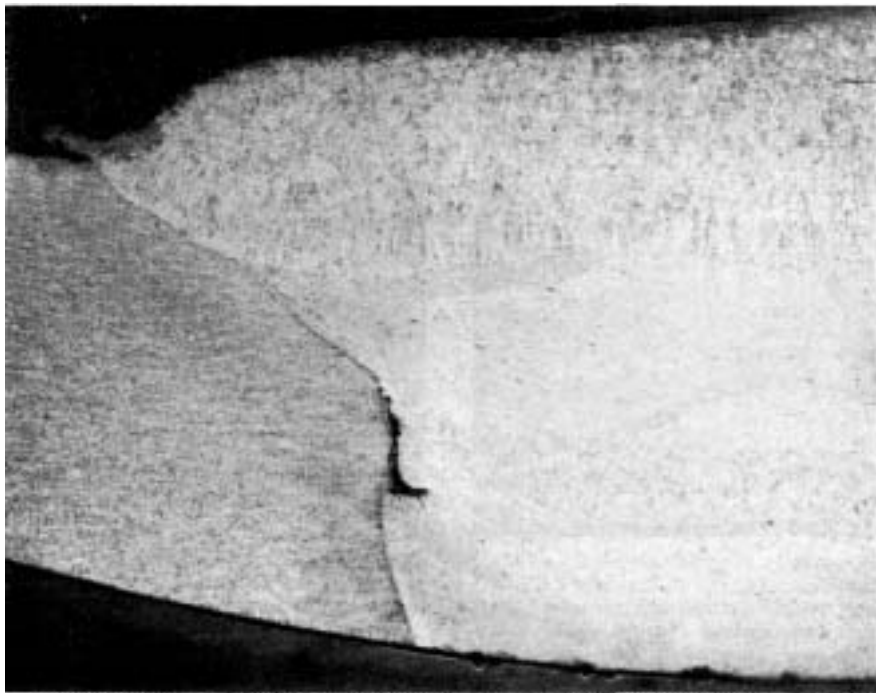
Identification. The term *slag inclusions* refers to nonmetallic solids trapped in the weld deposit, or between the weld metal and base metal. Slag forms by a high-temperature chemical reaction, which may occur during the welding process. These inclusions may be present as isolated particles, or as continuous or interrupted bands. Figure 20.2 illustrates a linear slag

Figure 20.2 Cross section through a linear slag inclusion. This weld had been in 650-psi (4.5-MPa) service for 25 years. (Magnification: 5X.) (Reprinted with permission from Helmut Thielsch, *Defects and Failures in Pressure Vessels and Piping*, New York, Van Nostrand Reinhold, 1965.)

inclusion located at the weld-metal/base-metal interface. Slag inclusions are not visible unless they emerge at a surface.

Service failures are generally associated with surface-lying slag inclusions, or inclusions that are of such size that they significantly reduce cross-sectional area of the wall.

Elimination. The number and size of slag inclusions can be minimized by maintaining weld metal at low viscosity, preventing rapid solidification, and maintaining sufficiently high weld-metal temperatures.

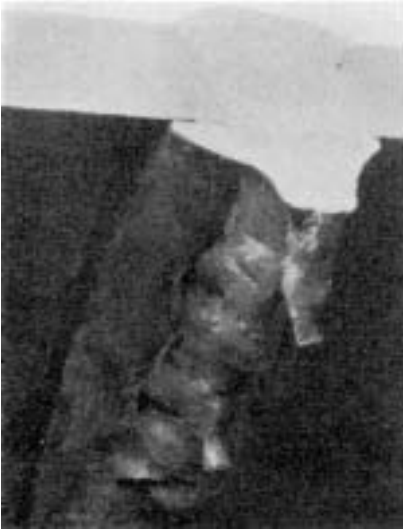
Identification. The term *excess penetration* refers to disruption of the weld bead beyond the root of the weld. This disruption can exist as either excess metal on the back side of the weld, which may appear as “icicles” (Fig. 20.3), or concavity of the weld metal on the back side of the weld, sometimes referred to as “sink” (Fig. 20.4).

Figure 20.3 Burnthrough resulting in icicles on the underside of a butt weld. (Reprinted with permission from Helmut Thielsch, *Defects and Failures in Pressure Vessels and Piping*, New York, Van Nostrand Reinhold, 1965.)

The first of these is undesirable because the excess material can disrupt coolant flow, possibly causing localized corrosion downstream of the defect (water tube), or localized overheating downstream of the defect (steam tube).

Elimination. Since disruptions of this type are frequently inaccessible for repair, elimination consists largely in preventing them from occurring in the first place. Excess penetration is frequently caused by improper welding techniques, poor joint preparation, and poor joint alignment.

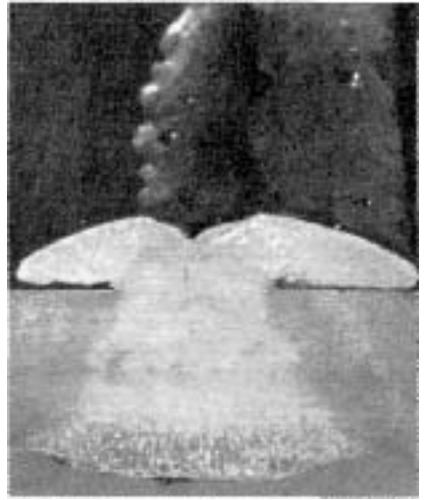
Figure 20.4 A burnthrough cavity formed on the backing ring of a tube weld. (Reprinted with permission from Helmut Thielsch, *Defects and Failures in Pressure Vessels and Piping*, New York, Van Nostrand Reinhold, 1965.)

The second of these, if severe, can cause root-pass cracking. Such cracks may not be revealed by radiographic examination. Concavity can also substantially reduce fatigue life, and excess concavity has been involved in thermal-fatigue failures.

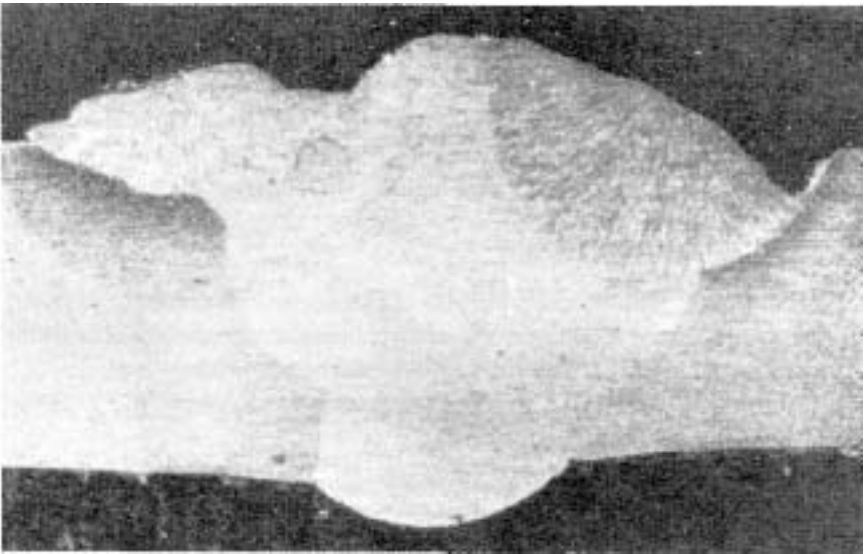
Figure 20.5 Cross section of welds containing severe undercut. (Magnification: 1.5 \times .) (Reprinted with permission from Helmut Thielsch, *Defects and Failures in Pressure Vessels and Piping*, New York, Van Nostrand Reinhold, 1965.)

Identification. The term *undercut* refers to the creation of a continuous or intermittent groove melted into the base metal at either the surface (toe of the weld) (Fig. 20.5) or the root of the weld. Depending upon depth and sharpness, undercutting may cause failure by either mechanical or thermal fatigue.

Elimination. Serious undercutting may be repaired either by grinding or by depositing additional weld metal. Undercutting is generally caused by using excessive welding currents for a particular electrode or maintaining too long an arc.

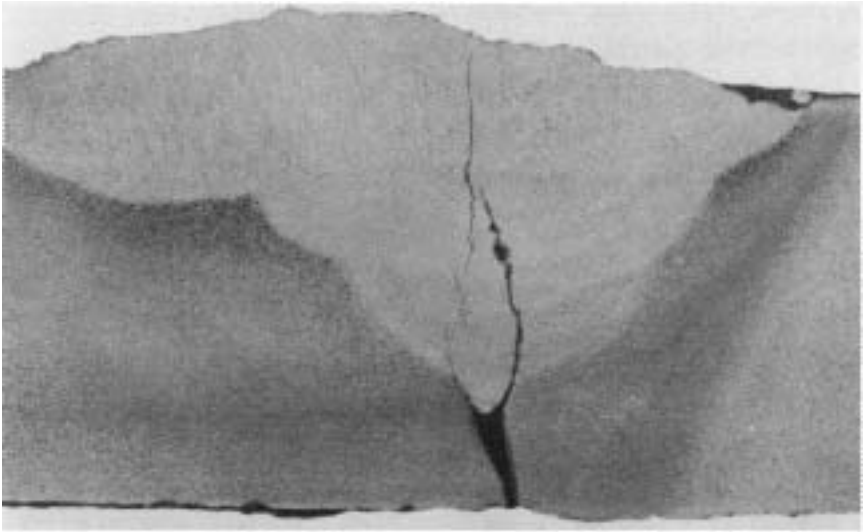
Figure 20.6 Lack of penetration in the root of a butt weld in a boiler feedwater line. Sodium hydroxide concentrating in the resulting crevice led to caustic stress-corrosion cracking. Note fine cracks emanating from crevice. (Reprinted with permission from Helmut Thielsch, Defects and Failures in Pressure Vessels and Piping, New York, Van Nostrand Reinhold, 1965.)

joint (Fig. 20.6). It usually applies to the initial weld pass, or to passes made from one or both sides of the joint. On double-welded joints, the defect may occur within the wall thickness (Fig. 20.7).

Inadequate joint penetration is one of the most serious welding defects. It has caused failures in both pressure vessels and tube welds. Failures by mechanical fatigue, thermal fatigue, stress-corrosion cracking, and simple corrosion have been associated with this defect.

Elimination. Inadequate joint penetration is generally caused by unsatisfactory groove design, too large an electrode, excessive weld travel rate, or insufficient welding current.

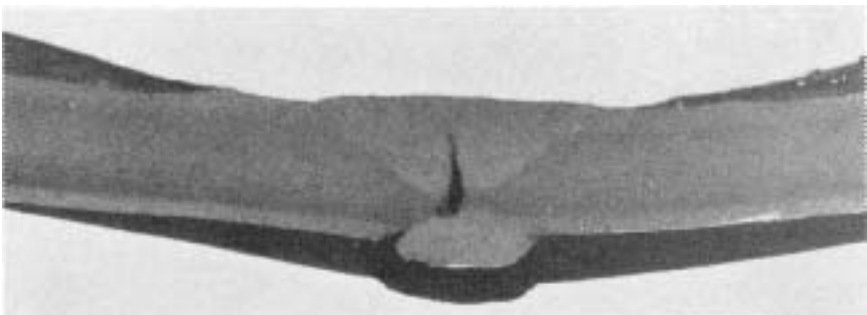
Figure 20.7 Cross section of circumferential butt weld. (Reprinted with permission from Helmut Thielsch, Defects and Failures in Pressure Vessels and Piping, New York, Van Nostrand Reinhold, 1965.)

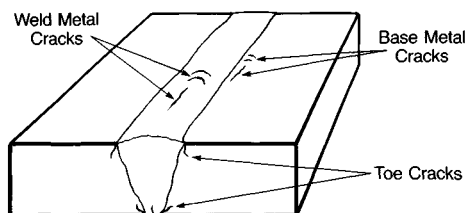
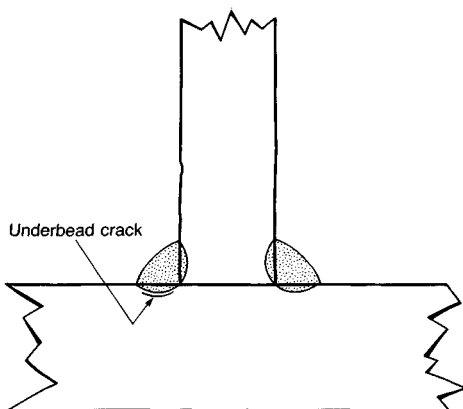
Identification. Cracks appear as linear openings at the metal surface. They can be wide, but frequently are tight. Such cracks are typically thick-walled and exhibit very little, if any, plastic deformation. Cracking of weld metal can be critical and has led to frequent service failures. Base-metal cracking (toe cracking, underbead cracking) is also critical and has caused service failures. Cracking may be either transverse or longitudinal (Fig. 20.8).

Figure 20.8 Typical crack locations in weldments.

Elimination. In general, cracking results from poor welding practice, inadequate joint preparation, use of improper electrodes, inadequate pre-heat, and an excessive cooling rate.

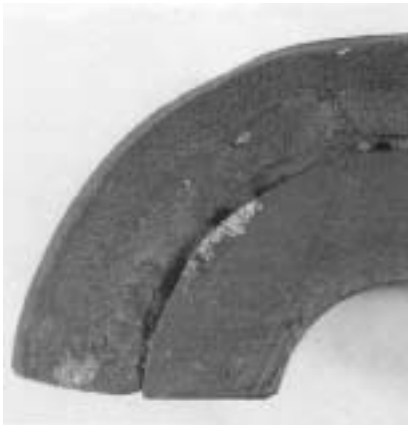
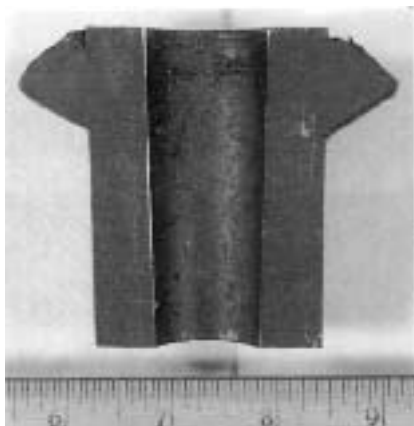
The tube illustrated in Figs. 20.9 and 20.10 had been welded to the finishing-superheater outlet header in the penthouse. The specimen shows a brittle fracture at the weld, which apparently popped out of the header after the failure. Similar fractures had not occurred previously, but several additional cracked and leaking welds were discovered upon the inspection associated with this failure. The boiler was base-loaded and in continuous service except for yearly maintenance outages.

Visual examination of the weld and the fracture face revealed that large areas of the weld root were unfused. Radial striations on the fracture face originated at the unfused region.

The specimen had failed at the weld that joined the tube to the header. Cracks initiated at the weld root, where incomplete fusion had occurred, and propagated from this region by a corrosion-fatigue mechanism. The unfused portion of the weld formed sharp crevices, which acted as stress-concentration sites that locally elevated normal stresses.

Figure 20.9 Cross section of tube showing weld metal (top of tube).

Figure 20.10 Fracture surface showing tube wall (inner ring) and fractured weld metal (outer ring).

Cyclic stressing in this region of the boiler is frequently caused by differences in rates and directions of thermal expansion between the header and the tubes. Terminal tubes are often affected and can crack at the toe of the weld even in connections that have been properly welded. The thermal expansion and contraction stresses are often associated with start-up and shutdown.

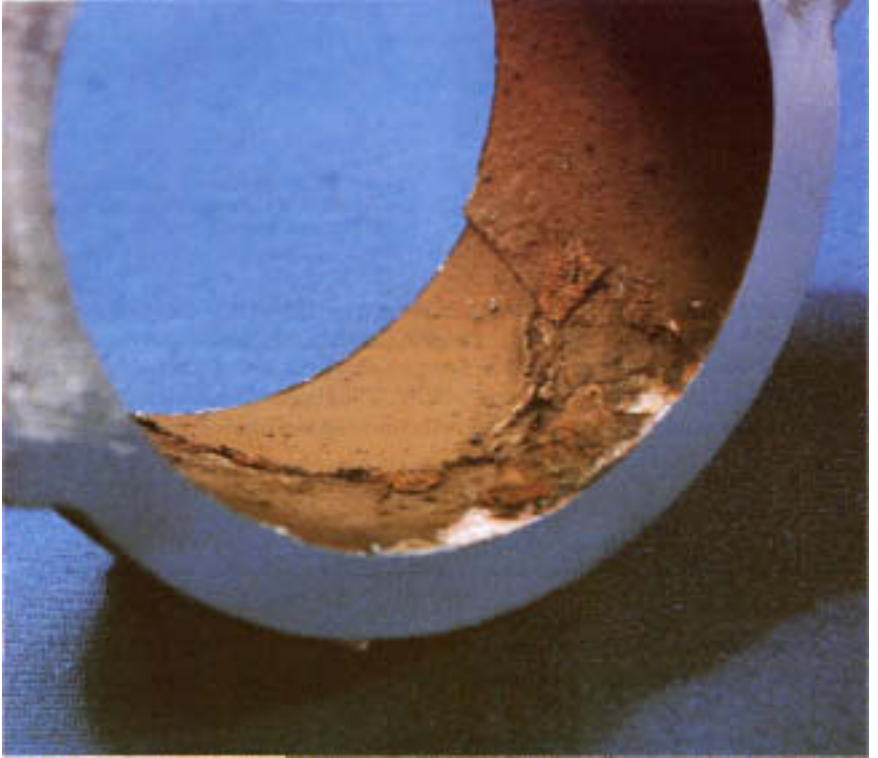
A “window” section had been cut out of the hot side of the tube illustrated in Fig. 20.11 and a new section welded into place from the external surface. Cross sections cut through the welded window revealed deep fissures associated with the welds (Fig. 20.12). The appearance of this defect suggests that entrapped slag, dirt, or flux prevented the formation of a sound metallurgical bond. Defects of this type can lead to through-wall fatigue cracking or corrosion fatigue due to the stress-concentrating effect of the fissure.

Figure 20.11 Internal surface of tube showing oval-shaped replacement window welded into place.

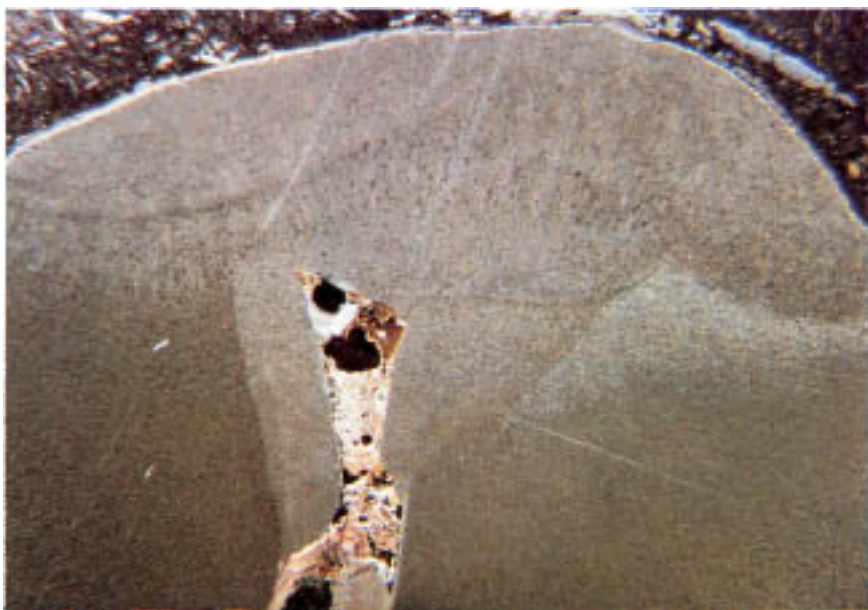
Figure 20.12 Cross section through window weld showing deep fissure in weld metal. (Magnification: 6X.)

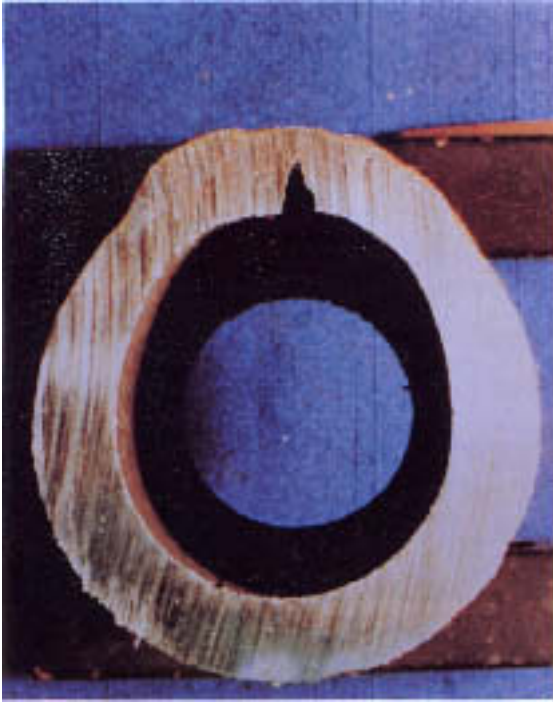
The boiler from which the tube illustrated in Fig. 20.13 was taken had experienced recurrent overheating failures in the areas around the cyclone burners and the furnace floor. The boiler had been in peaking service for the last 6 years.

Figure 20.13 Profile of tube wall showing unfused fissure remaining after weld repair.

Failures were repaired by patch-weld overlays. The illustration indicates that the weld metal has not penetrated through the tube wall, leaving the thick-walled fissure caused by the in-service overheating unfused. These fissures operate as stress-concentration sites. Consequently, under the combined influence of normal service stresses and high operating temperatures, creep cracks (see Chap. 2, “Long-Term Overheating”) formed at the tip of the fissure. Failure of the weld-repaired tube wall was imminent.

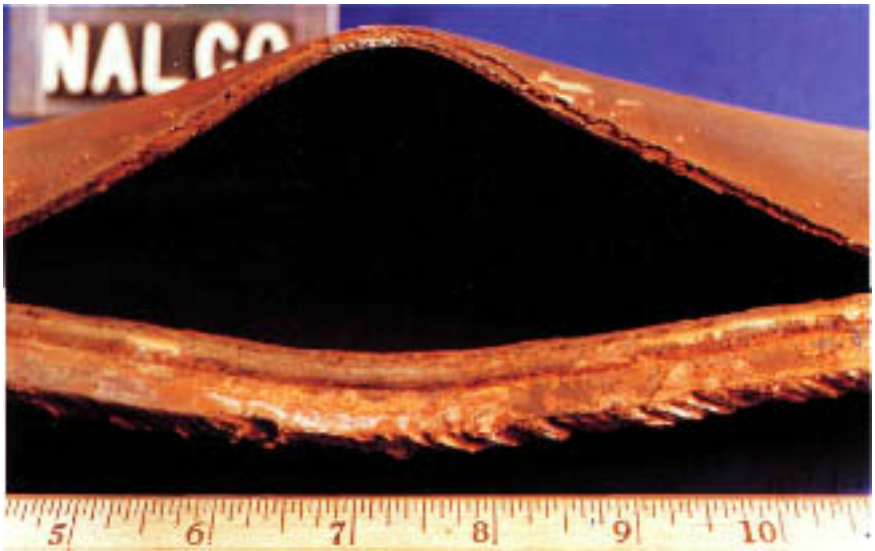
Fig. 20.14 illustrates a massive fracture along the weld bead attaching the membrane to the tube wall. Microstructural examinations revealed an aligned chain of graphite nodules in the heat-affected zone immediately adjacent to the weld bead. The fracture had occurred through this chain. The proximity and alignment of the graphite nodules provided a weak plane where a fracture could readily propagate due to stresses imposed by internal pressure. This tube section had been exposed to metal temperatures in excess of 850°F (454°C) for a very long period of time.

Figure 20.14 Massive fracture along weld bead resulting from weld-related graphitization. (Courtesy of National Association of Corrosion Engineers.)
