## **Materials Deficiency**

## CASE HISTORY 21.1

## CASE HISTORY 21.2

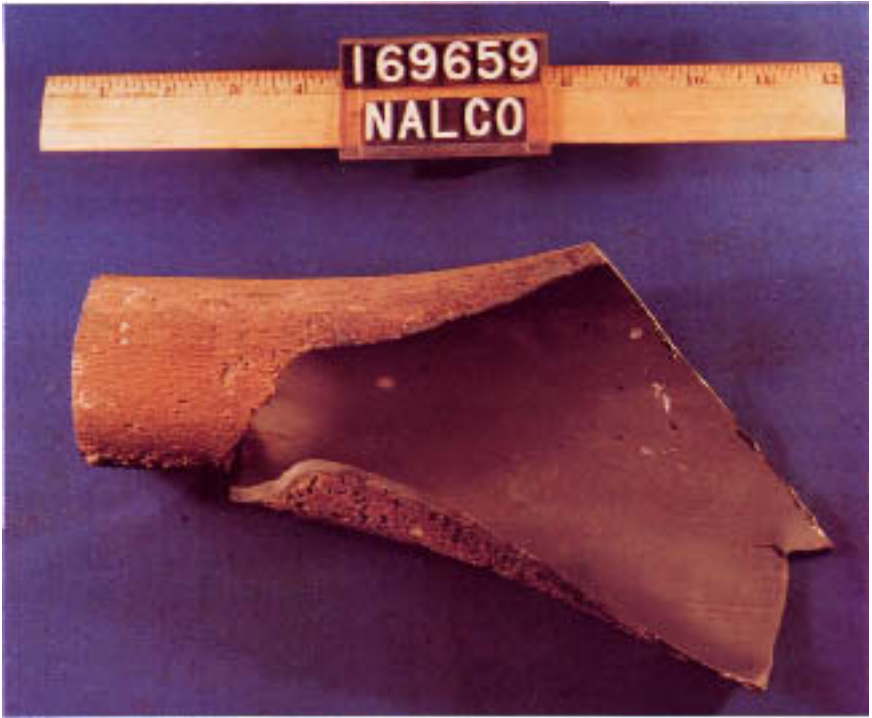
The tube illustrated in Fig. 21.2 ruptured in service in a bark-fired boiler. Three similar failures had occurred over the previous year in this section of the superheater. The boiler is operated continuously except for semiannual maintenance outages.

**Figure 21.2** Part of a thick-walled rupture in a superheater tube.

The rupture edges are thick, and have a chisel-like contour. The external surface is covered with a bark-like encrustation of thermally decomposed metal. The internal surface is smooth and free of deposits and corrosion products.

Microstructural examinations of the metal revealed the presence of graphite and spheroidized iron carbides in the tube wall at all locations. Intergranular oxidation, as well as thick layers of iron oxide (thermally decomposed metal), was also observed at all surfaces.

The tube had been operated above the scaling temperature [approximately 1000 to 1050°F (538 to 566°C) for plain carbon steel] for this metal over a long period. Previous failures, the first of which occurred a year after start-up of the boiler, indicate a possible imbalance between heat flux and coolant flow rate in this superheater section. However, failure is improbable had the tubes been fabricated from low-alloy steel (SA-213 T22).

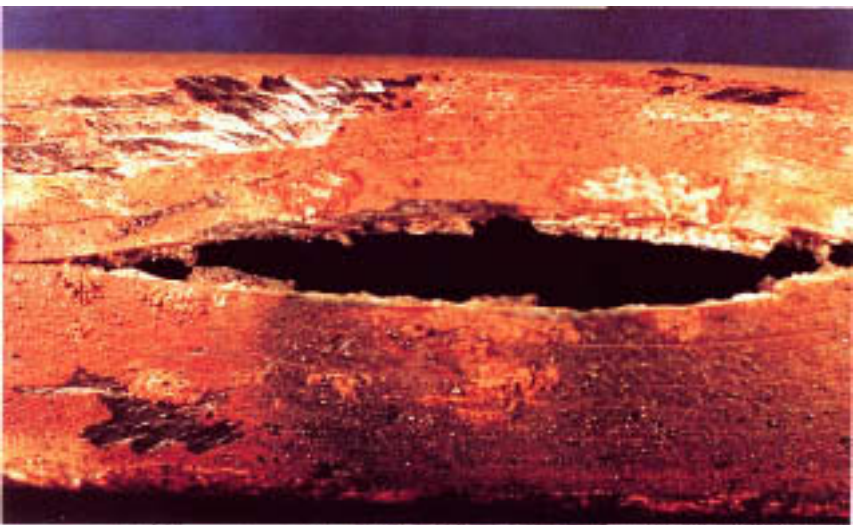
The thick-walled rupture shown in Fig. 21.3 is one of many similar failures that occurred sporadically in this section of the boiler. The boiler is presently base-loaded, but had been in peaking service previously.

The external surfaces are covered with thick layers of black iron oxide (thermally deteriorated metal) overlaid with light-colored deposits. The internal surface is also covered with thick layers of iron oxide.

Microstructural examinations of the metal revealed a dense population of graphite nodules and spheroidal iron carbides in the tube wall. Intergranular oxidation was apparent at all surfaces.

The failure of this tube is a direct result of operation in an environment that exceeded the thermal stability of the metal. A low-alloy steel tube (SA-213 T22) that had been butt-welded to the ruptured tube did not fail and had sustained only mild thermal deterioration.

**Figure 21.3** Thick-walled rupture in a reheater tube. Note fissures on external surface aligned with the rupture.
