## Dealloying

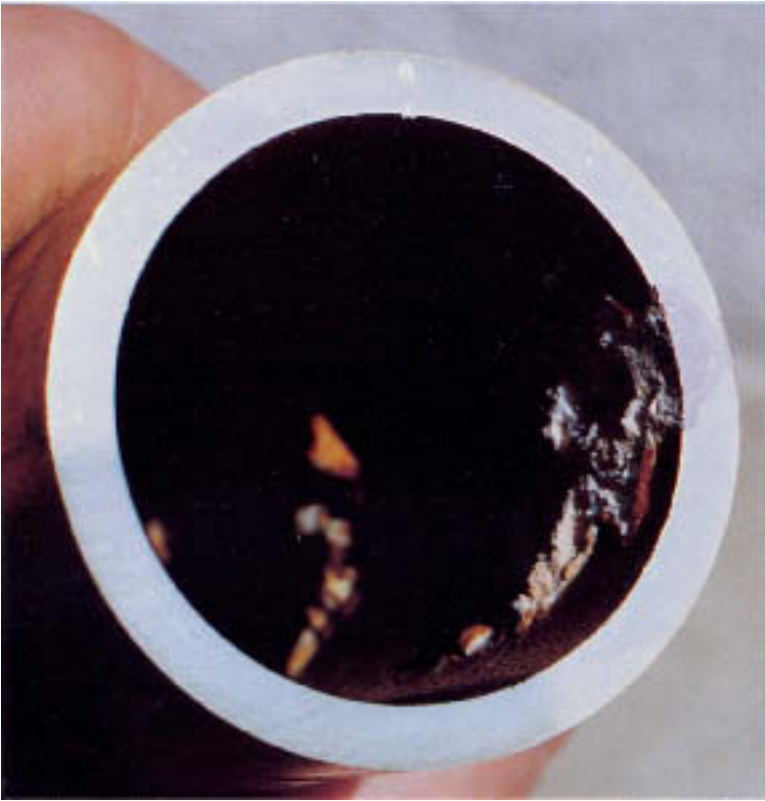
**Figure 23.1** Plug-type dezincification beneath a deposit in admiralty brass tube.

There are two commonly recognized forms of dezincification. Attack is either of a *plug* or *layer* type. Small localized areas of metal loss occur in the tube wall, producing plugs that can be blown out of pressurized tubes (Fig. 23.1). More general attack is called *layer-type dezincification* (Fig. 23.2). Cupronickels are more prone to layer-type attack than to plug-type deterioration. However, cupronickel wastage is usually slight compared to attack in brasses. It is likely that fundamental mechanisms of plug-type and layer-type attack are similar. However, plug-type attack can produce localized wastage rates of up to several hundred milliinches per year, while much milder attack is common with layer-type dealloying.

change to a deep red or salmon color of elemental copper (Figs. 23.1 and 23.2).

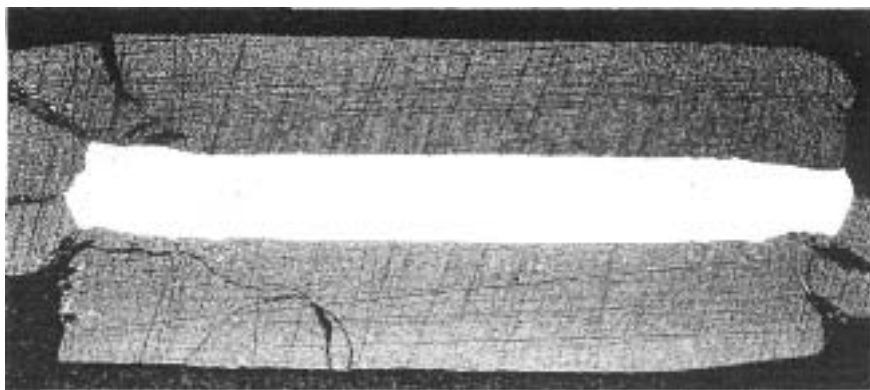
*Destannification* (loss of tin) can occur in gunmetal and some phosphor bronzes. This is especially the case in steam environments and in hot feedwaters. Monel steam strainers have been attacked when exposed to steam containing sulfur compounds at elevated temperatures (Fig. 23.3).

**Figure 23.3** Cross section through a corroded Monel metal steam strainer. The dark area consists of oxides, sulfides, and elemental copper (Magnification: 15X.)

A Monel turbine steam strainer was discovered to contain many broken elements. The metal was converted to oxide, sulfide, and elemental copper (Fig. 23.3). The deteriorated metal consisted of numerous elemental copper

particles embedded in an oxide-sulfide matrix. Cracks in the wasted metal were lined with elemental copper.

Failure was attributed to carryover of sulfur-containing compounds in the steam. The system had a history of poor steam purity and carryover of boiler water into the superheater.

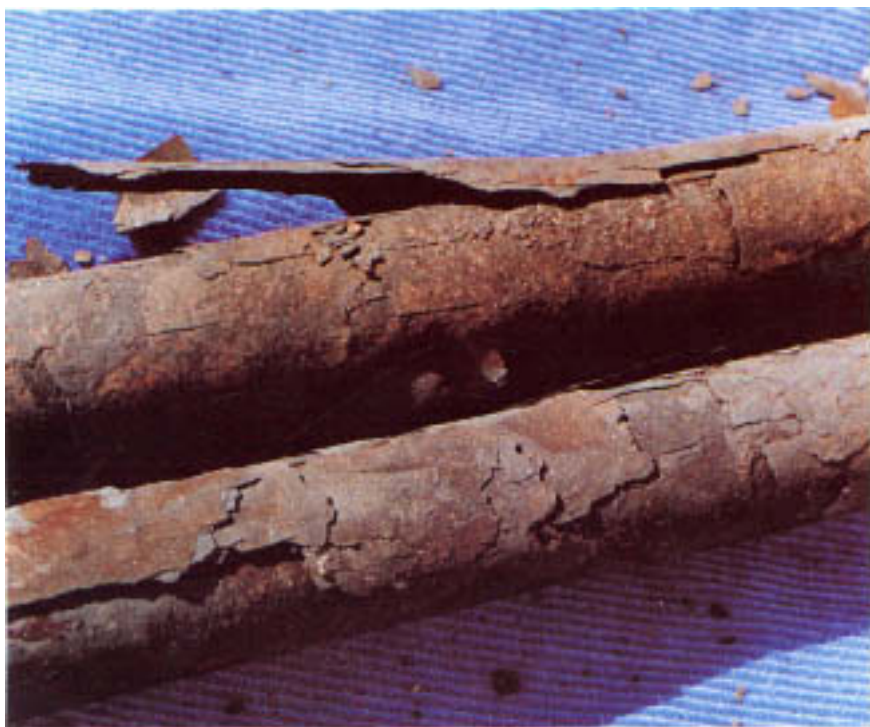
**Figure 23.4** Peeling surfaces on a cupronickel high-pressure feedwater heater tube.

Feedwater heater tubes were thinned by cyclic oxidation followed by reduction of oxides in service (Fig. 23.4). Wall thickness was reduced by as much as 15%.

During the previous 2 years, the boiler had experienced frequent outages in which air leaked into the heater shell and caused surface oxidation. Conversion of oxide to elemental copper occurred during normal operation.
