Corrosion-Fatigue Cracking

General Description

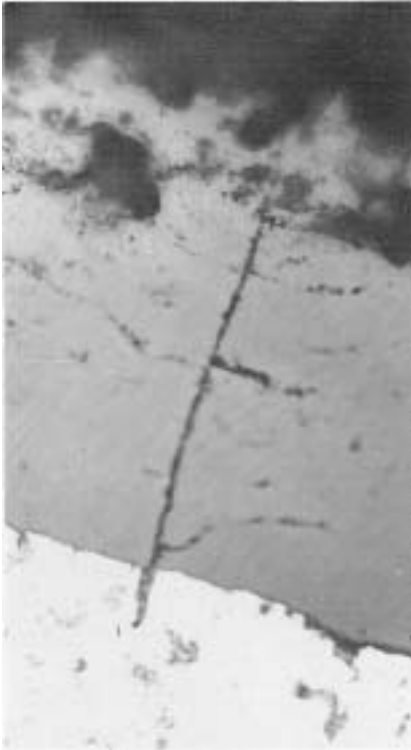
Figure 15.1 Incipient corrosion-fatigue crack formed at base of cracked layer of iron oxide. (Magnification: 400X. Etchant: Picral.) (Courtesy of National Association of Corrosion Engineers.)

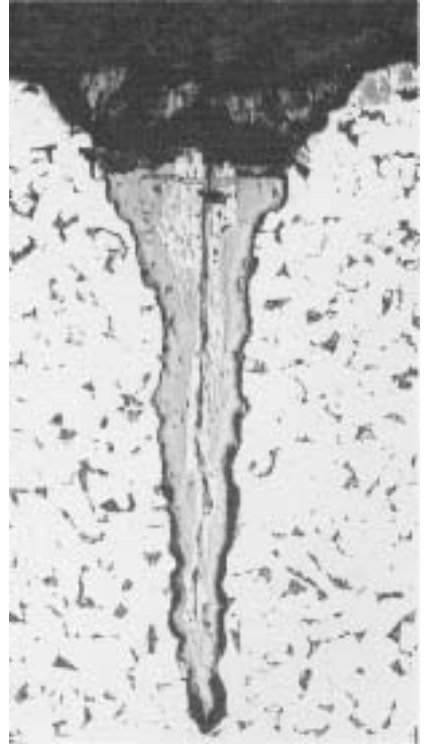
Figure 15.2 Mature corrosion-fatigue crack. (Magnification: 200X. Etchant: Nital.) (Courtesy of National Association of Corrosion Engineers.)

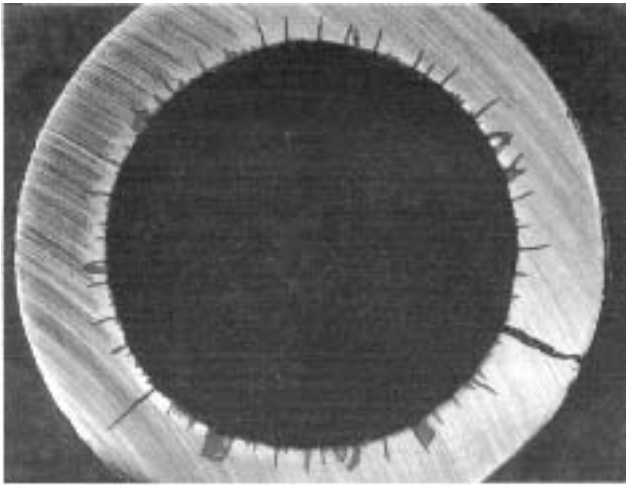
Figure 15.3 A family of longitudinal cracks resulting from fluctuation in internal pressure. (Courtesy of National Association of Corrosion Engineers.)

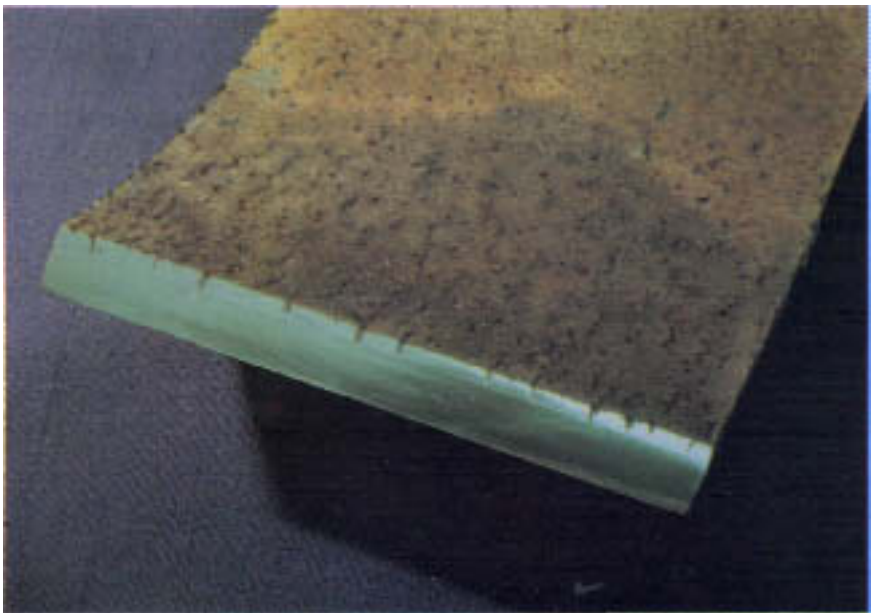
Figure 15.4 Transverse cracks originating on the internal surface.

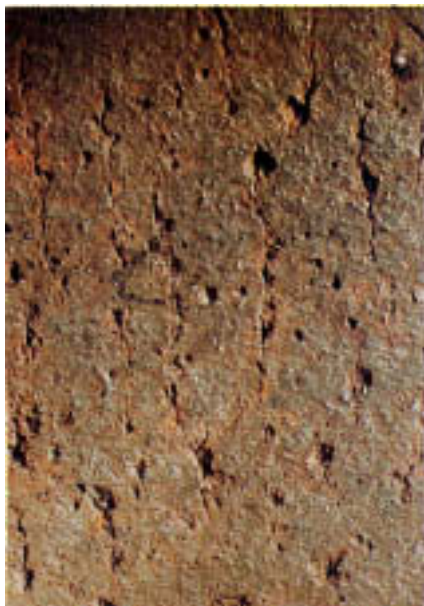
Figure 15.5 Transverse cracks and associated oxygen pits.

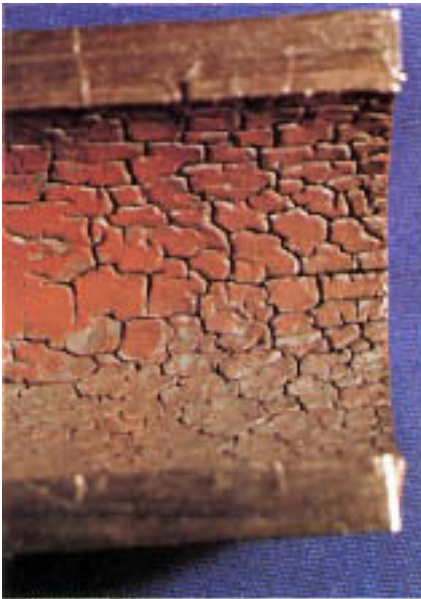
Figure 15.6 Thermal-fatigue cracks on internal surface.

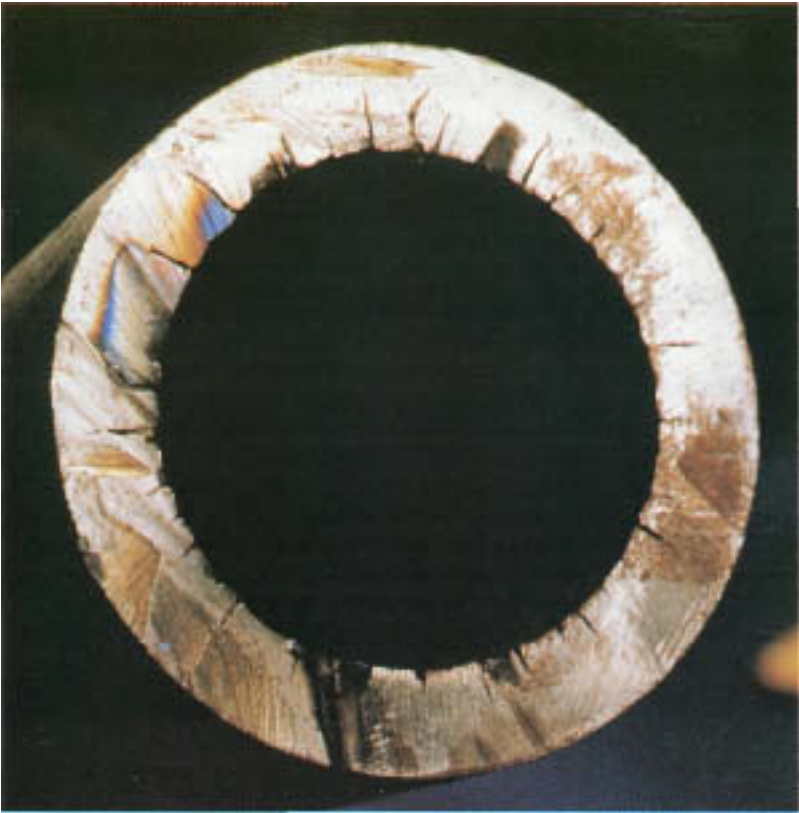
Figure 15.7 Cross section through cracks.

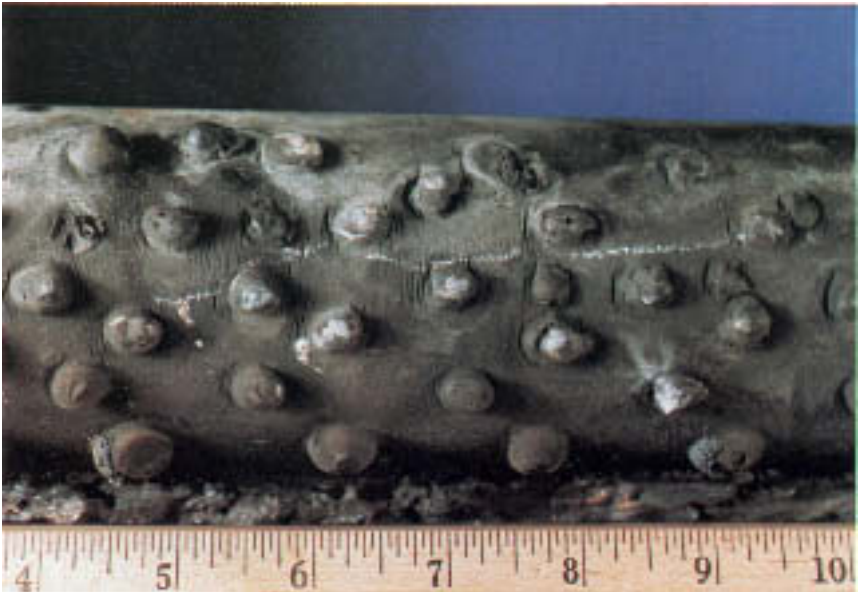
Figure 15.8 Transverse fissures at and near stud bases.

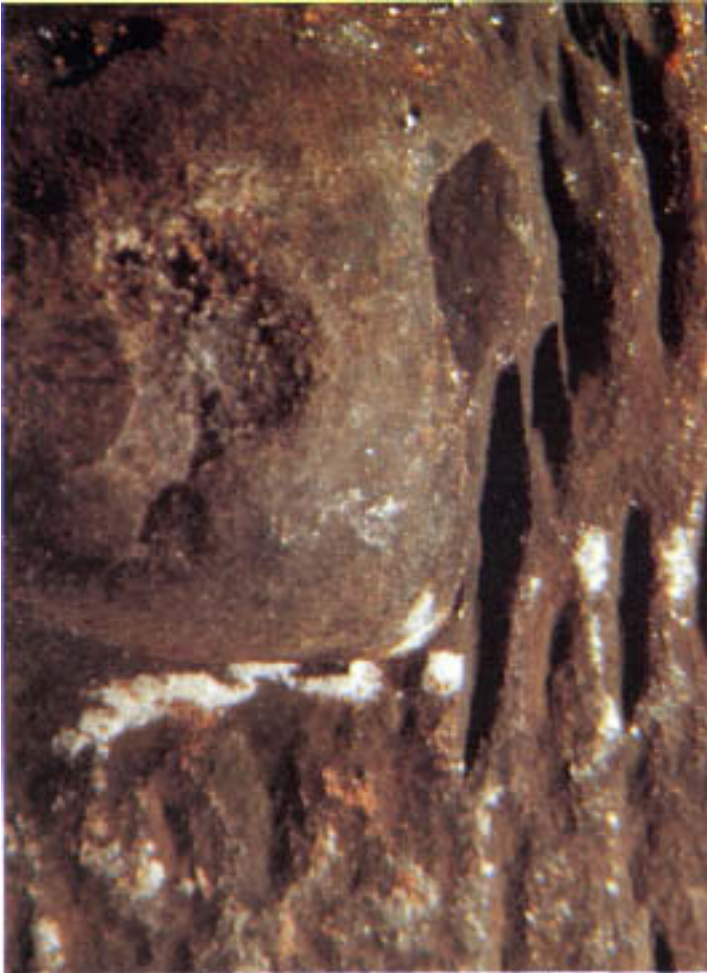
Figure 15.9 Transverse fissures near stud (center). (Magnification: 6.5X.)

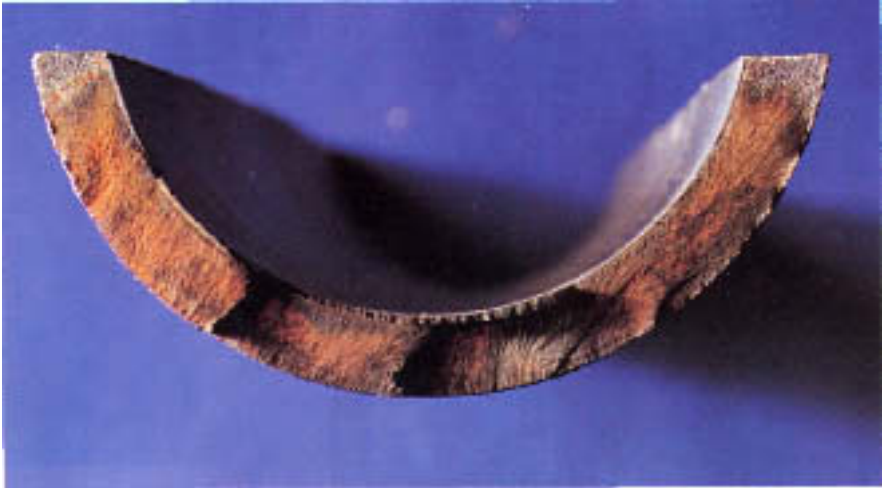
Figure 15.10 Brittle fracture face resulting from corrosion fatigue.

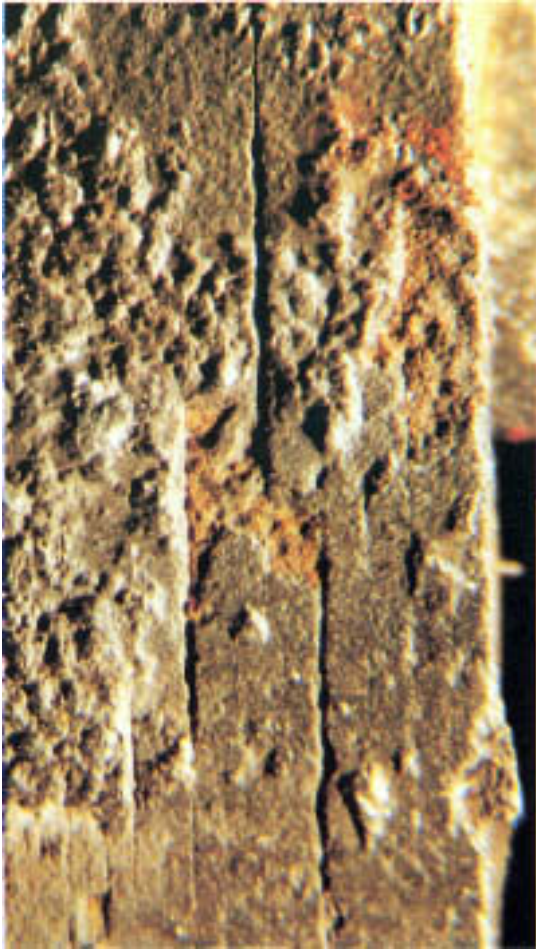
Figure 15.11 Secondary corrosion-fatigue cracks on external surface. (Magnification: 6.5X.)
