## **Graphitic Corrosion**

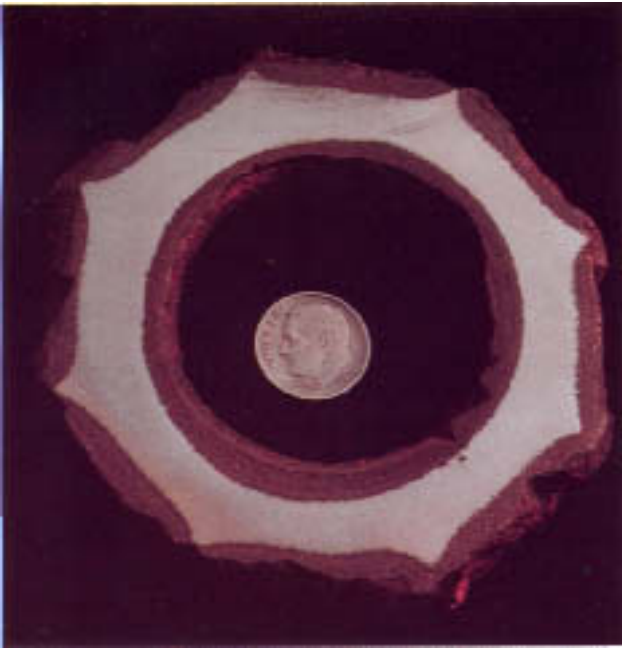
**Figure 22.1** Pump impeller severely attacked by graphitic corrosion. Material of the impeller is gray cast iron. Note the gray areas on both internal and external surfaces where the metal has been converted to rust and graphite.

Cast iron is converted to a soft mixture of iron oxides and graphite (Figs. 22.1 and 22.2). Pieces of corrosion product smudge hands and can be used to mark paper, just as if the corroded material were lead in a pencil (Fig. 22.3). Attack is often uniform, with all exposed surfaces corroded to roughly the same depth (Figs. 22.4 and 22.5). If localized deposits are present, especially those containing sulfate and chloride or other acidic species, corrosion may be confined to pockets. When attack is severe or prolonged, the entire component is converted to corrosion product. Surface contour and appearance are often preserved. Attack is usually not apparent until surfaces are probed or stressed.

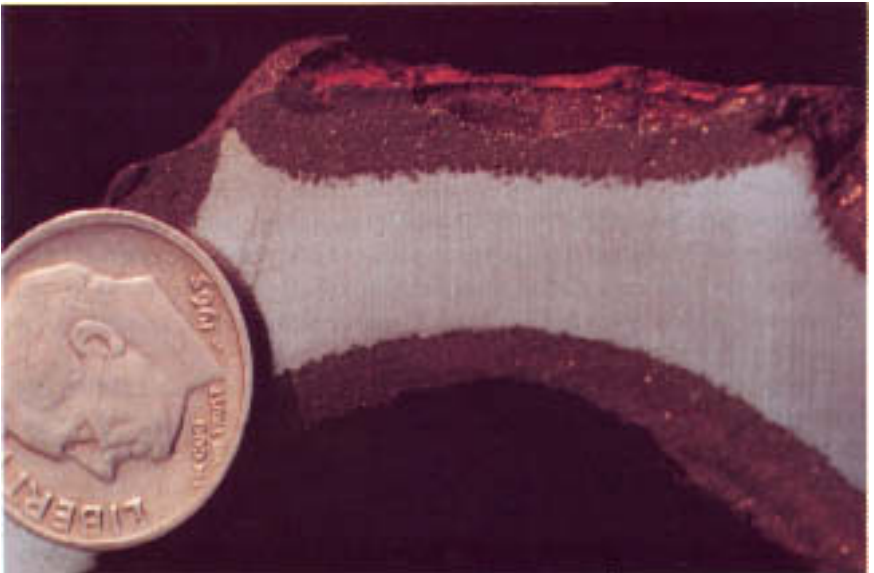
**Figure 22.2** Note how uniformly metal is converted to corrosion product. Impeller vanes were lost in service because the graphitically corroded metal is brittle.

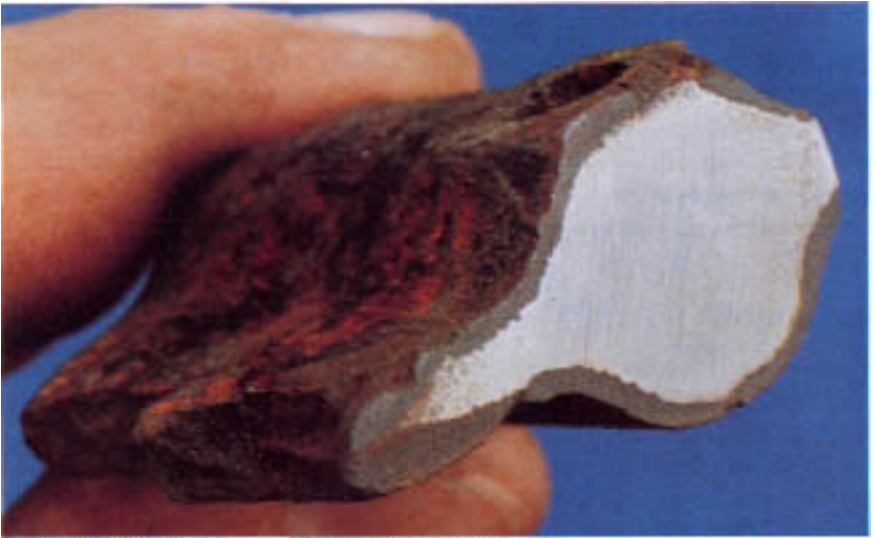
**Figure 22.4** Graphitically corroded valve butterfly. Original surface contours are preserved. Edges, which were completely converted to brittle corrosion product, have broken.

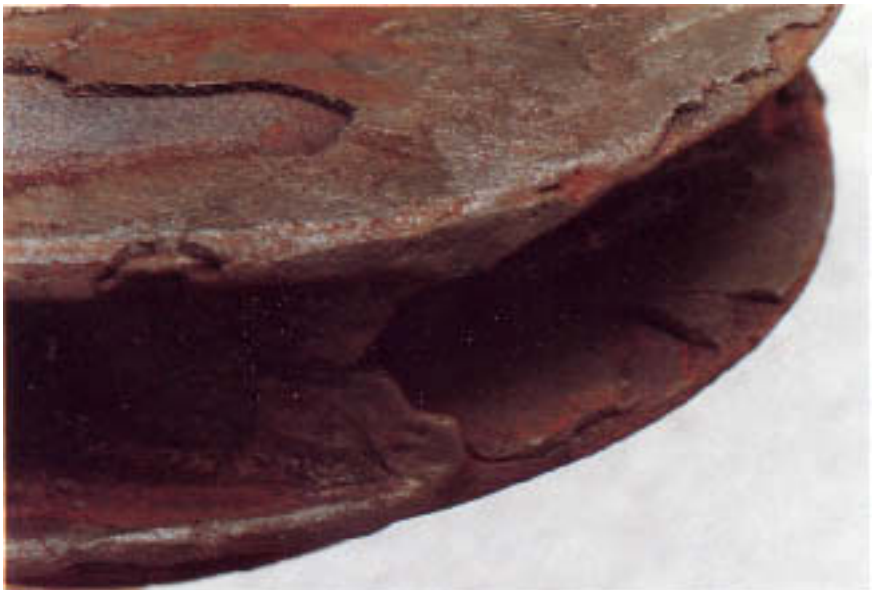
**Figure 22.5** Severe graphitic corrosion of a gray cast iron feedwater-pump impeller. Patches of corrosion product have cracked and spalled, revealing uniform general wastage. Note the fracture in the impeller vane.

A small feedwater-pump impeller was removed during a scheduled maintenance outage. The entire impeller surface was converted into soft, black corrosion products. In some areas, no trace of the original impeller alloy was left. Vane tips were totally converted to corrosion product. Vanes were cracked, and pieces of the corrosion product were dislodged, producing irregular contours (Fig. 22.5).

The impeller had been used intermittently, with greater than 50% idle time in the previous 2 years.
