# Structures & construction in historic building conservation

Edited by

**Michael Forsyth**

Department of Architecture and Civil Engineering  
University of Bath

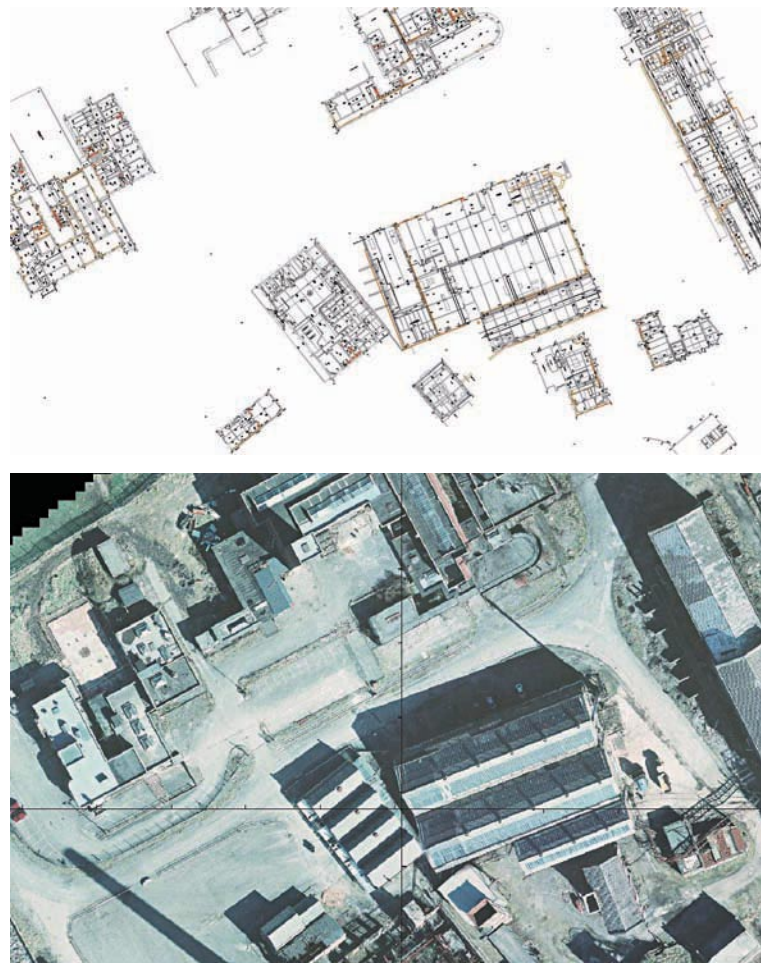
**Figure 4.1** Metric survey at Chatterly Whitfield Colliery, Staffordshire: orthophotograph and building plans, originally at 1:200 and 1:50 scale respectively. The survey work was carried out on a common control so composites are possible in CAD without problems of differing scale and orientation.

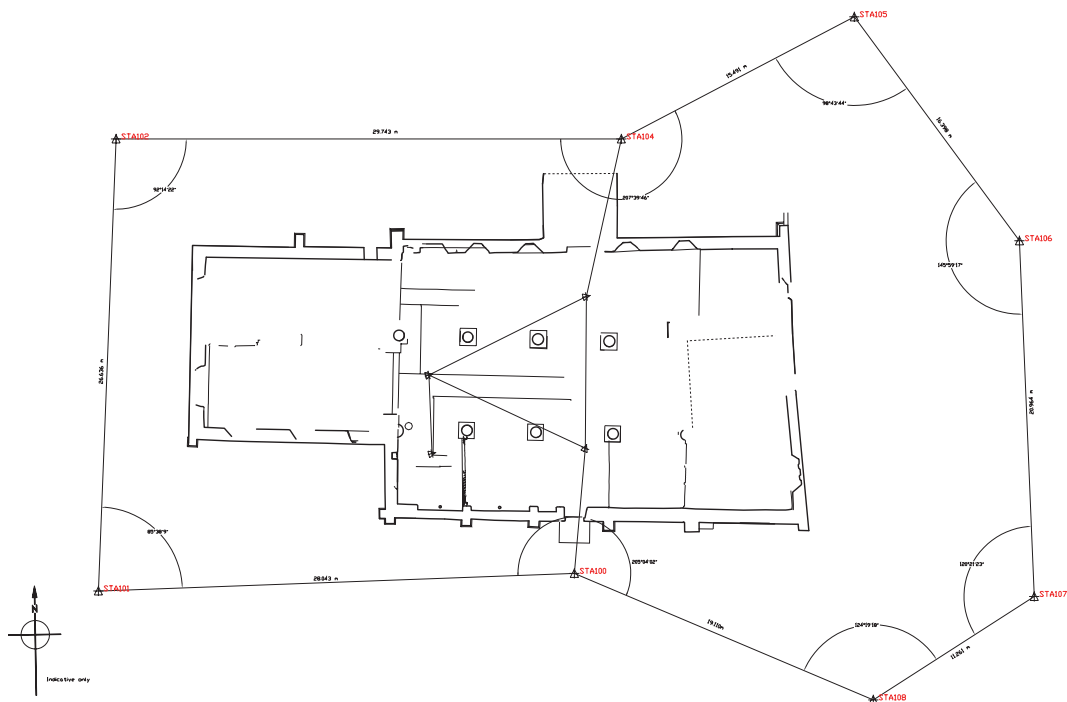
**Figure 4.3** Traverse at St Giles' Church, Oxford. The four stations inside the church are tied to the closed loop. The stations on the loop are adjusted and the plan is prepared by polar observation from them. Further interior control is achieved by resection, end over end or spur legs; checks are possible by linking back to the loop. The plan is in progress; wall thickness, window reveals, nave arcade and overhead detail will be recorded from further stations and hand measurement.

A traverse consists of a number of points known as stations linked by lines known as legs (Figure 4.3). To undertake a traverse, at least three

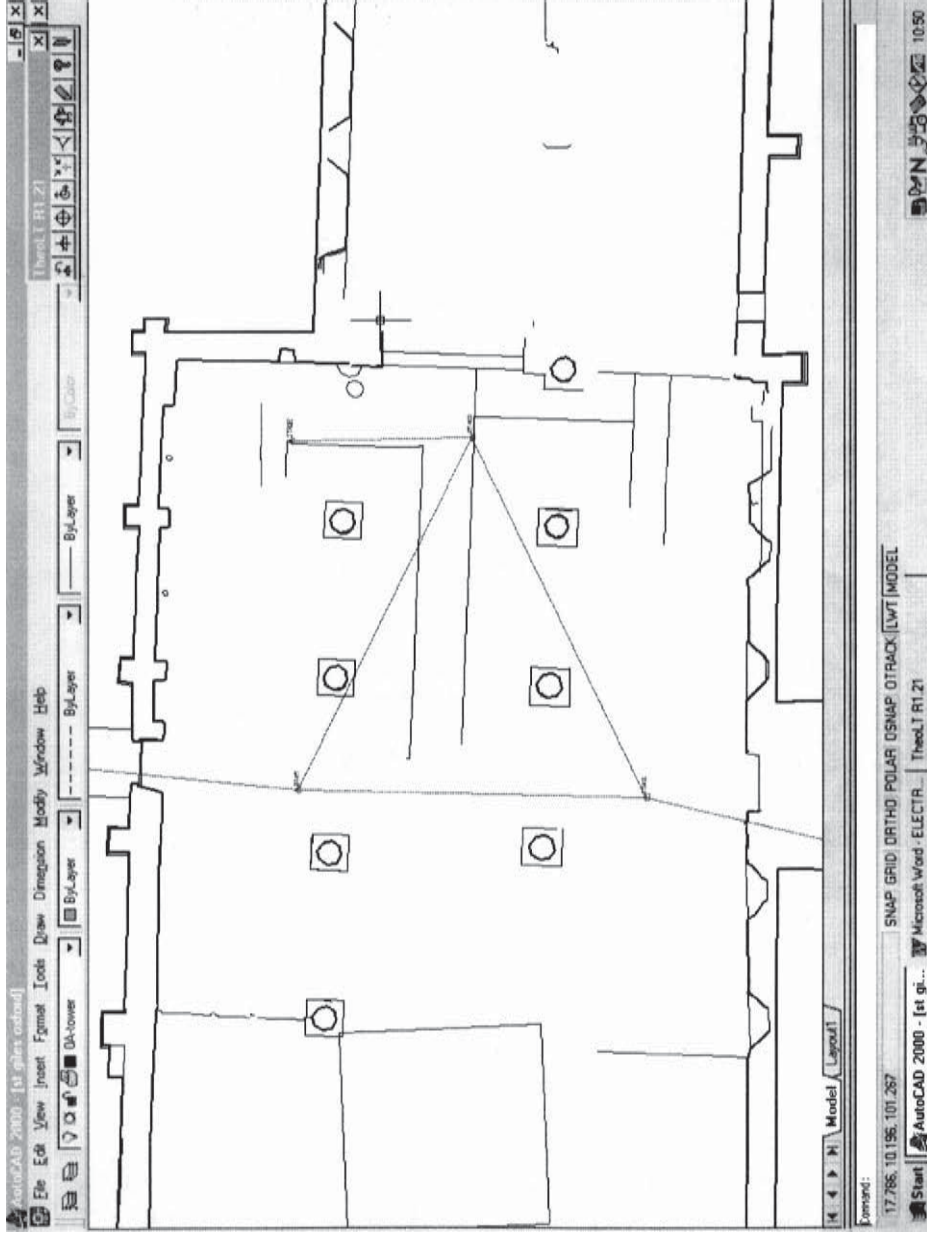
**Figure 4.4** Resection in TheolT. The station position can be resolved by observation to two or more known positions; the station on the centre of the nave has been located by observation to the stations on the loop. A spur has placed a station in front of the north wall from the resected position. Resection is useful with REDM when sight lines are blocked or when a prism cannot be placed at the target easily.

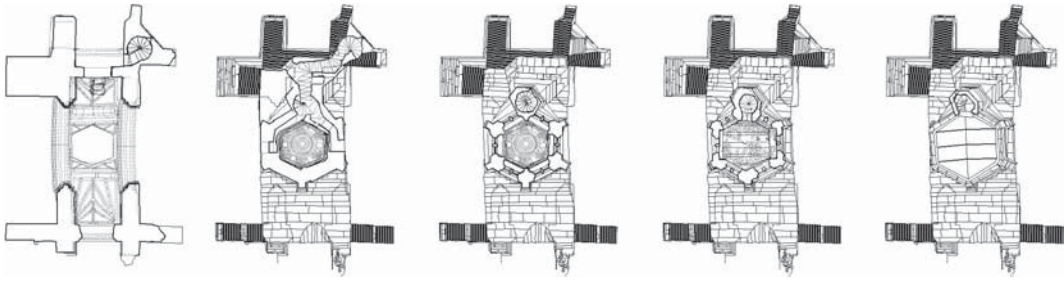
**Figure 4.6** Stacked plans to record displacement at Greyfriars Tower, Kings Lynn, Norfolk. The common control used required a traverse to place stations at high level on the floors for consistency of detail position.

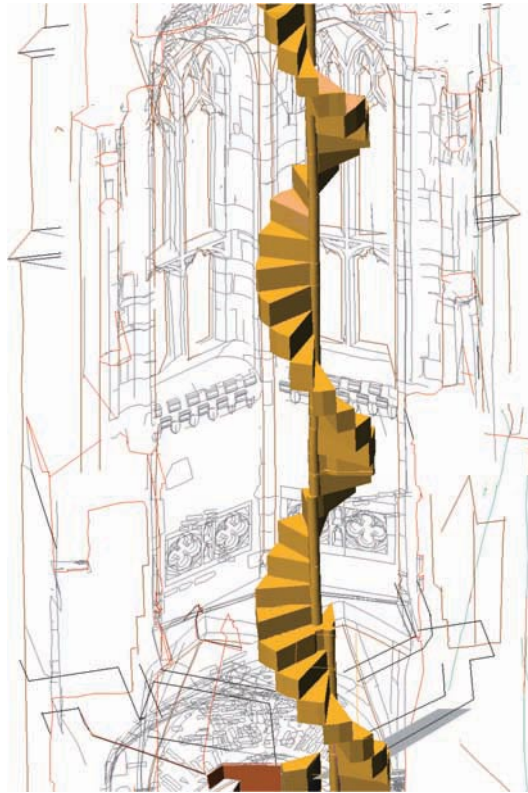
**Figure 4.7** 3D data collection for 3D model. The spiral stair has been solid modelled; the outline of all other features are in 3D wireframe. Views of the stair on the sectional elevation.

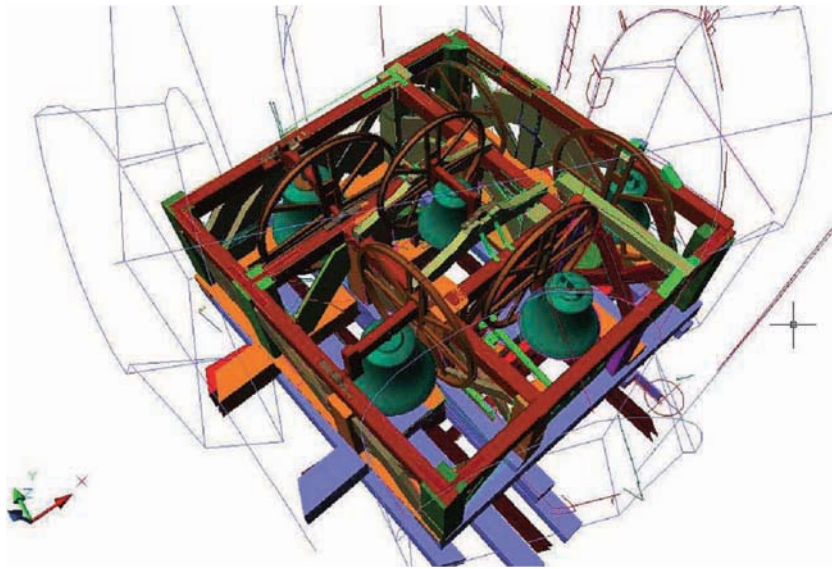
**Figure 4.10** A 3D CAD model of the bell frame at St Mary's Church, Attleborough, Norfolk, to help the design of strengthening work and encourage interest in the project, as all the work is hidden from view. The same data was used for traditional plans and sections.

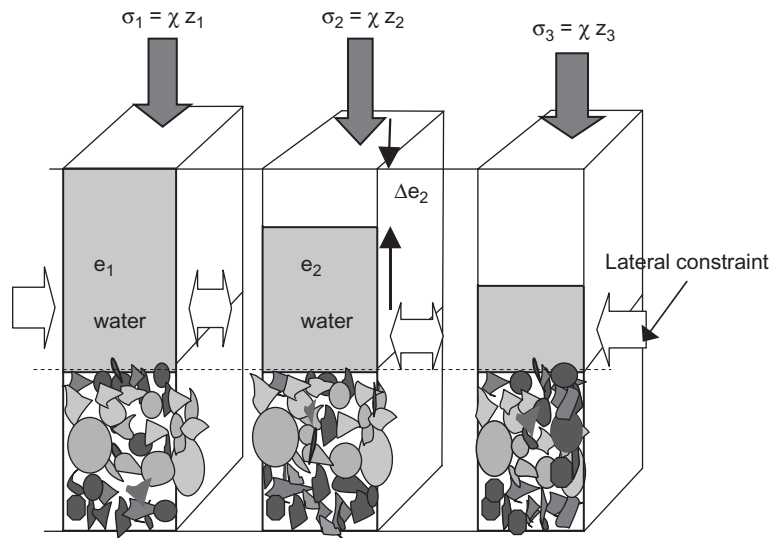
**Figure 6.4** One-dimensional sedimentation process. Columns of soil are laterally confined by those adjacent. They can change length or thickness, but not their plan shape.

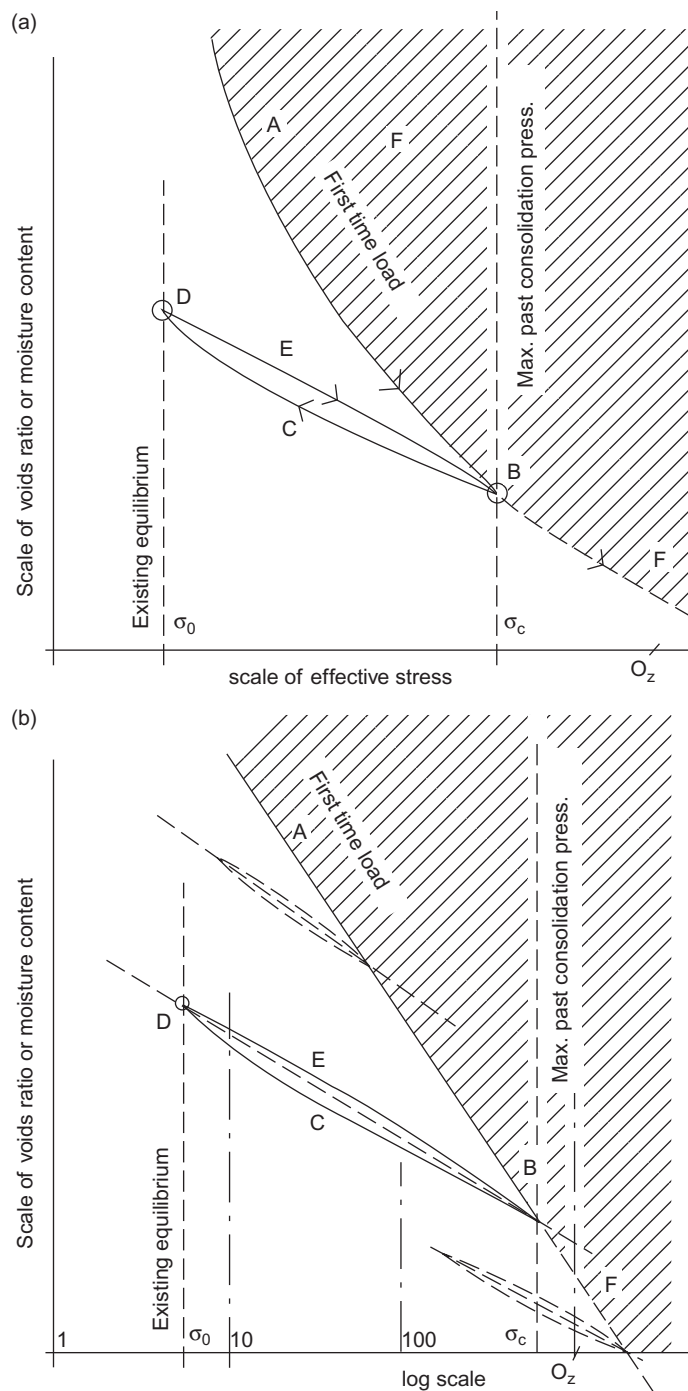
**Figure 6.5** (a) and (b) Volume change versus compression during sedimentation. Loading–unloading and re-loading (shown to natural scale and ‘log’ scale).

- Engineers normally draw the relationship to a logarithmic scale (Figure 6.5b), because the first-time loading and unload/reload curves then follow near straight lines. This is how it would be seen in a test result.
- For a specific material defined by the line A–B–F, no point can exist above and to its right-hand side. However, there are an infinite variety of un-load/re-load possibilities to the left. The pattern is the same for

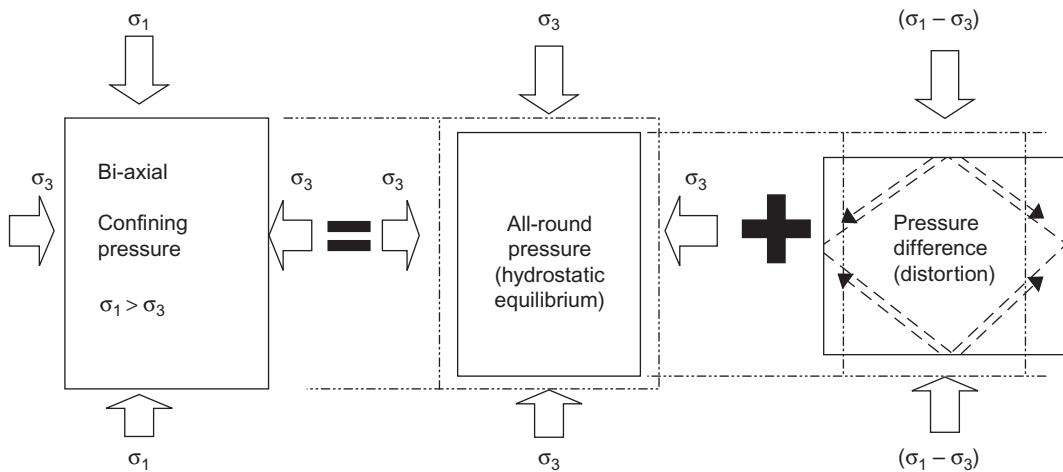
**Figure 6.6** Two-dimensional system of pressure subdivision into all-round stress and stress difference.

Internal forces set up by this deformation are shown by the arrows alongside. The whole gives a visual picture of the fact that simple axial loading (taking  $\sigma_3 = \text{zero}$ ) invokes what is defined as **shear**. In fact, the ultimate criterion of strength in soils, and indeed virtually all materials, rests with a

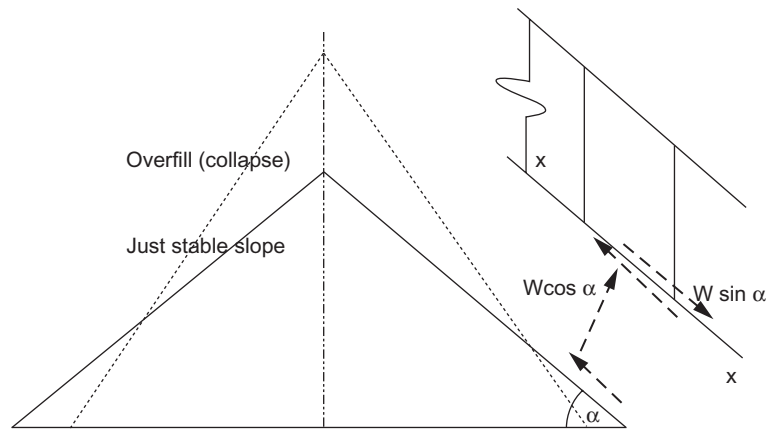
**Figure 6.7** Limiting stability of the surface of a sand heap.

In soil mechanics the coefficient of friction  $\mu$  is discarded in preference to the use of an **angle of friction**  $\Phi$ . In the particular case above, the angle of friction  $\Phi$  is shown by the limiting angle of slope  $\alpha$ . This may be theo-

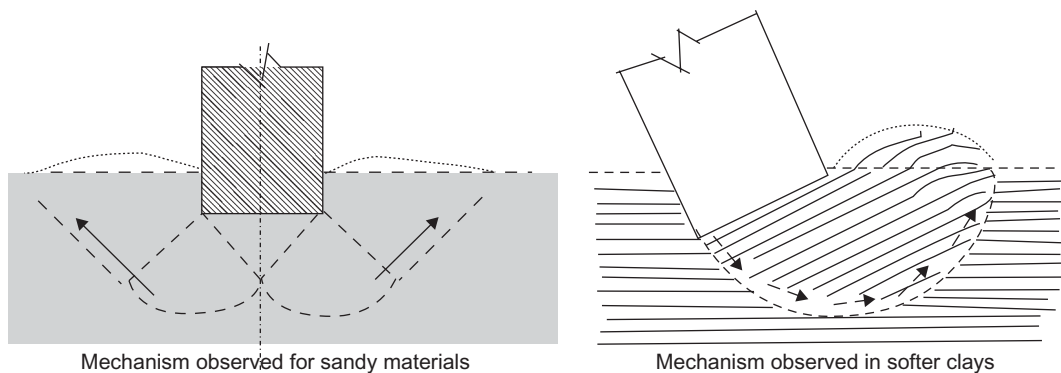
**Figure 6.9** Local bearing failure under a strip footing.

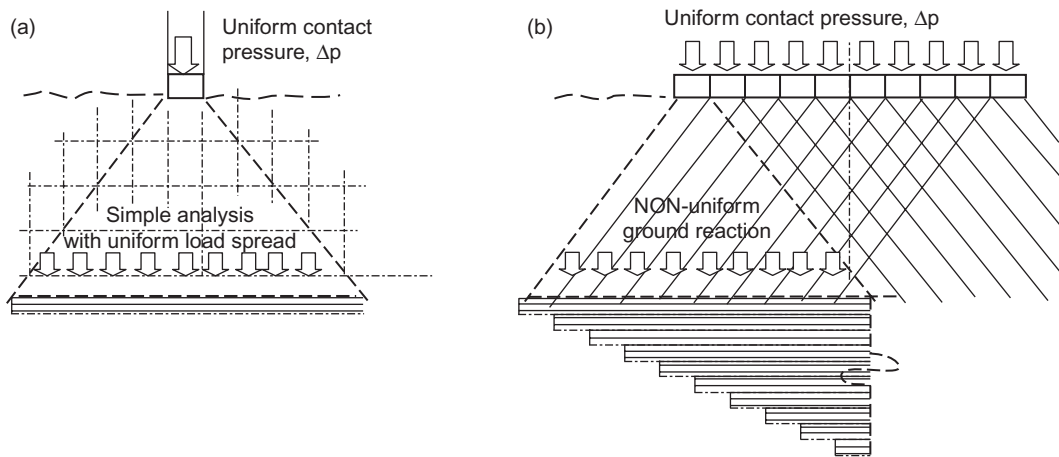
**Figure 6.10** (a) Assumption of a simple 45° load spread; (b) 45° load spread pattern divided into a series of small segments. Soil reactive pressures vary across any horizontal plane.

We could refine this reasoning by dividing up the same foundation width into a series of smaller-sized elements (Figure 6.10b). This is admissible, whether the actual width of the elements is large or small; it simply goes one step further towards advancing the concept of 'load spread'. Now, however, we see adjacent  $45^\circ$  segments overlapping, the more so as the load spread penetrates deeper underground. Without recourse to heavy mathematics, this points to some important facts:

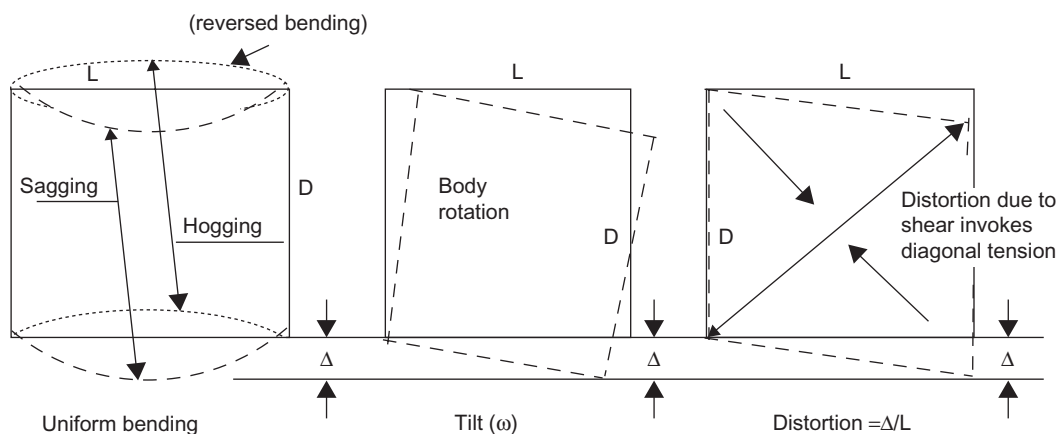
Figure 6.11 Customary definitions of building settlement.

At the risk of stating the obvious, settlement refers to (usually) movement of the finished building structure. Differential settlement is movement that causes the structure to change shape and therefore introduces strains within the fabric. Figure 6.11 reduces the forms of deformation movement

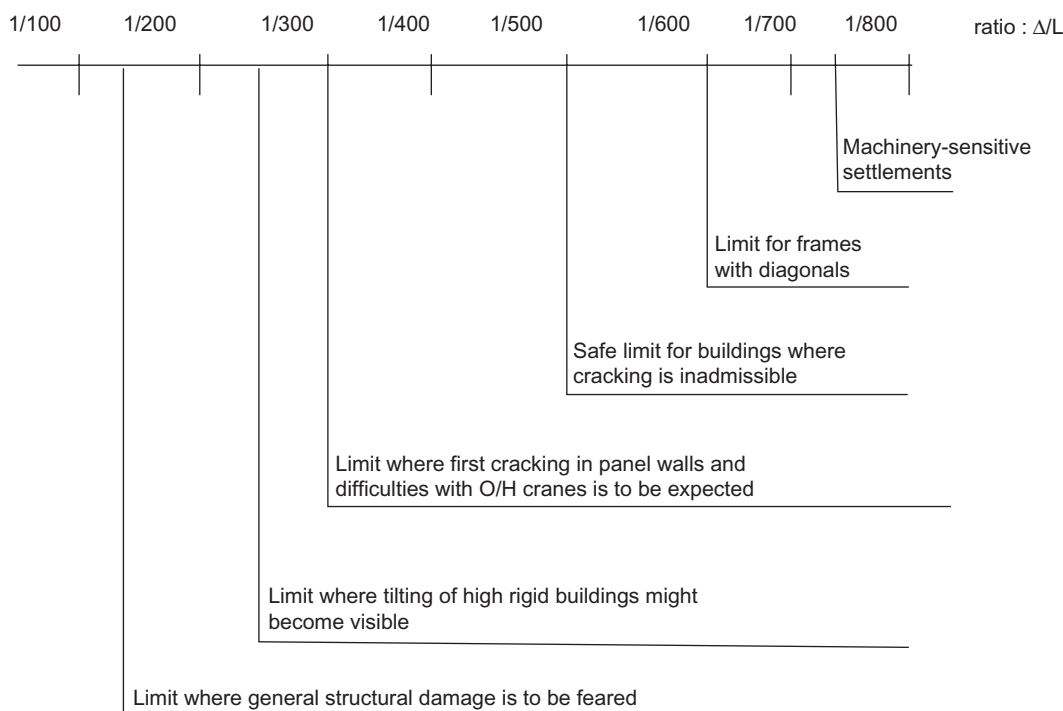
**Figure 6.12** Limitations on building settlement (from Bjerrum, 1963).

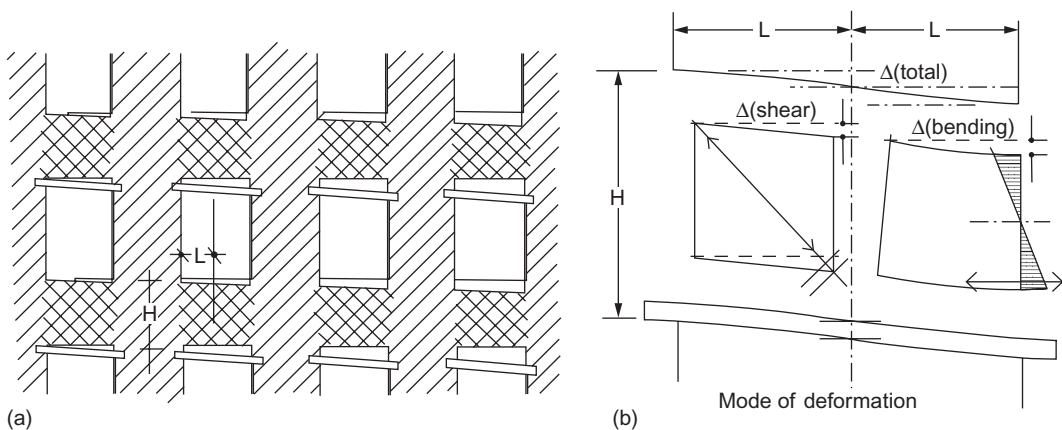
**Figure 6.13** (a) Long facade: regular pattern of columns and windows; (b) Spandrel wall acts as a fixed-end beam in shear and bending.

- A view of the whole facade shows a pattern of alternating columns of solid masonry and columns of windows separated by their spandrels. However, this undoubtedly elegant architecture means that a precise

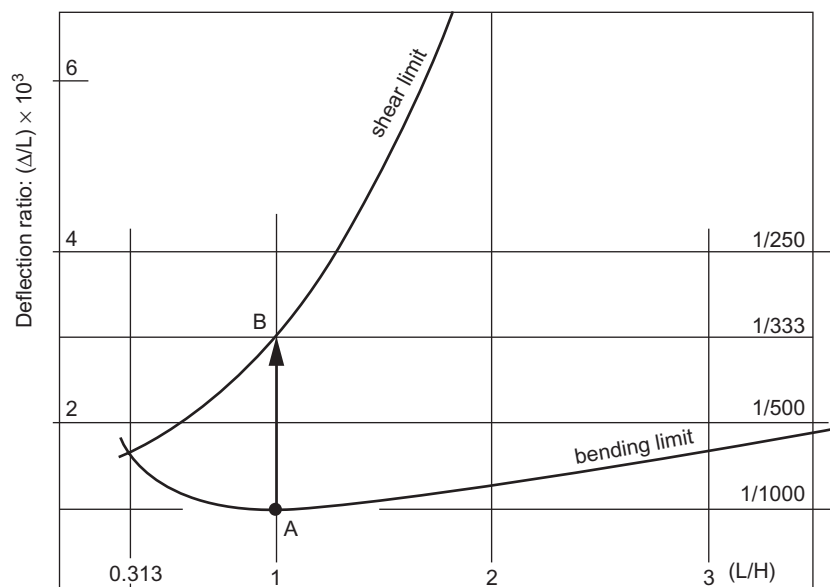
**Figure 6.14** Deflection ratio ( $\Delta/L$ ) versus ( $L/H$ ), for a limiting tensile strain of 0.075% in shear or bending.

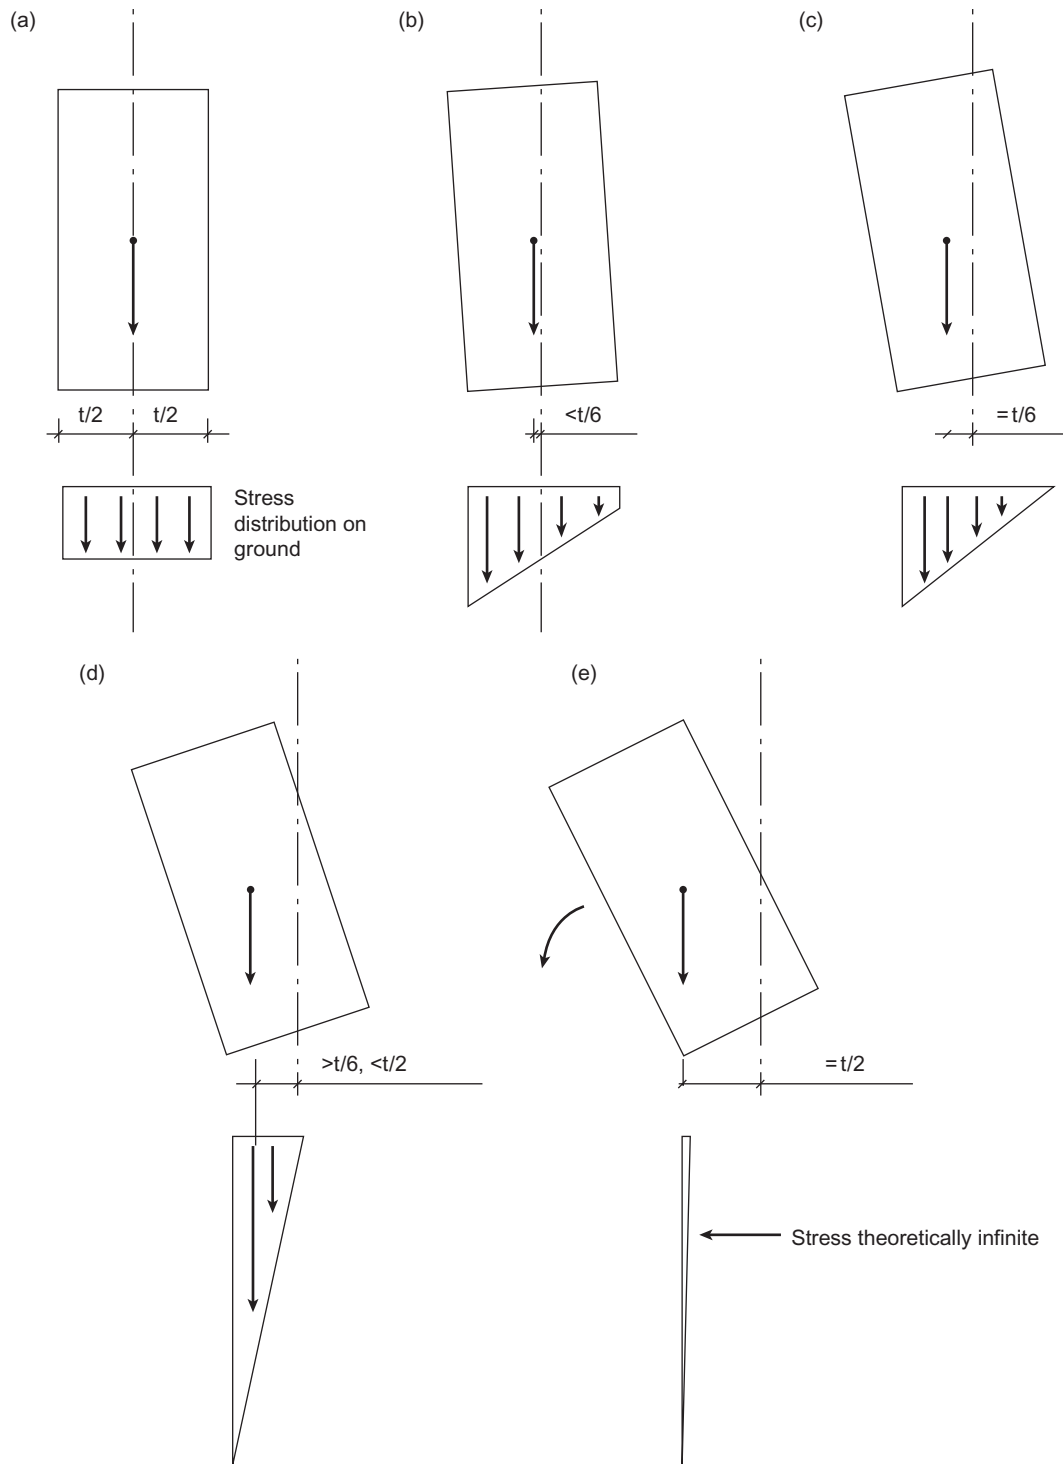
**Figure 7.1** Effect of tilt on ground stress distribution and stability.

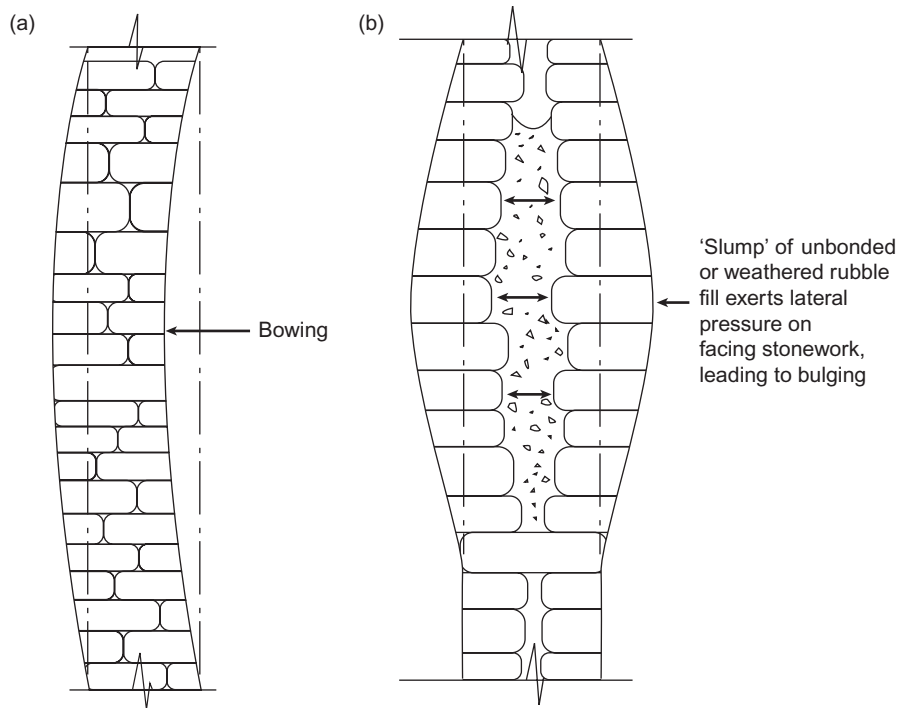
**Figure 7.2** Bowing and bulging of a wall: (a) bowing (b) bulging.

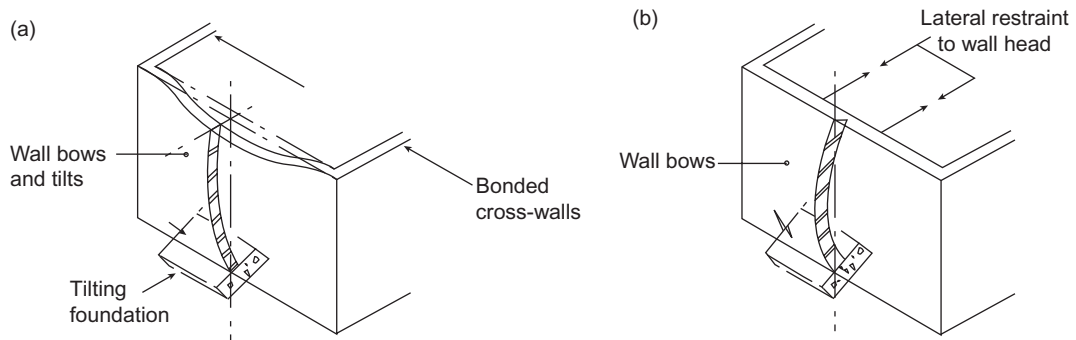
**Figure 7.3** (a) Wall both bowing and tilting owing to foundation rotation; (b) tilting of the wall prevented by lateral restraint to head of wall.

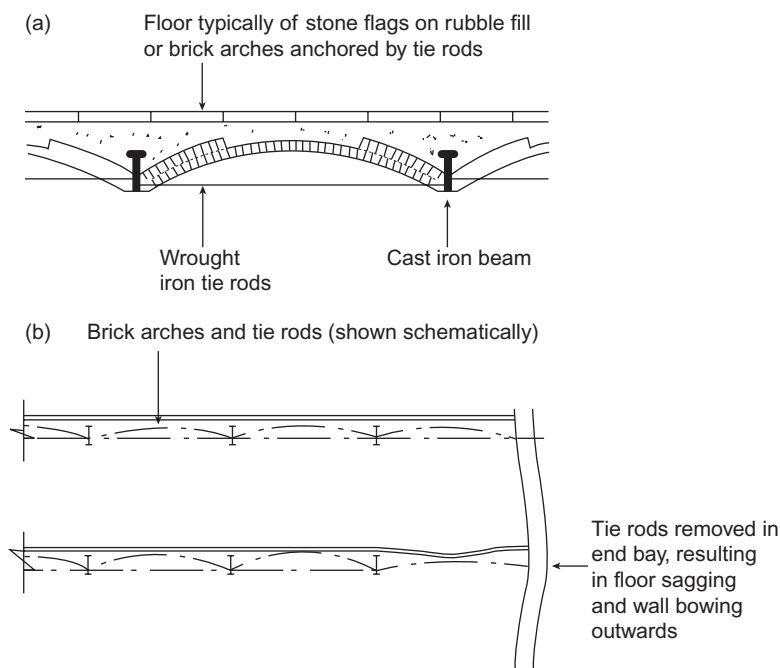
**Figure 7.4** (a) Brick 'jack-arches' in floor, restrained from spreading by tie rods; (b) arch spread and distortion of wall arising from omitted or removed tie rods in end bay.

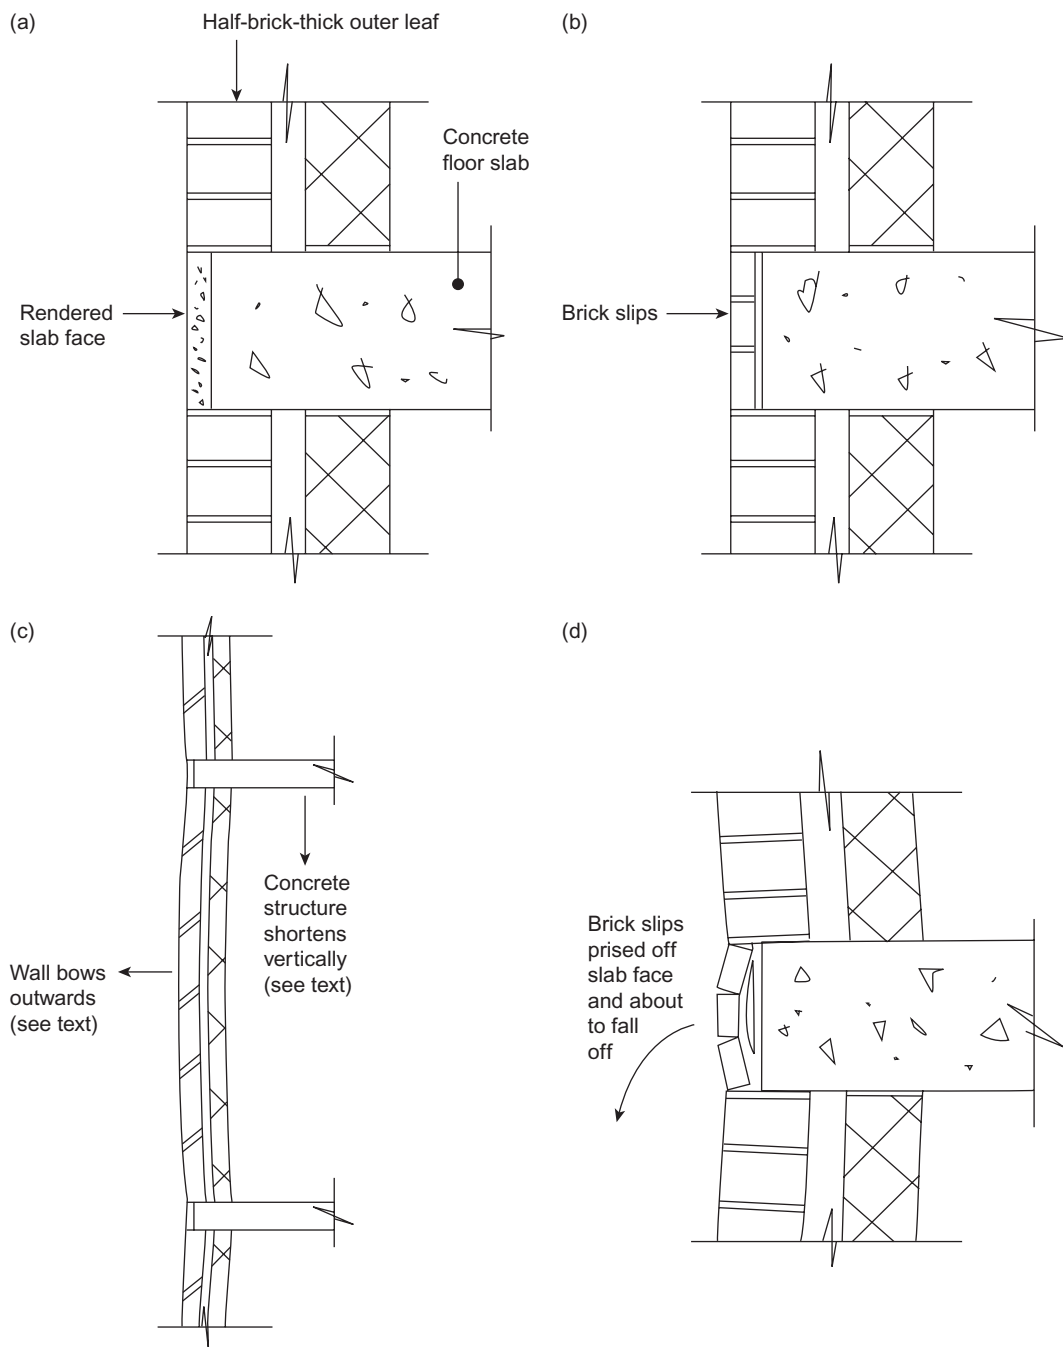
**Figure 7.5** Brick cladding in concrete-framed building: (a) render facing to edge of concrete floor slab; (b) brick 'slips' used in place of render to present continuous brick face; (c) bowing of cavity wall as concrete frame shortens owing to time-dependent movements; (d) brick slips about to be prised off by pressure from bowed walls above and/or below.

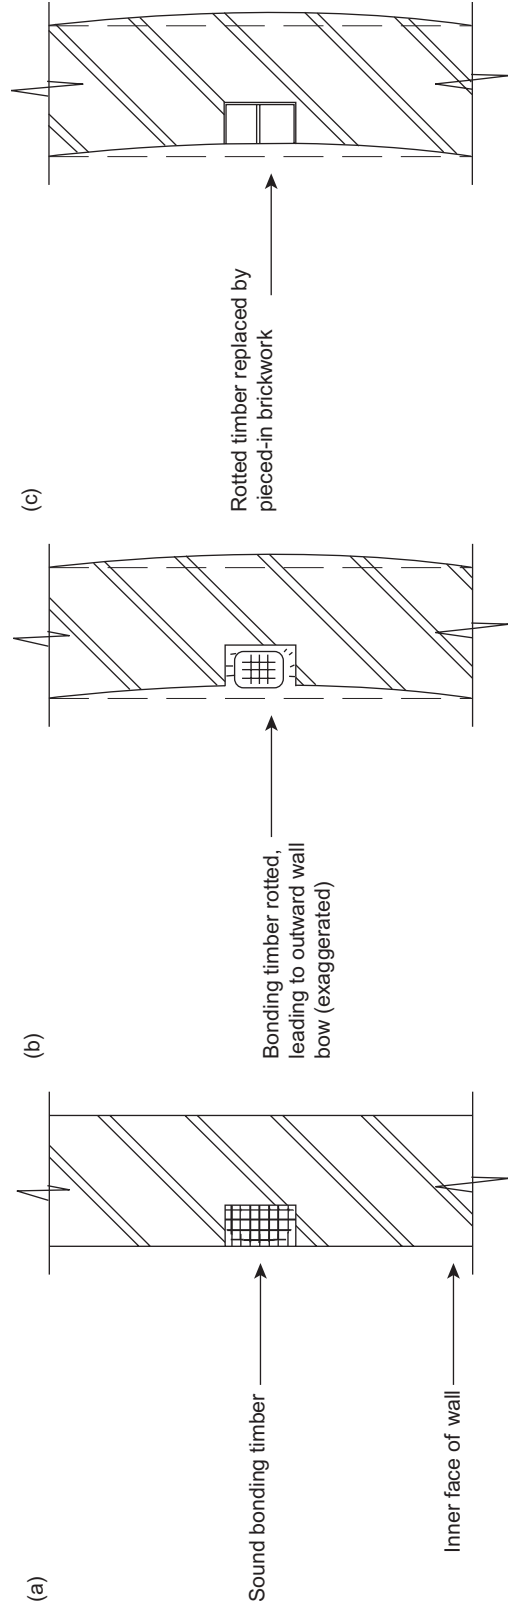
**Figure 7.6** (a) Sound bonding timber in external brick wall; (b) timber later rots, leading to bowing of wall; (c) rotted timber replaced by pieced-in bricks.

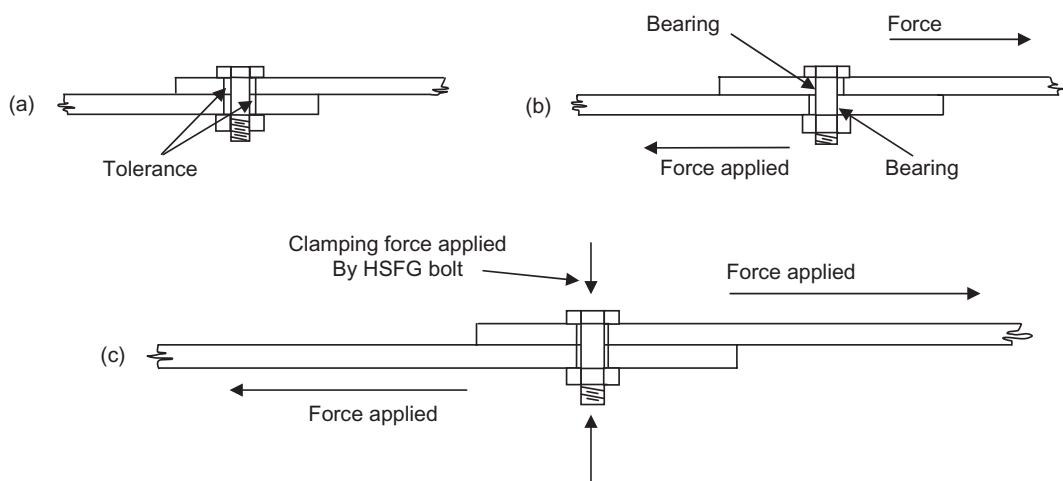
**Figure 8.1** (a) The bolted connection before loading; (b) the bolted connection after loading; (c) how a high-strength friction grip bolt works.

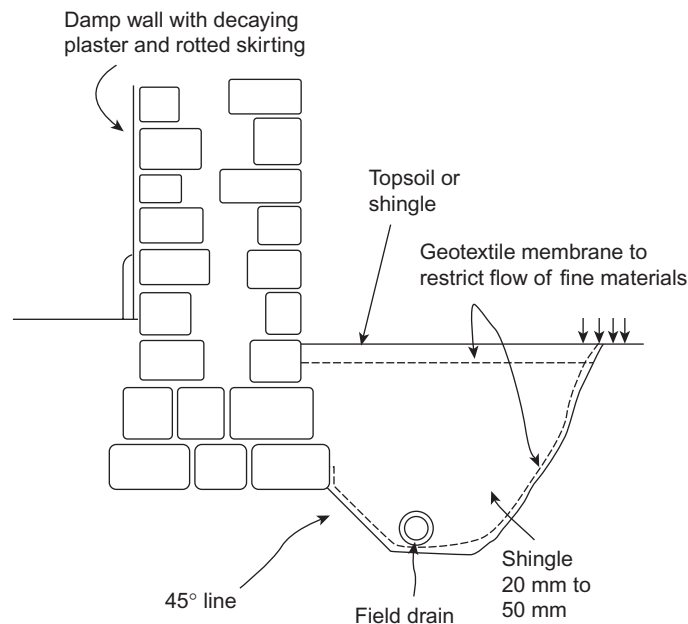
**Figure 8.2** French drain. Excavation must not go beneath the wall or encroach within a 45° line from the base of the wall.

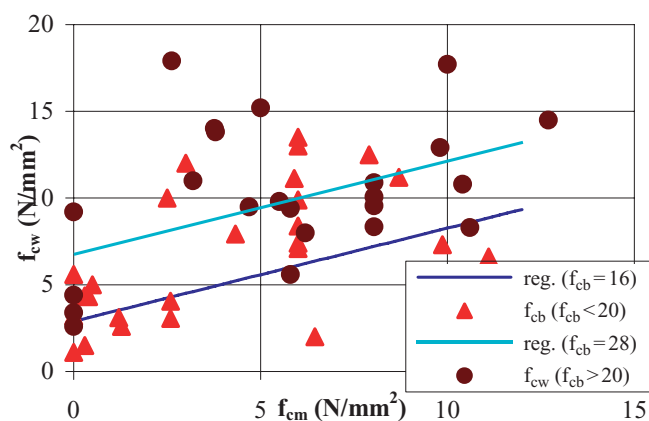
Figure 9.1 Equation (9.1) for discrete values of  $f_{cb}$ .

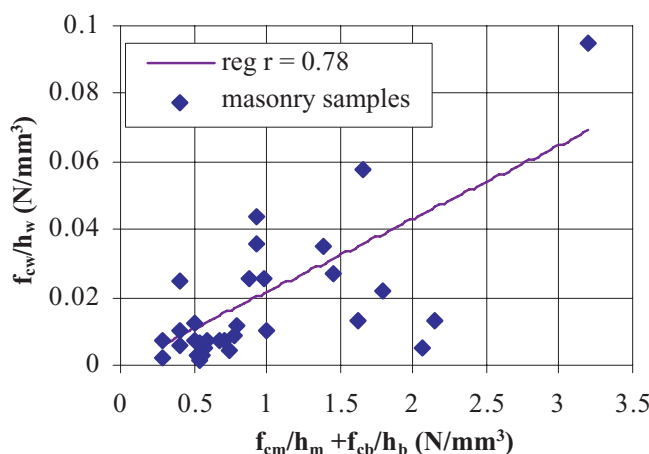
Figure 9.2 Equation (9.2) regression coefficient  $r = 0.78$ .

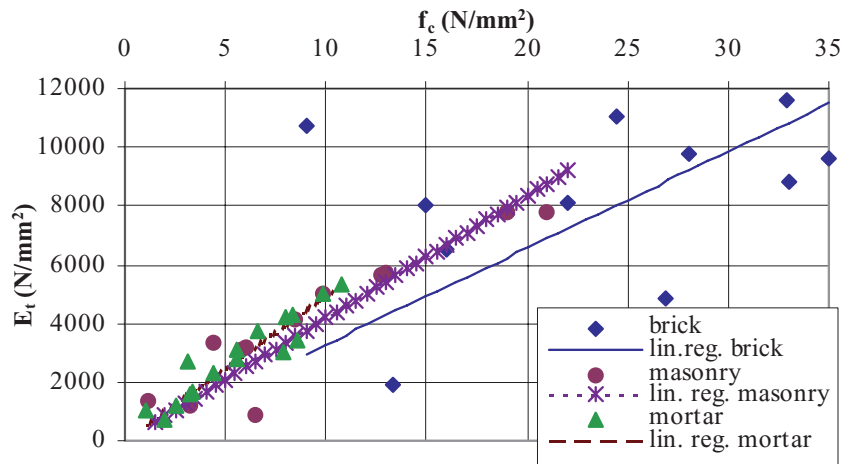
Figure 9.3 Regression of  $E_t$  ( $f_c$ ).

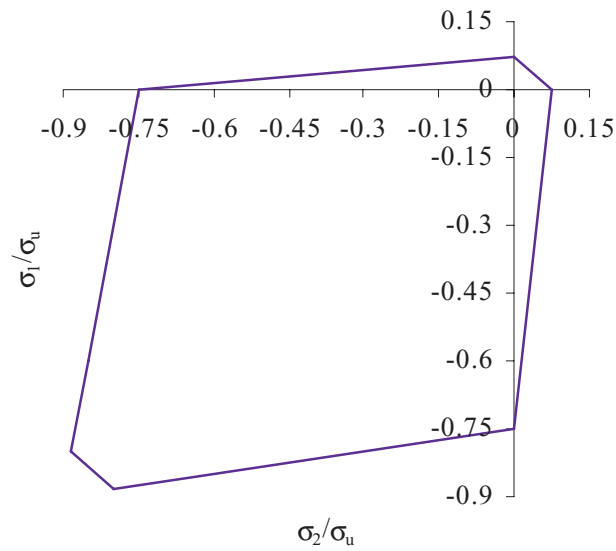
**Figure 9.4** Rankine-type failure domain.

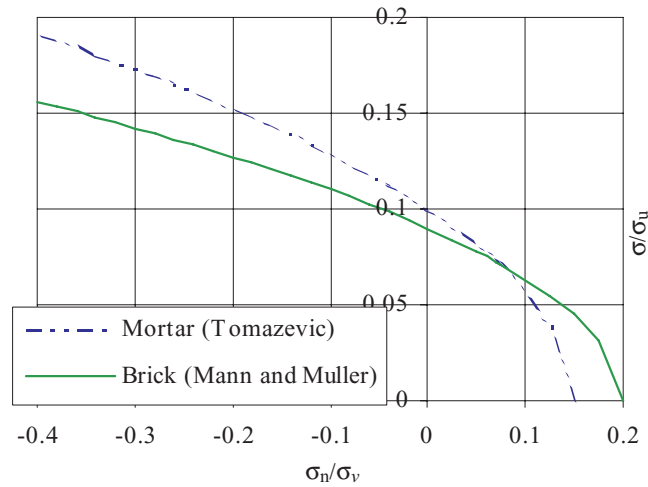
**Figure 9.5** Mohr-Coulomb-type failure domain.

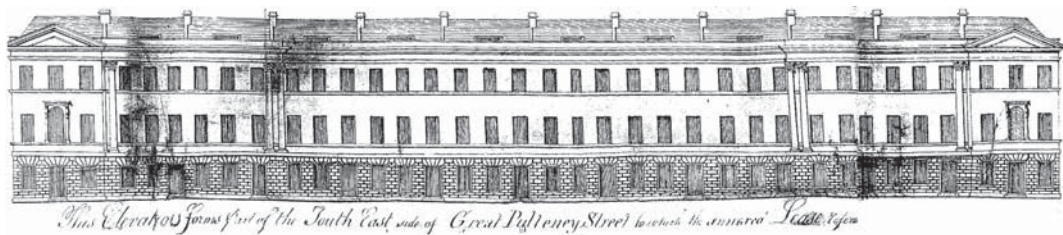
**Figure 9.6** Elevation of nos. 42–51 Great Pulteney Street, Bath, by Thomas Baldwin, from a lease of 1791.

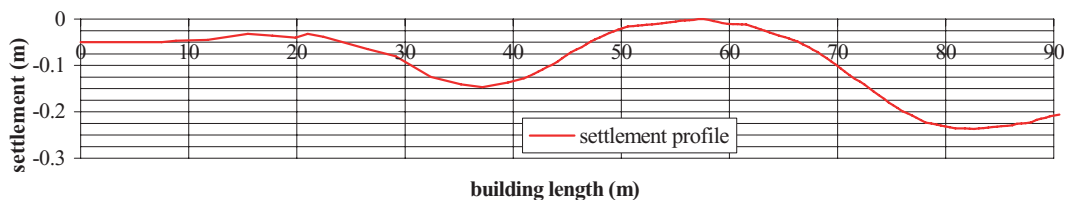
**Figure 9.7** Settlement profile as surveyed at cornice level in 1992 by Cook.

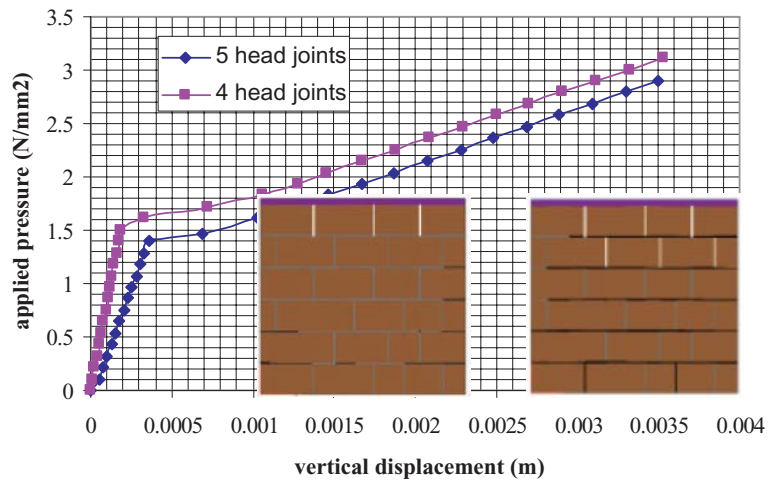
**Figure 9.8**  $p$ - $\delta$  curves for compression test of wallets: white joints indicate tensile failure, black compression.

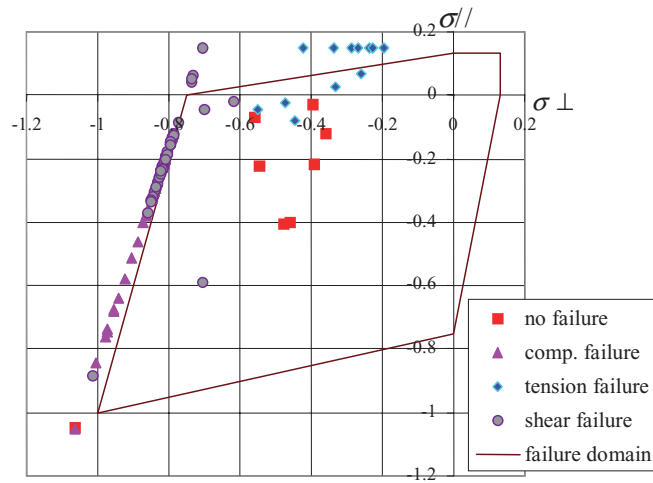
**Figure 9.9** Distribution of state of stress for mortar joints.

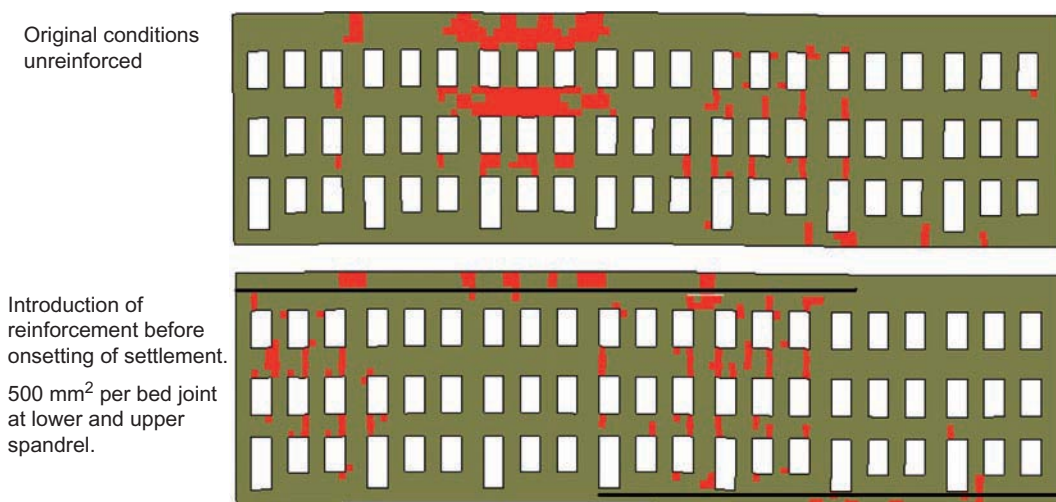
Figure 9.10 Computed crack pattern associated with surveyed settlement.

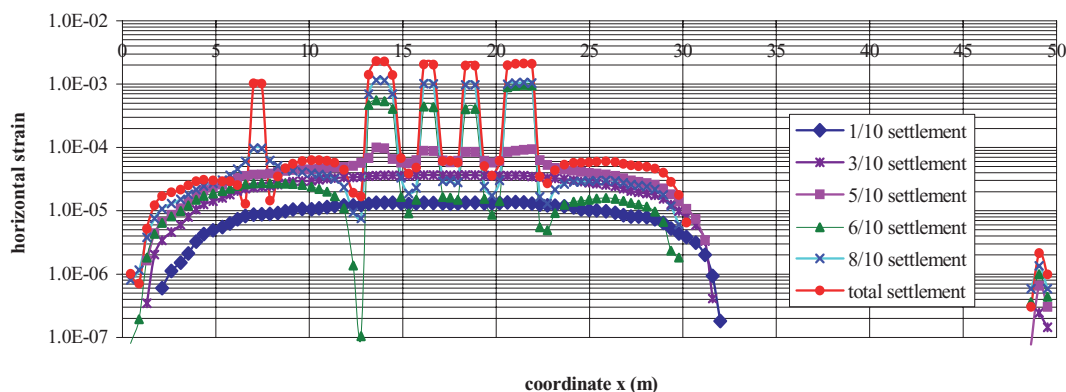
Figure 9.11 Distribution of horizontal strains at top spandrel in original configuration (+ve only).

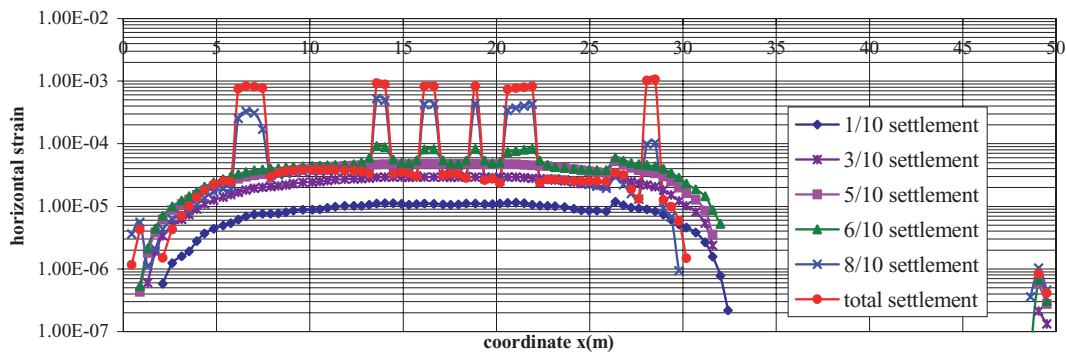
**Figure 9.12** Distribution of horizontal strains at top spandrel in reinforced configuration (+ve only).

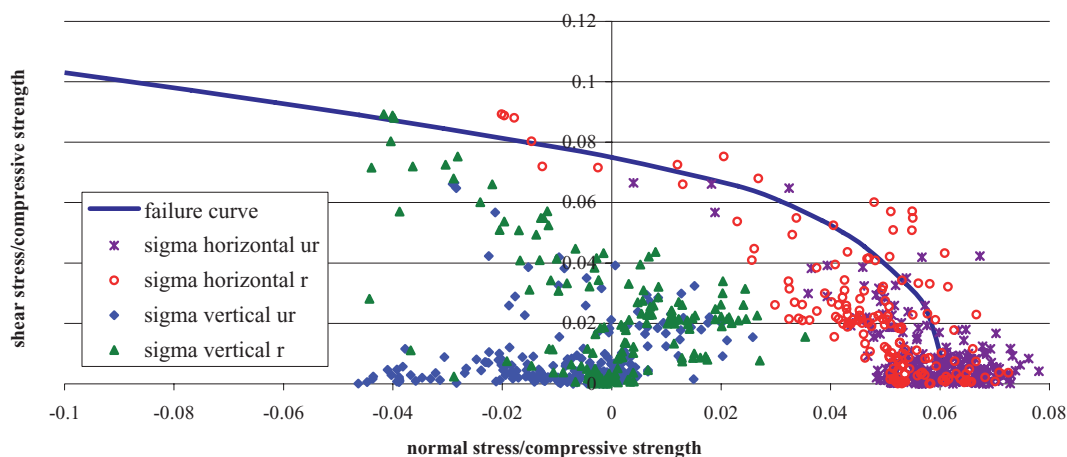
**Figure 9.13** Mohr-Coulomb-type failure curve and state of stress of failed element in two perpendicular planes for the unreinforced and reinforced case.

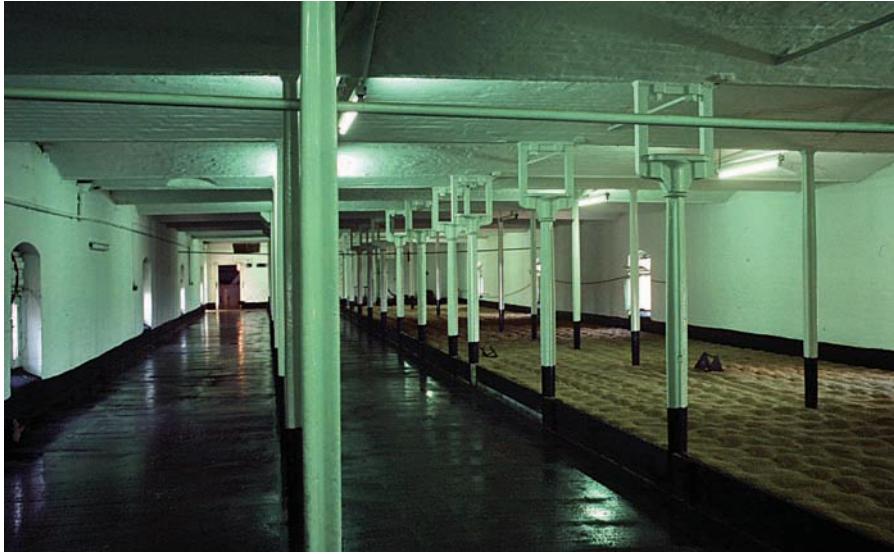
**Figure 10.2** Ditherington Mill, Shrewsbury, Shropshire of 1797, the world's first iron-framed multi-storey building, using cast iron for both beams and its cruciform-section columns.

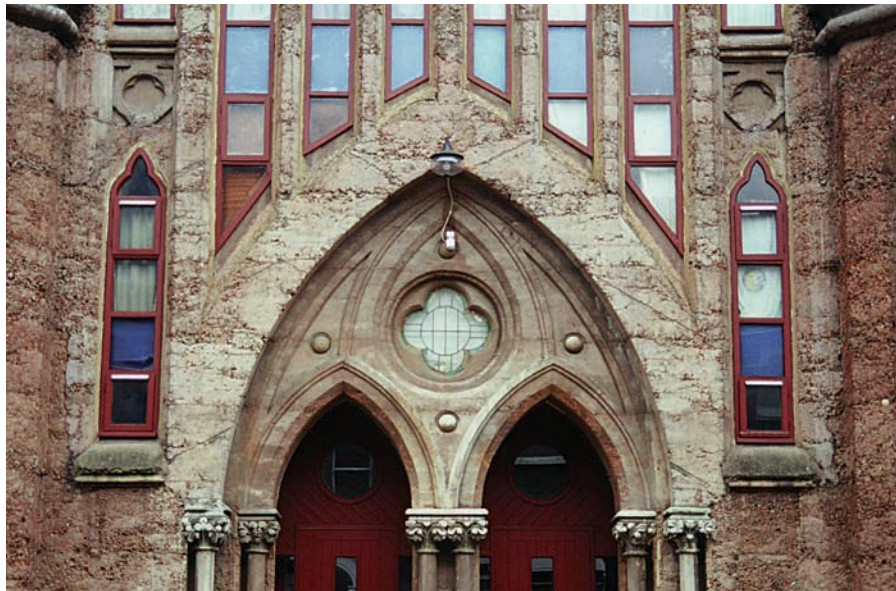
**Figure 11.1** The neo-Gothic, unreinforced mass concrete Swedenborg Church, Waldegrave Road, south London, 1883, by W.J.E. Henley.
