# Erosion

## Introduction

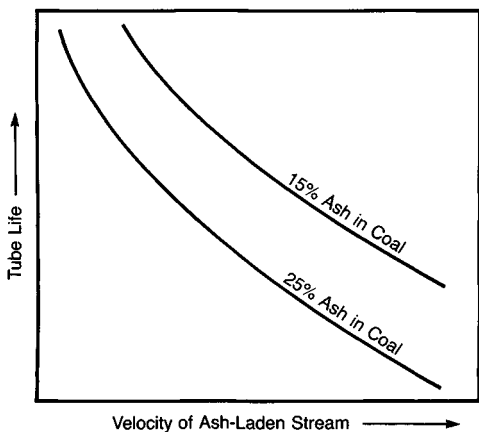
Erosive metal loss increases as particle hardness, flow velocity, and ash concentration increase. Of these factors, flow velocity and ash concentration are most important (Fig. 17.7). Erosive loss increases as the angle of impingement between gas flow and the metal surface increases. The direct incidence of fly ash is more damaging than glancing blows. As temperature increases, erosive metal loss decreases because particles become softer.

**Figure 17.7** Effects of velocity and ash content on the life of a tube. Increases in the number and velocity of the impacting ash particles can result in reduced service life. (Courtesy of Electric Power Research Institute, EPRI Manual for Investigation and Correction of Boiler Tube Failures, EPRI, 1985. Originally in E. Raask, "Tube Erosion by Ash Impaction," WEAR, 13:(1969), pp. 301–315.)
