## Long-Term Overheating

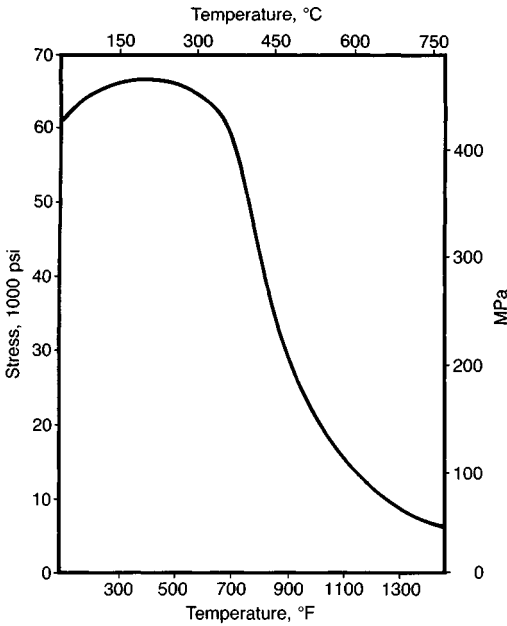
**Figure 2.1** Yield stress of plain carbon steel as a function of temperature. Note the rapid strength decrease above 800°F (430°C).
