Coal-Ash Corrosion

CASE HISTORY 10.1

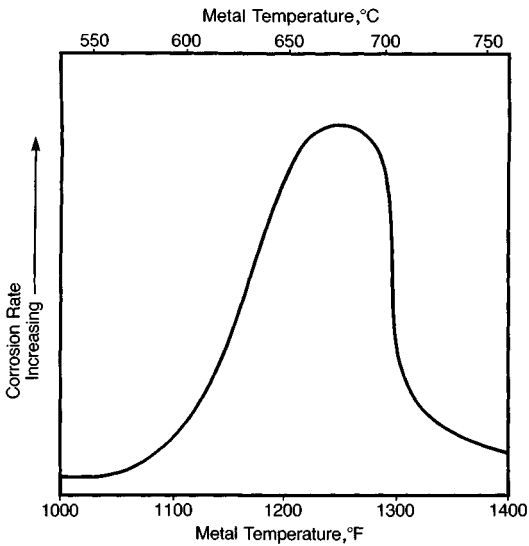
The corrosion rate is a nonlinear function of temperature, reaching a maximum between 1250 and 1350°F (677 and 732°C). At higher temperatures, the corrosion rate decreases rapidly because of thermal decomposition of the corrosives (Fig. 10.2).

Figure 10.2 Nonlinear relationship between temperature and corrosion rate.

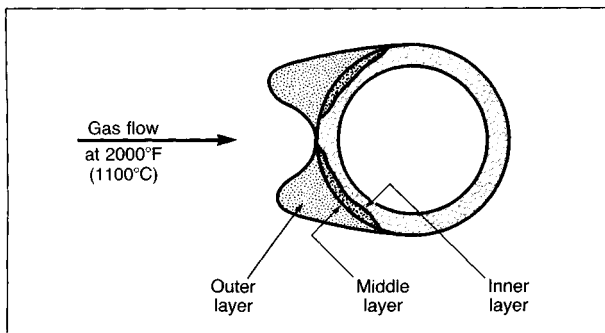
Corrosion is almost always associated with a sintered or slag-type deposit that is strongly bonded to the metal surface. This deposit consists of three distinct layers (Fig. 10.3). The outer layer is a bulky layer of porous

fly ash; the intermediate layer consists of whitish, water-soluble alkali sulfates, which are responsible for the corrosive attack. This layer is typically $\frac{1}{2}$ to $\frac{1}{4}$ in. (0.79 to 6.35 mm) thick; a thin inner layer is composed of glassy black iron oxides and sulfides at the metal surface. This layer is seldom thicker than $\frac{1}{8}$ in. (3.2 mm).

Figure 10.3 Layers of deposit associated with coal-ash corrosion.
